Profile/Photo Observation Report

Street:	OFF PRIVATE DR	Flow Control:	Not Controlled
City:	Hobart, IN	Year Renewed:	
Location:	Other	Tape/Media #:	
Purpose:	Not Known	Dia/Height:	8"
Use:	Sanitary	Material:	VCP
Drain Area:	NA	Lining:	
Category:	NA		
Comment:

Location Details:		Direction of Survey:	Downstream
US MH:	M-704-070	DS MH:	M-704-061
		Total Length Surveyed (ft):	31.8

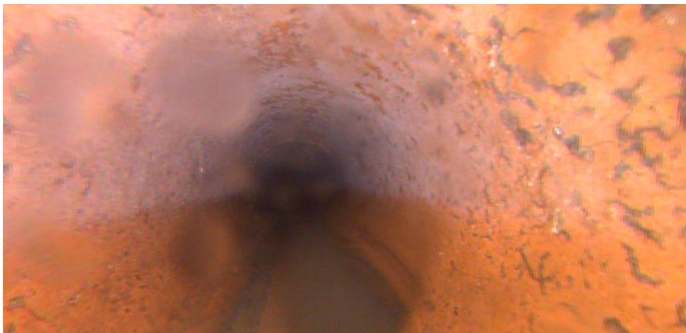
Position	Code	Observation	Video (sec)	Grade
.0	AMH	Manhole	10	NA
.0	MWL	Water Level	21	NA
19.0	RMC	Roots Medium Connection	71	M 3
19.0	TFD	Tap Factory Defective	82	M 2
19.2	RFJ	Roots Fine Joint	94	M 1
29.1	RMJ	Roots Medium Joint	125	M 3
31.8	MSA	Abandoned Survey	141	NA

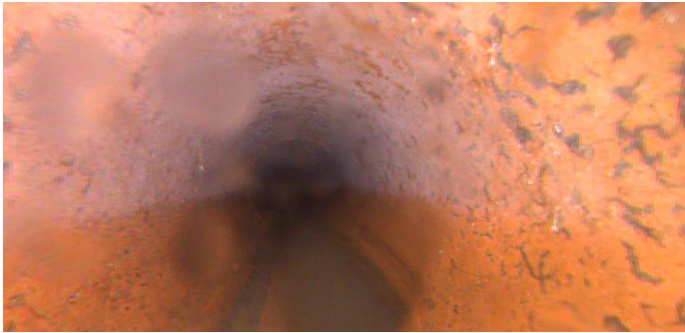
Code:	MWL
Description:	Water Level

Distance (ft):	.0
Structural Grade:	0
O&M Grade:	0
Clock Start/From:	
Clock To:	
1st Value:	
2nd Value:	
Value Percent:	5.000
Continuous Index:	
Within 8" of Joint:	NO
Remarks:

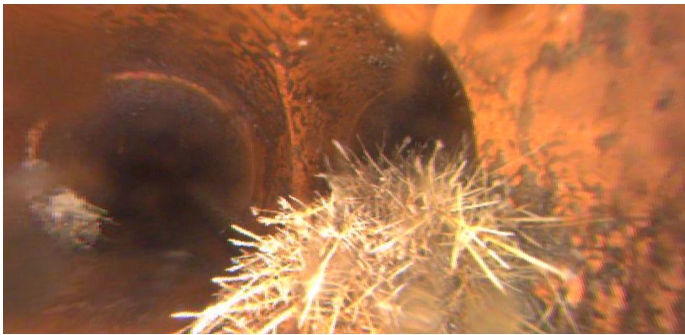
Code:	RMC
Description:	Roots Medium Connection

Distance (ft):	19.0
Structural Grade:	0
O&M Grade:	3
Clock Start/From:	4
Clock To:	5
1st Value:	
2nd Value:	
Value Percent:	10.000
Continuous Index:	
Within 8" of Joint:	NO
Remarks:

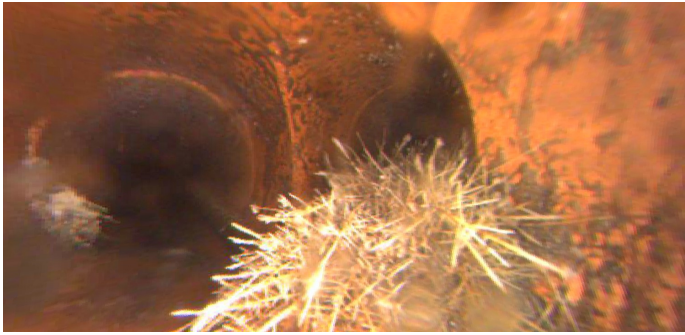
Code: **TFD**
Description: **Tap Factory Defective**

Distance (ft): **19.0**
Structural Grade: **0**
O&M Grade: **2**
Clock Start/From: **3**
Clock To:
1st Value: **4.000**
2nd Value:
Value Percent:
Continuous Index:
Within 8" of Joint: **YES**
Remarks: **partially blocked by roots**

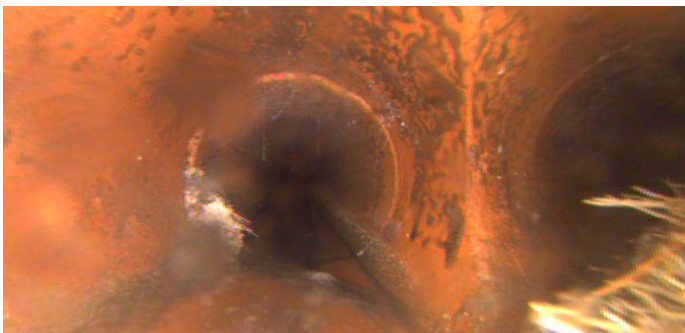
Code: **RFJ**
Description: **Roots Fine Joint**

Distance (ft): **19.2**
Structural Grade: **0**
O&M Grade: **1**
Clock Start/From: **8**
Clock To:
1st Value:
2nd Value:
Value Percent:
Continuous Index:
Within 8" of Joint: **YES**
Remarks:

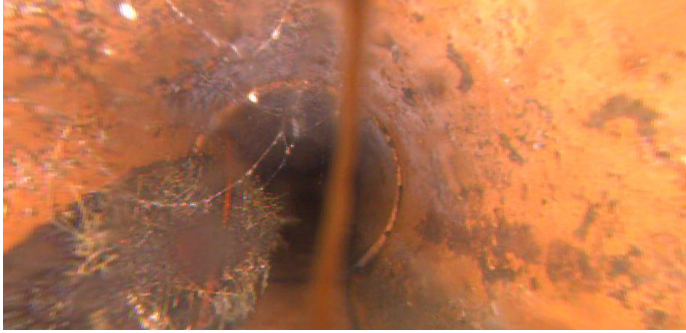
Code: **RMJ**
Description: **Roots Medium Joint**

Distance (ft): **29.1**
Structural Grade: **0**
O&M Grade: **3**
Clock Start/From: **7**
Clock To: **10**
1st Value:
2nd Value:
Value Percent: **20.000**
Continuous Index:
Within 8" of Joint: **YES**
Remarks: **into barrel**

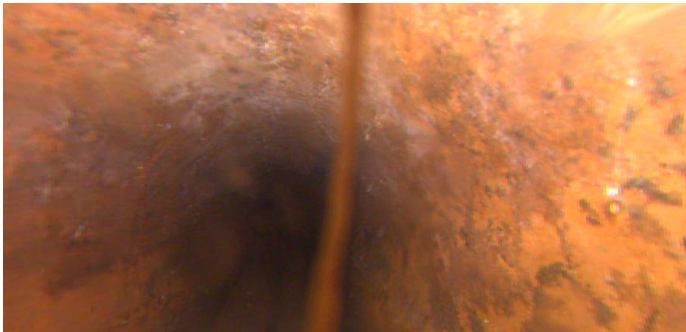
Code: **MSA**
Description: **Abandoned Survey**

Distance (ft): **31.8**
Structural Grade: **0**
O&M Grade: **0**
Clock Start/From:
Clock To:
1st Value:
2nd Value:
Value Percent:
Continuous Index:
Within 8" of Joint: **NO**
Remarks: **rmj**
