Profile/Photo Observation Report

Date:	03/08/2024	Weather:		Coding:	PACP 7.0
Pipe Length (ft):	404.0	Owner:	City of Hobart	Pre Clean:	Light Cleaning
P.O.#:		Surveyor:	S. Bucklin	PSR:	P-704-072.2-072
Customer:	City of Hobart	Clean Date:	03/08/2024	Shape:	C

Street:	SHORE SIDE DR	Flow Control:	Not Controlled
City:	Hobart, IN	Year Renewed:	
Location:	Easement/Right of Way	Tape/Media #:	
Purpose:	Sewer System Evaluation Survey (SS	Dia/Height:	8"
Use:	Sanitary Sewage Pipe	Material:	PVC
Drain Area:		Lining:	None
Category:	NA		
Comment:			
Location Details:		Direction of Survey:	Downstream
US MH:	M-704-072.2	DS MH:	M-704-074
		Total Length Surveyed (ft):	404.4

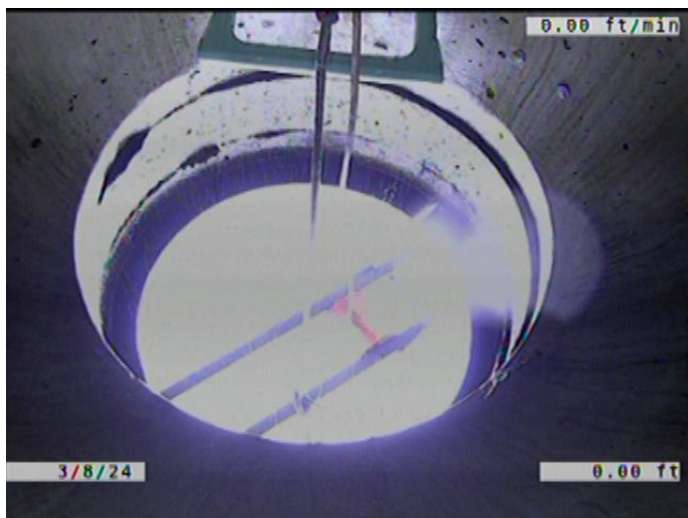
Code: **AMH**
Description: **Manhole**

Distance (ft): **.0**
Structural Grade: **0**
O&M Grade: **0**
Clock Start/From:
Clock To:
1st Value:
2nd Value:
Value Percent:
Continuous Index:
Within 8" of Joint: **NO**
Remarks: **M-704-072.2**

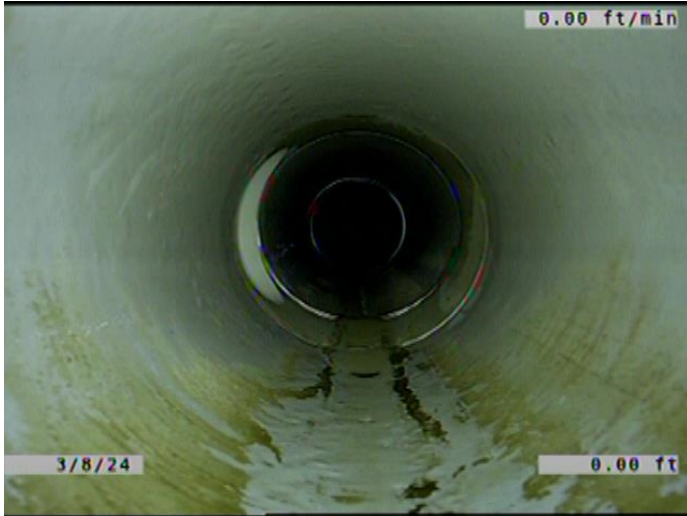
Code:	MWL
Description:	Miscellaneous Water Level
Distance (ft):	.0
Structural Grade:	0
O&M Grade:	0
Clock Start/From:	
Clock To:	
1st Value:	
2nd Value:	
Value Percent:	5.000
Continuous Index:	
Within 8" of Joint:	NO
Remarks:

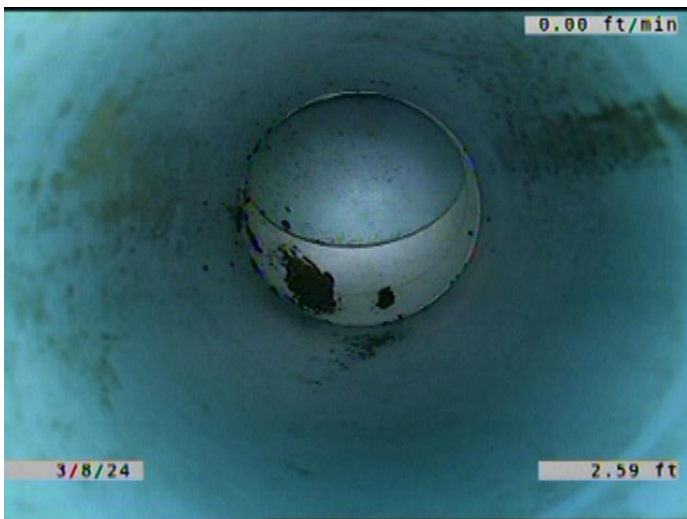
Code:	TF
Description:	Tap Factory
Distance (ft):	2.6
Structural Grade:	0
O&M Grade:	0
Clock Start/From:	9
Clock To:	
1st Value:	6.000
2nd Value:	
Value Percent:	
Continuous Index:	
Within 8" of Joint:	YES
Remarks:

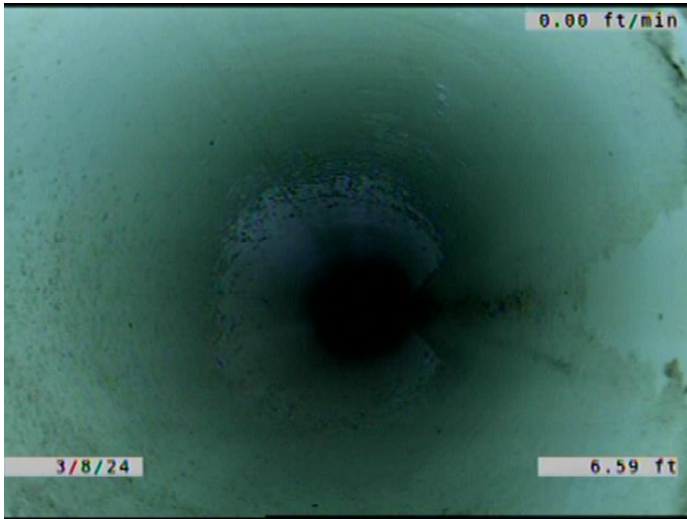
Code: **TF**
Description: **Tap Factory**

Distance (ft): **6.6**
Structural Grade: **0**
O&M Grade: **0**
Clock Start/From: **3**
Clock To:
1st Value: **6.000**
2nd Value:
Value Percent:
Continuous Index:
Within 8" of Joint: **YES**
Remarks:

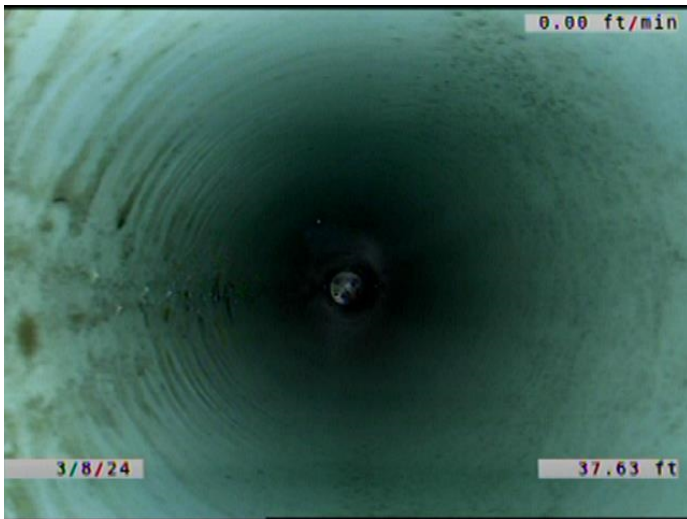
Code: **TFC**
Description: **Tap Factory Capped**

Distance (ft): **37.6**
Structural Grade: **0**
O&M Grade: **0**
Clock Start/From: **9**
Clock To:
1st Value: **6.000**
2nd Value:
Value Percent:
Continuous Index:
Within 8" of Joint: **YES**
Remarks:

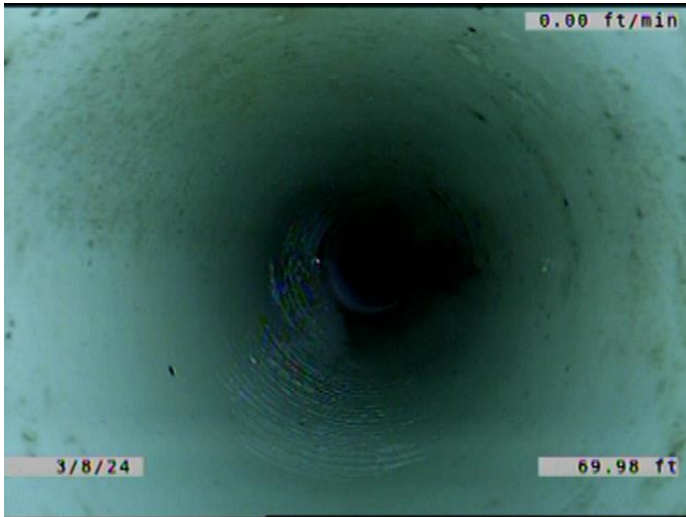
Code: **TF**
Description: **Tap Factory**

Distance (ft): **70.0**
Structural Grade: **0**
O&M Grade: **0**
Clock Start/From: **3**
Clock To:
1st Value: **6.000**
2nd Value:
Value Percent:
Continuous Index:
Within 8" of Joint: **YES**
Remarks:

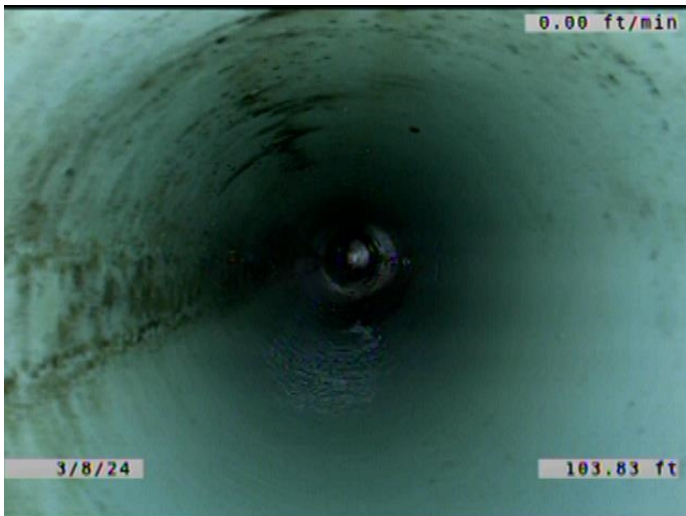
Code: **TFC**
Description: **Tap Factory Capped**

Distance (ft): **103.8**
Structural Grade: **0**
O&M Grade: **0**
Clock Start/From: **9**
Clock To:
1st Value: **6.000**
2nd Value:
Value Percent:
Continuous Index:
Within 8" of Joint: **YES**
Remarks:

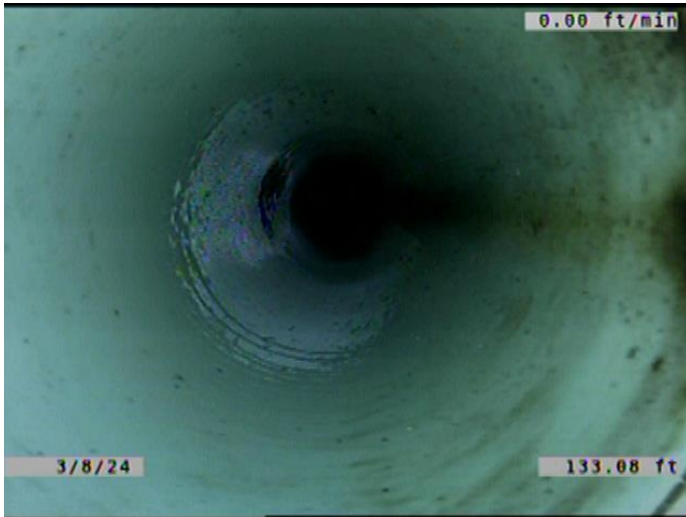
Code: **TF**
Description: **Tap Factory**

Distance (ft): **133.1**
Structural Grade: **0**
O&M Grade: **0**
Clock Start/From: **3**
Clock To:
1st Value: **6.000**
2nd Value:
Value Percent:
Continuous Index:
Within 8" of Joint: **YES**
Remarks:

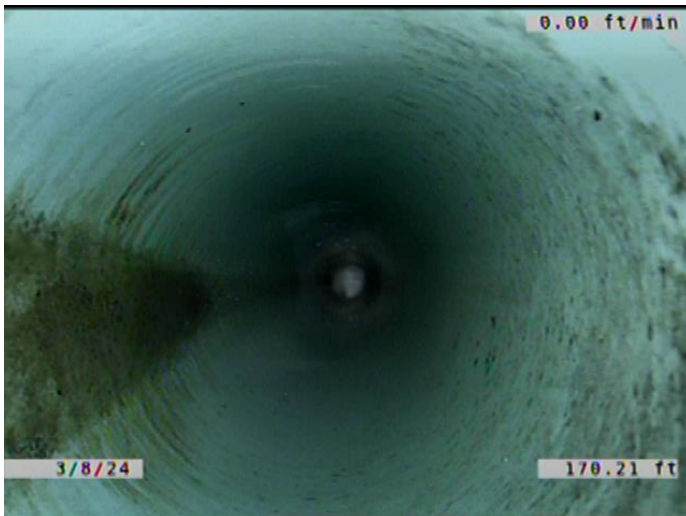
Code: **TFC**
Description: **Tap Factory Capped**

Distance (ft): **170.2**
Structural Grade: **0**
O&M Grade: **0**
Clock Start/From: **9**
Clock To:
1st Value: **6.000**
2nd Value:
Value Percent:
Continuous Index:
Within 8" of Joint: **YES**
Remarks:

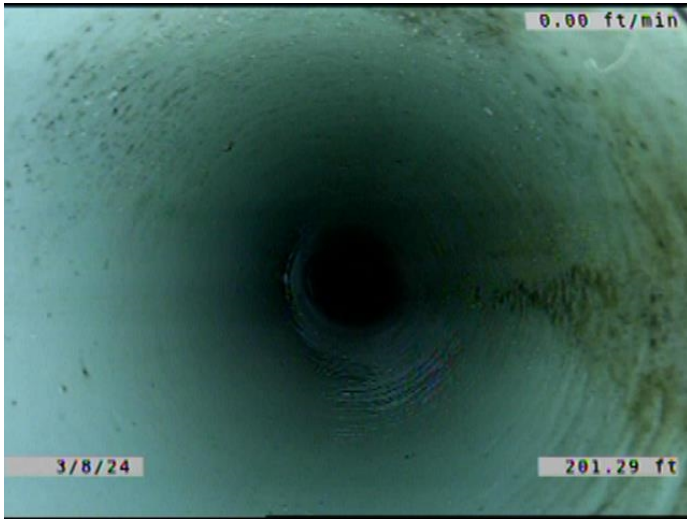
Code: **TF**
Description: **Tap Factory**

Distance (ft): **201.3**
Structural Grade: **0**
O&M Grade: **0**
Clock Start/From: **3**
Clock To:
1st Value: **6.000**
2nd Value:
Value Percent:
Continuous Index:
Within 8" of Joint: **YES**
Remarks:

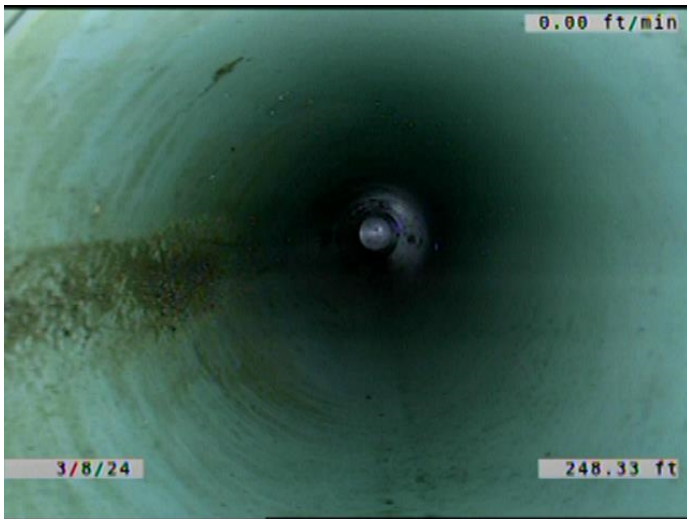
Code: **TFC**
Description: **Tap Factory Capped**

Distance (ft): **248.3**
Structural Grade: **0**
O&M Grade: **0**
Clock Start/From: **9**
Clock To:
1st Value: **6.000**
2nd Value:
Value Percent:
Continuous Index:
Within 8" of Joint: **YES**
Remarks:

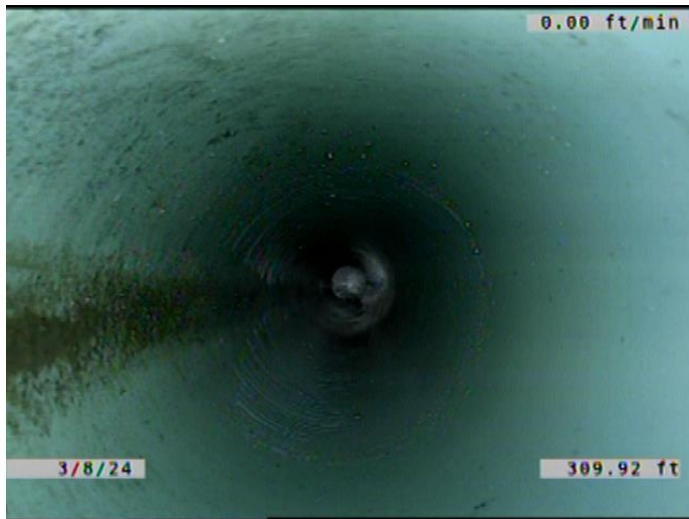
Code: **TFC**
Description: **Tap Factory Capped**

Distance (ft): **309.9**
Structural Grade: **0**
O&M Grade: **0**
Clock Start/From: **9**
Clock To:
1st Value: **6.000**
2nd Value:
Value Percent:
Continuous Index:
Within 8" of Joint: **YES**
Remarks:

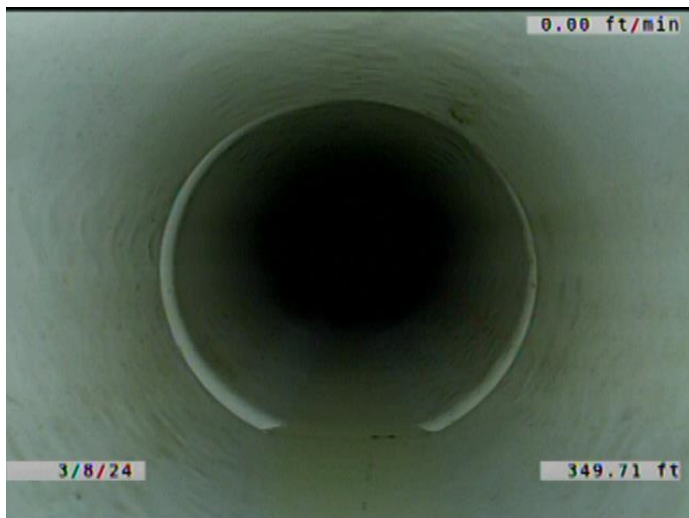
Code: **MWLS**
Description: **Miscellaneous Water Level Sag**

Distance (ft): **349.7**
Structural Grade: **2**
O&M Grade: **0**
Clock Start/From:
Clock To:
1st Value:
2nd Value:
Value Percent: **5.000**
Continuous Index:
Within 8" of Joint: **NO**
Remarks:

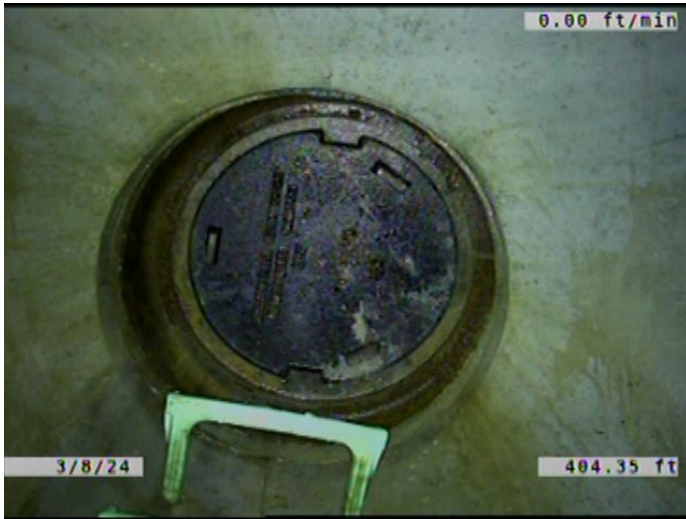
Code:	AMH
Description:	Manhole
Distance (ft):	404.4
Structural Grade:	0
O&M Grade:	0
Clock Start/From:	
Clock To:	
1st Value:	
2nd Value:	
Value Percent:	
Continuous Index:	
Within 8" of Joint:	NO
Remarks:	M-704-074
