Profile/Photo Observation Report

Street:	339 Edgewater Dr	Flow Control:	Not Controlled
City:	Hobart In	Year Renewed:	
Location:	Sidewalk	Tape/Media #:	Deliverable 1
Purpose:	Routine Assessment	Dia/Height:	8"
Use:	Sanitary	Material:	PVC
Drain Area:	Northeast	Lining:	
Category:	NA		
Comment:	436-1/DSMH is covered/8" diameter pipe.		
Location Details:	Edge of walk	Direction of Survey:	Downstream
US MH:	M-704-073	DS MH:	M-704-074
		Total Length Surveyed (ft):	233.1

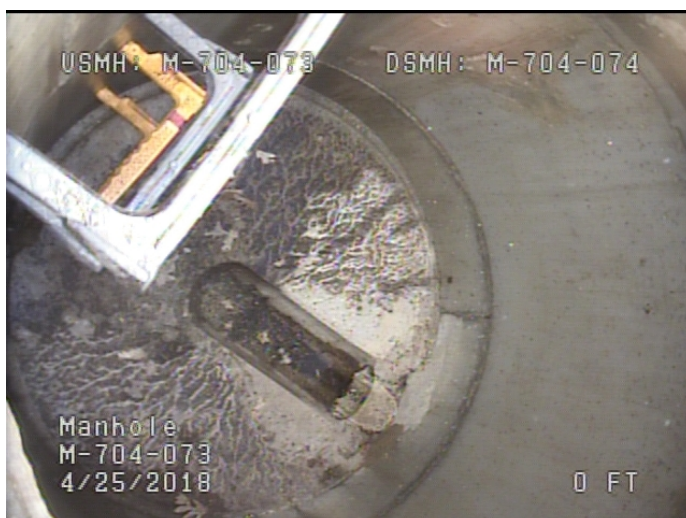
Code:	AMH
Description:	Manhole
Distance (ft):	.0
Structural Grade:	0
O&M Grade:	0
Clock Start/From:	
Clock To:	
1st Value:	
2nd Value:	
Value Percent:	
Continuous Index:	
Within 8" of Joint:	NO
Remarks:	M-704-073

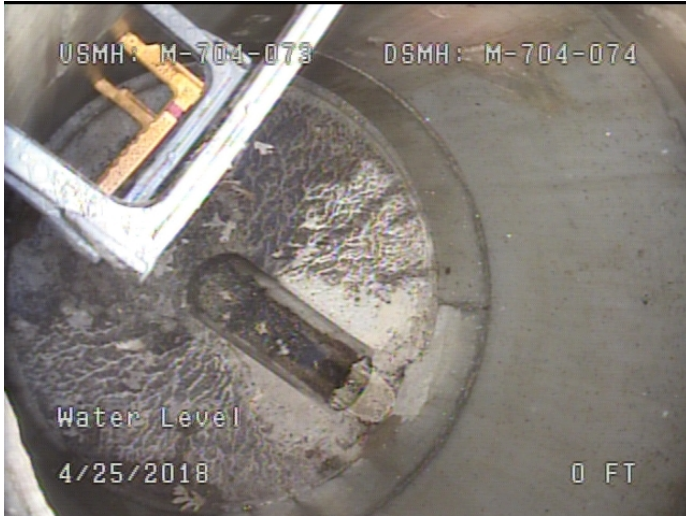
Code: **MWL**
Description: **Water Level**

Distance (ft): **.0**
Structural Grade: **0**
O&M Grade: **0**
Clock Start/From:
Clock To:
1st Value:
2nd Value:
Value Percent: **0.000**
Continuous Index:
Within 8" of Joint: **NO**
Remarks:

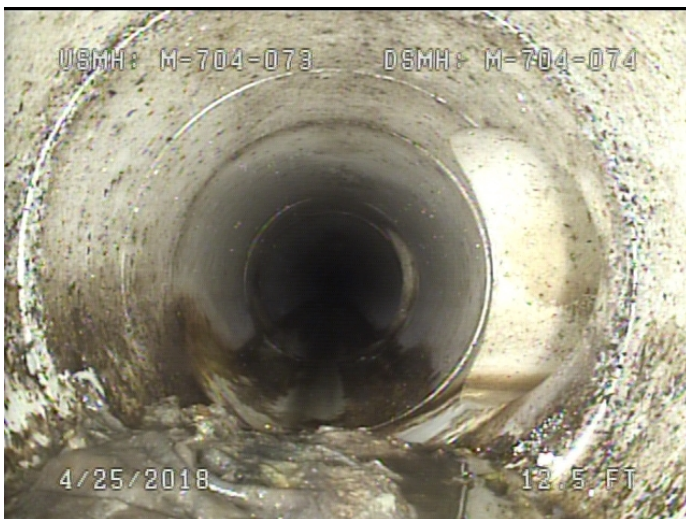
Code: **TF**
Description: **Tap Factory**

Distance (ft): **12.5**
Structural Grade: **0**
O&M Grade: **0**
Clock Start/From: **3**
Clock To:
1st Value: **6.000**
2nd Value:
Value Percent:
Continuous Index:
Within 8" of Joint: **NO**
Remarks:

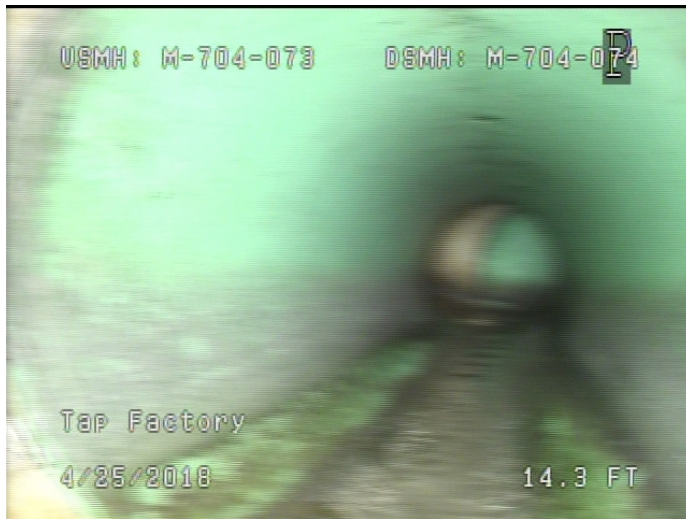
Code: **TF**
 Description: **Tap Factory**

Distance (ft): **14.3**
 Structural Grade: **0**
 O&M Grade: **0**
 Clock Start/From: **3**
 Clock To:
 1st Value: **6.000**
 2nd Value:
 Value Percent:
 Continuous Index:
 Within 8" of Joint: **NO**
 Remarks:

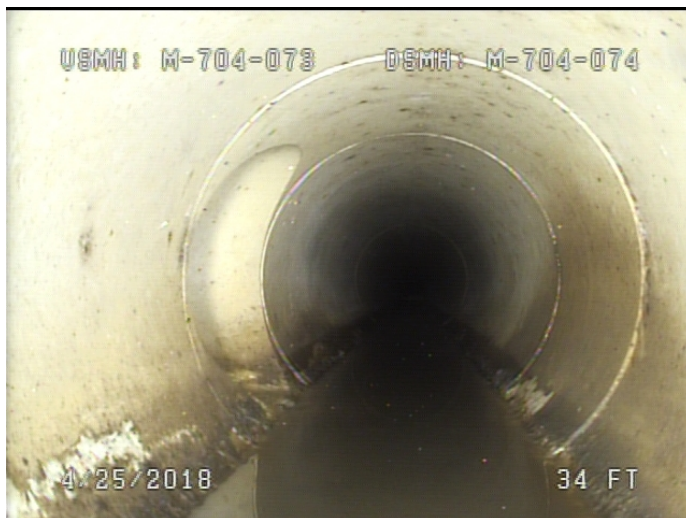
Code: **TF**
 Description: **Tap Factory**

Distance (ft): **34.0**
 Structural Grade: **0**
 O&M Grade: **0**
 Clock Start/From: **9**
 Clock To:
 1st Value: **6.000**
 2nd Value:
 Value Percent:
 Continuous Index:
 Within 8" of Joint: **NO**
 Remarks:

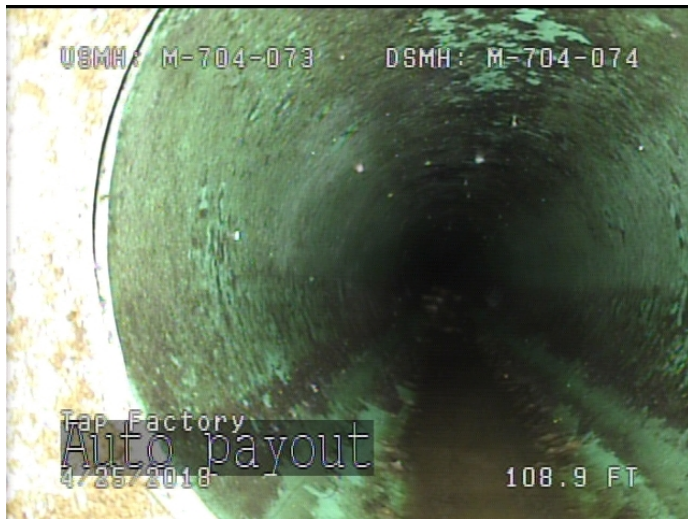
Code: **TF**
 Description: **Tap Factory**

Distance (ft): **108.8**
 Structural Grade: **0**
 O&M Grade: **0**
 Clock Start/From: **3**
 Clock To:
 1st Value: **6.000**
 2nd Value:
 Value Percent:
 Continuous Index:
 Within 8" of Joint: **NO**
 Remarks:

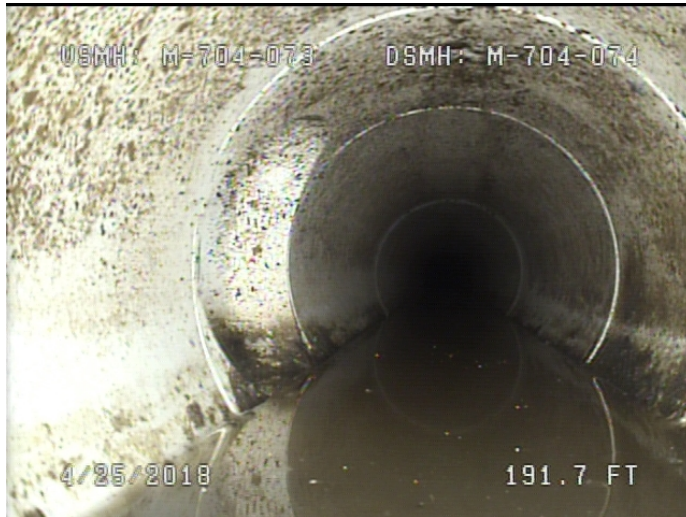
Code: **TF**
 Description: **Tap Factory**

Distance (ft): **191.7**
 Structural Grade: **0**
 O&M Grade: **0**
 Clock Start/From: **9**
 Clock To:
 1st Value: **6.000**
 2nd Value:
 Value Percent:
 Continuous Index:
 Within 8" of Joint: **NO**
 Remarks:

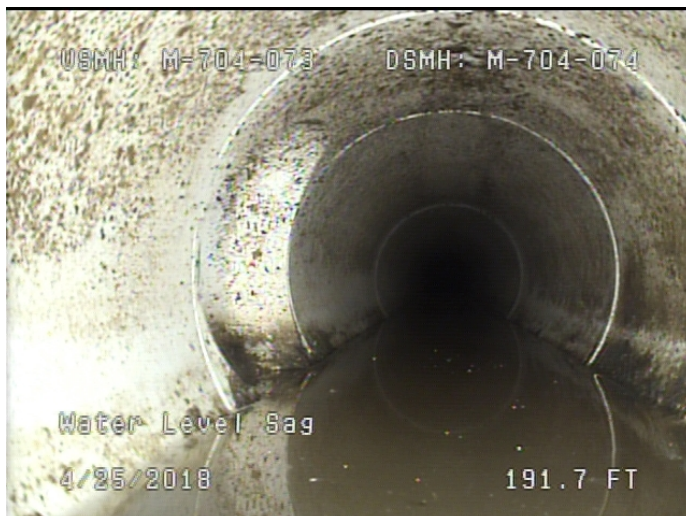
Code: **MWLS**
 Description: **Water Level Sag**

Distance (ft): **191.7**
 Structural Grade: **2**
 O&M Grade: **3**
 Clock Start/From:
 Clock To:
 1st Value:
 2nd Value:
 Value Percent: **20.000**
 Continuous Index: **S01**
 Within 8" of Joint: **NO**
 Remarks:

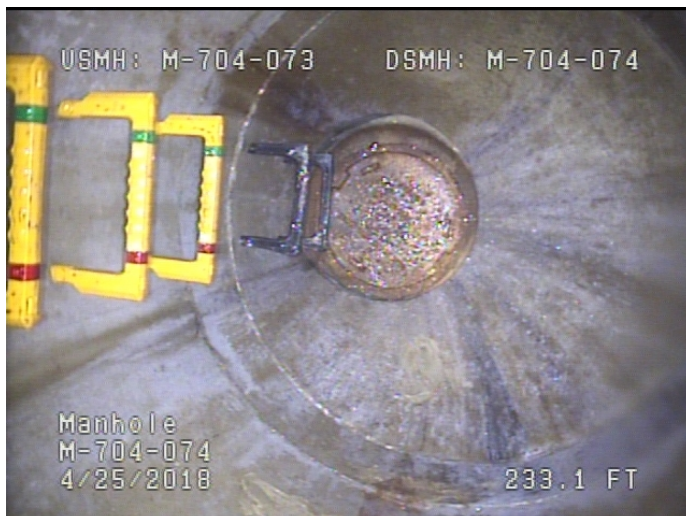
Code: **AMH**
 Description: **Manhole**

Distance (ft): **233.1**
 Structural Grade: **0**
 O&M Grade: **0**
 Clock Start/From:
 Clock To:
 1st Value:
 2nd Value:
 Value Percent:
 Continuous Index:
 Within 8" of Joint: **NO**
 Remarks: **M-704-074**
