Profile/Photo Observation Report

Street:	HARBOR CLUB DR	Flow Control:	Not Controlled
City:	Hobart, IN	Year Renewed:	
Location:	Easement/Right of Way	Tape/Media #:	
Purpose:	Sewer System Evaluation Survey (SS	Dia/Height:	8"
Use:	Sanitary Sewage Pipe	Material:	PVC
Drain Area:		Lining:	None
Category:	NA		
Comment:			
Location Details:		Direction of Survey:	Downstream
US MH:	M-704-075	DS MH:	M-704-051
		Total Length Surveyed (ft):	170.2

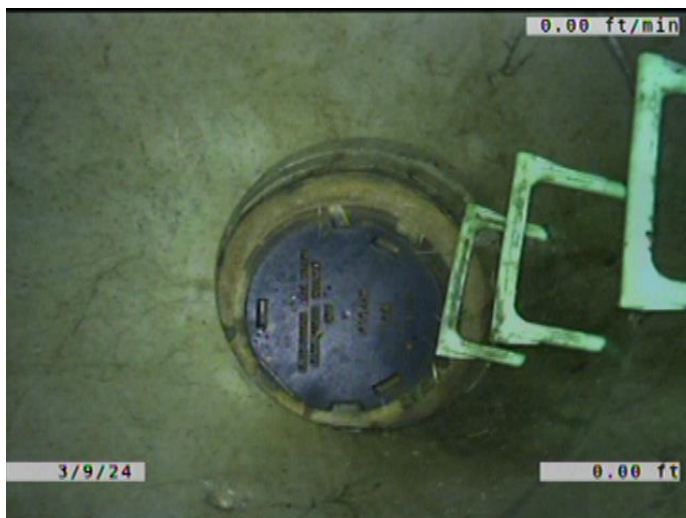
Code: **AMH**
Description: **Manhole**

Distance (ft): **.0**
Structural Grade: **0**
O&M Grade: **0**
Clock Start/From:
Clock To:
1st Value:
2nd Value:
Value Percent:
Continuous Index:
Within 8" of Joint: **NO**
Remarks: **M-704-075**

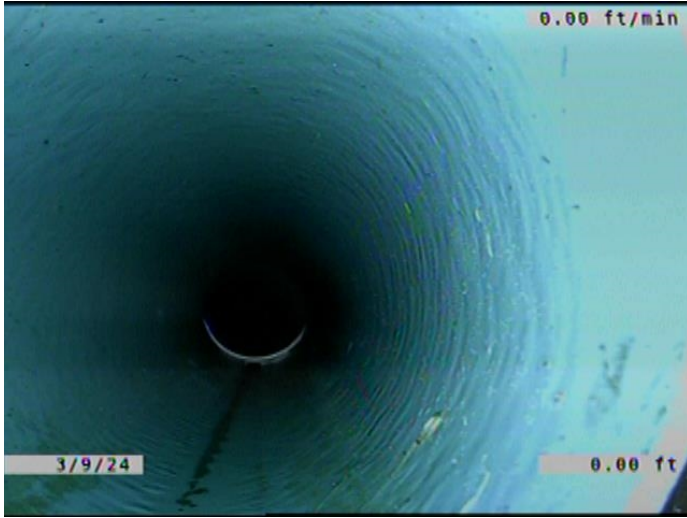
Code:	MWL
Description:	Miscellaneous Water Level
Distance (ft):	.0
Structural Grade:	0
O&M Grade:	0
Clock Start/From:	
Clock To:	
1st Value:	
2nd Value:	
Value Percent:	5.000
Continuous Index:	
Within 8" of Joint:	NO
Remarks:

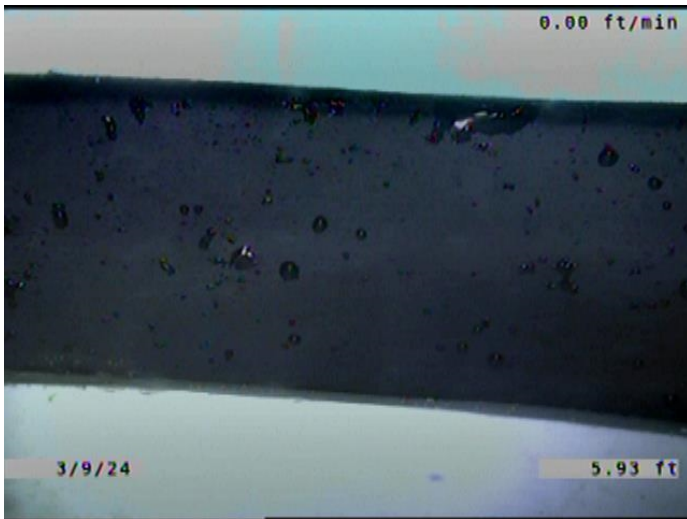
Code:	MGO
Description:	Miscellaneous General Observation
Distance (ft):	5.9
Structural Grade:	0
O&M Grade:	0
Clock Start/From:	
Clock To:	
1st Value:	
2nd Value:	
Value Percent:	
Continuous Index:	
Within 8" of Joint:	NO
Remarks:	WHERE BOWEN TIED THE EXISTING SEWER BACK TOGETHER AFTER THEY

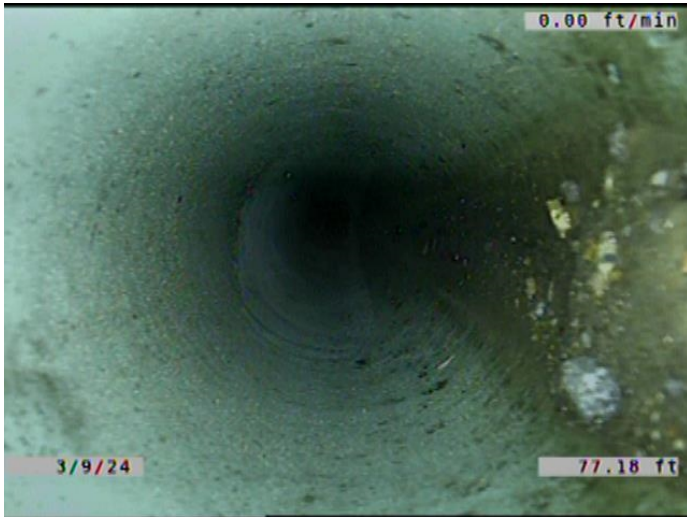
Code: **TF**
Description: **Tap Factory**

Distance (ft): **77.2**
Structural Grade: **0**
O&M Grade: **0**
Clock Start/From: **3**
Clock To:
1st Value: **6.000**
2nd Value:
Value Percent:
Continuous Index:
Within 8" of Joint: **YES**
Remarks:

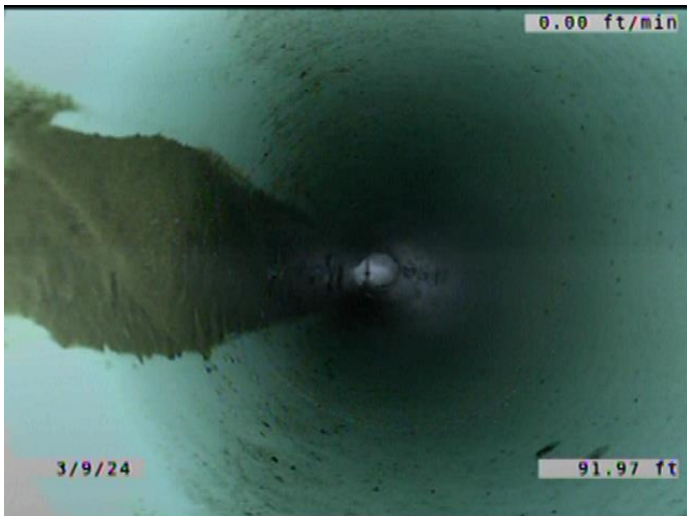
Code: **TFC**
Description: **Tap Factory Capped**

Distance (ft): **92.0**
Structural Grade: **0**
O&M Grade: **0**
Clock Start/From: **9**
Clock To:
1st Value: **6.000**
2nd Value:
Value Percent:
Continuous Index:
Within 8" of Joint: **YES**
Remarks:

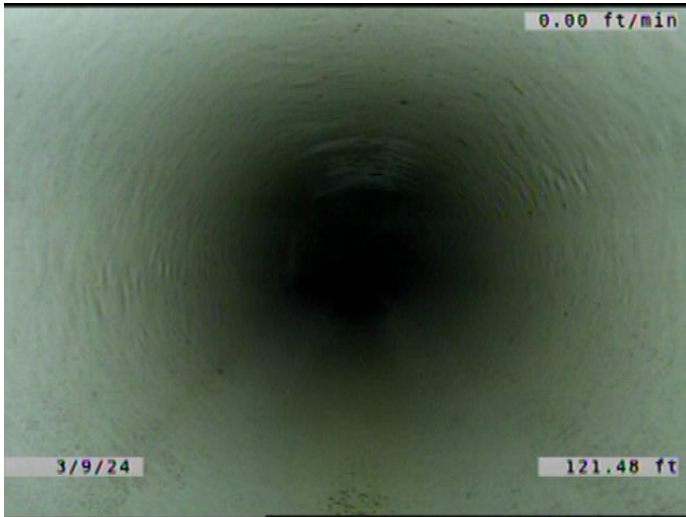
Code: **MWLS**
Description: **Miscellaneous Water Level Sag**

Distance (ft): **121.5**
Structural Grade: **2**
O&M Grade: **0**
Clock Start/From:
Clock To:
1st Value:
2nd Value:
Value Percent: **5.000**
Continuous Index:
Within 8" of Joint: **NO**
Remarks:

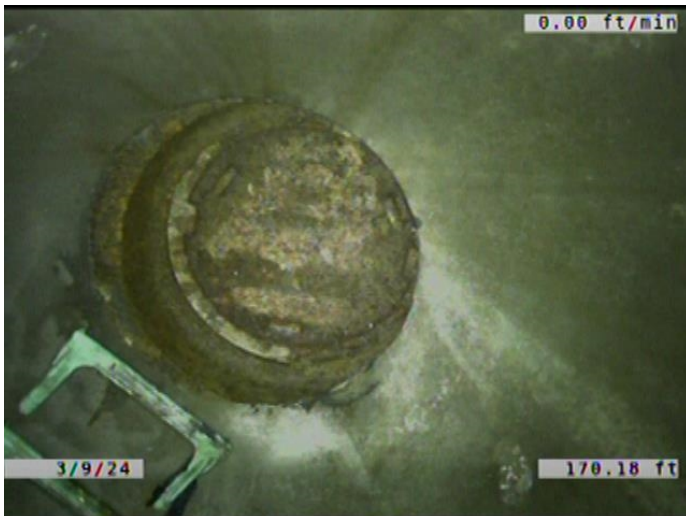
Code: **AMH**
Description: **Manhole**

Distance (ft): **170.2**
Structural Grade: **0**
O&M Grade: **0**
Clock Start/From:
Clock To:
1st Value:
2nd Value:
Value Percent:
Continuous Index:
Within 8" of Joint: **NO**
Remarks: **M-704-051**
