Profile/Photo Observation Report

Date:	04/22/2018	Weather:		Coding:	PACP 6.0
Pipe Length (ft):	195.7	Owner:	NA	Pre Clean:	Not Known
P.O.#:		Surveyor:	Mark Ruby	PSR:	P-705-080-014
Customer:		Clean Date:	01/01/1900	Shape:	C

Street:	OFF S LAKE PARK AV	Flow Control:	Not Controlled
City:	Hobart, IN	Year Renewed:	
Location:	Other	Tape/Media #:	
Purpose:	Not Known	Dia/Height:	8"
Use:	Sanitary	Material:	VCP
Drain Area:	NA	Lining:	
Category:	NA		
Comment:

Location Details:		Direction of Survey:	Upstream
US MH:	M-705-014	DS MH:	M-705-080
		Total Length Surveyed (ft):	74.9

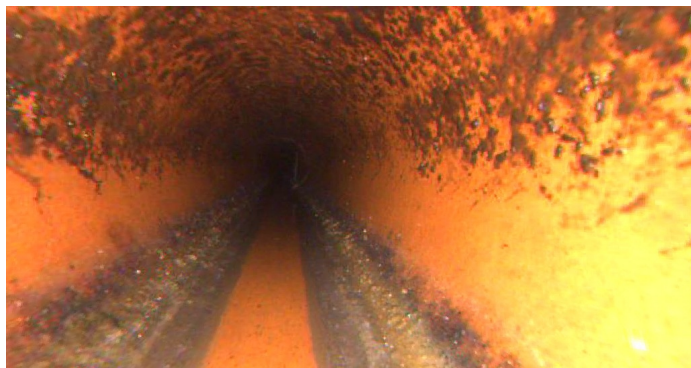
Code: **AMH**
Description: **Manhole**

Distance (ft): **.0**
Structural Grade: **0**
O&M Grade: **0**
Clock Start/From:
Clock To:
1st Value:
2nd Value:
Value Percent:
Continuous Index:
Within 8" of Joint: **NO**
Remarks: **M-705-080**

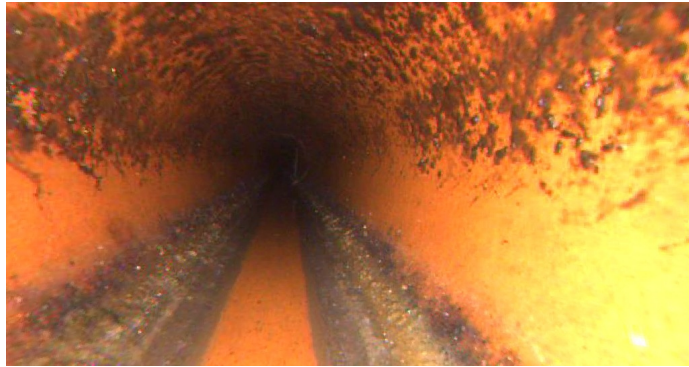
Code: **MWL**
Description: **Water Level**

Distance (ft): **.0**
Structural Grade: **0**
O&M Grade: **0**
Clock Start/From:
Clock To:
1st Value:
2nd Value:
Value Percent: **10.000**
Continuous Index:
Within 8" of Joint: **NO**
Remarks:

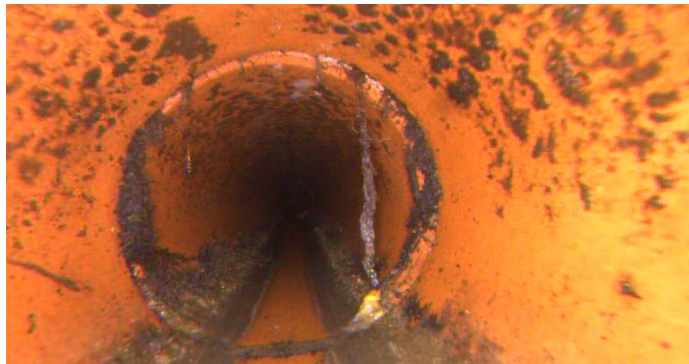
Code: **RFJ**
Description: **Roots Fine Joint**

Distance (ft): **4.4**
Structural Grade: **0**
O&M Grade: **1**
Clock Start/From: **7**
Clock To: **5**
1st Value:
2nd Value:
Value Percent:
Continuous Index:
Within 8" of Joint: **YES**
Remarks:

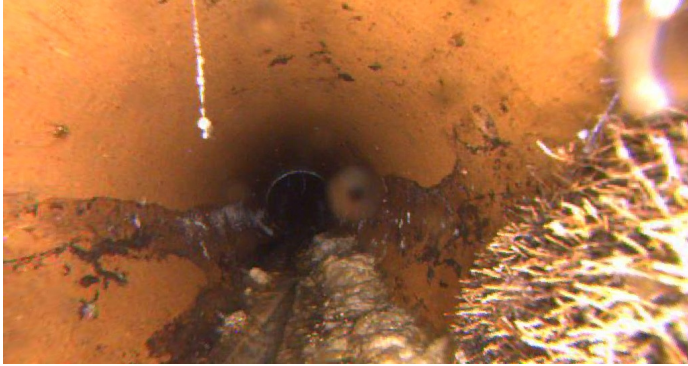
Code: **RMJ**
Description: **Roots Medium Joint**

Distance (ft): **74.9**
Structural Grade: **0**
O&M Grade: **3**
Clock Start/From: **7**
Clock To: **5**
1st Value:
2nd Value:
Value Percent: **10.000**
Continuous Index:
Within 8" of Joint: **YES**
Remarks:

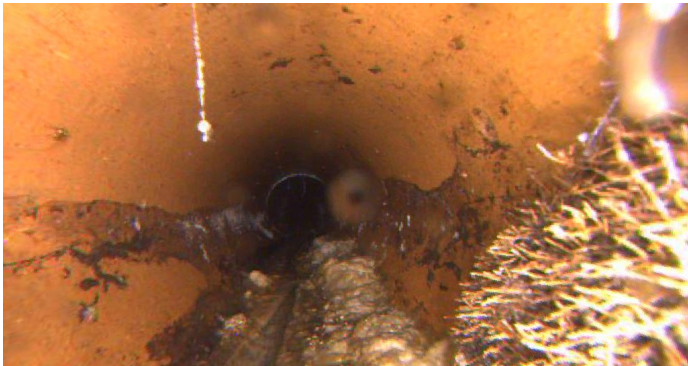
Code: **MSA**
Description: **Abandoned Survey**

Distance (ft): **74.9**
Structural Grade: **0**
O&M Grade: **0**
Clock Start/From:
Clock To:
1st Value:
2nd Value:
Value Percent:
Continuous Index:
Within 8" of Joint: **NO**
Remarks: **RMJ**
