## Profile/Photo Observation Report

Street:	<b>Hobart Lake</b>	Flow Control:	<b>Not Controlled</b>
City:	<b>Hobart, IN</b>	Year Renewed:	
Location:	<b>Other</b>	Tape/Media #:	
Purpose:	<b>Not Known</b>	Dia/Height:	<b>8"</b>
Use:	<b>Sanitary</b>	Material:	<b>VCP</b>
Drain Area:	<b>NA</b>	Lining:	
Category:	<b>NA</b>		
Comment:

Location Details:		Direction of Survey:	<b>Upstream</b>
US MH:	<b>M-705-014</b>	DS MH:	<b>M-705-080</b>
		Total Length Surveyed (ft):	<b>74.9</b>

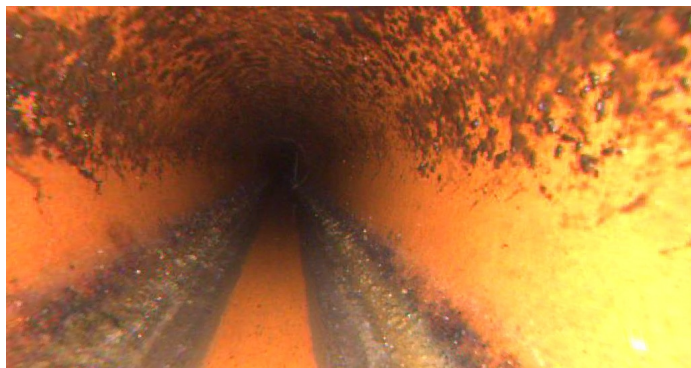
Code: **AMH**  
Description: **Manhole**

Distance (ft): **.0**  
Structural Grade: **0**  
O&M Grade: **0**  
Clock Start/From:  
Clock To:  
1st Value:  
2nd Value:  
Value Percent:  
Continuous Index:  
Within 8" of Joint: **NO**  
Remarks: **M-705-080**

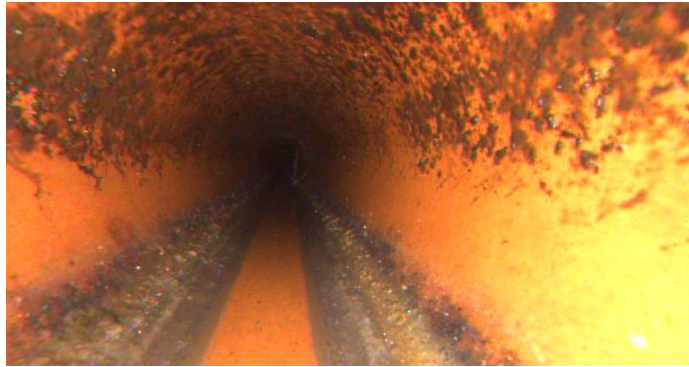
Code: **MWL**  
Description: **Water Level**

Distance (ft): **.0**  
Structural Grade: **0**  
O&M Grade: **0**  
Clock Start/From:  
Clock To:  
1st Value:  
2nd Value:  
Value Percent: **10.000**  
Continuous Index:  
Within 8" of Joint: **NO**  
Remarks:

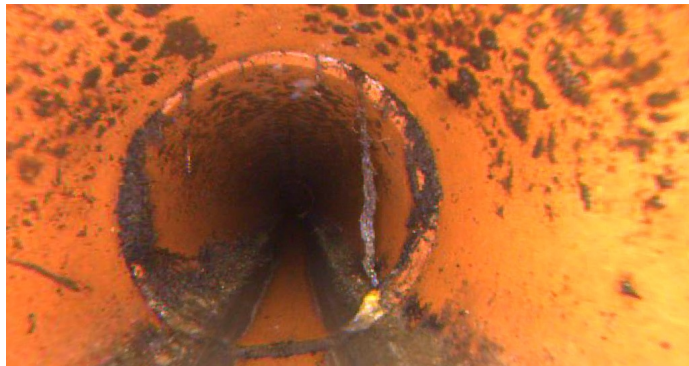
Code: **RFJ**  
Description: **Roots Fine Joint**

Distance (ft): **4.4**  
Structural Grade: **0**  
O&M Grade: **1**  
Clock Start/From: **7**  
Clock To: **5**  
1st Value:  
2nd Value:  
Value Percent:  
Continuous Index:  
Within 8" of Joint: **YES**  
Remarks:

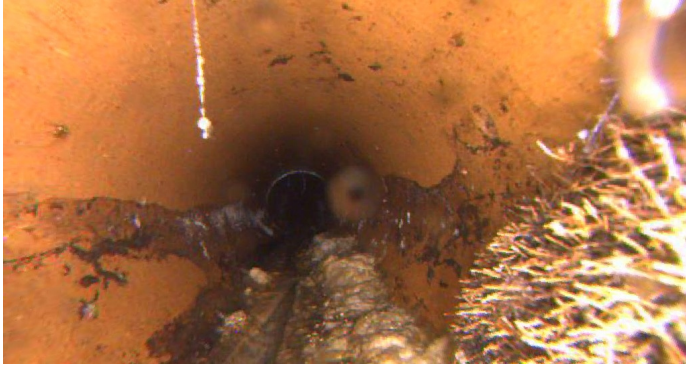
Code:	<b>RMJ</b>
Description:	<b>Roots Medium Joint</b>
Distance (ft):	<b>74.9</b>
Structural Grade:	<b>0</b>
O&M Grade:	<b>3</b>
Clock Start/From:	<b>7</b>
Clock To:	<b>5</b>
1st Value:	
2nd Value:	
Value Percent:	<b>10.000</b>
Continuous Index:	
Within 8" of Joint:	<b>YES</b>
Remarks:

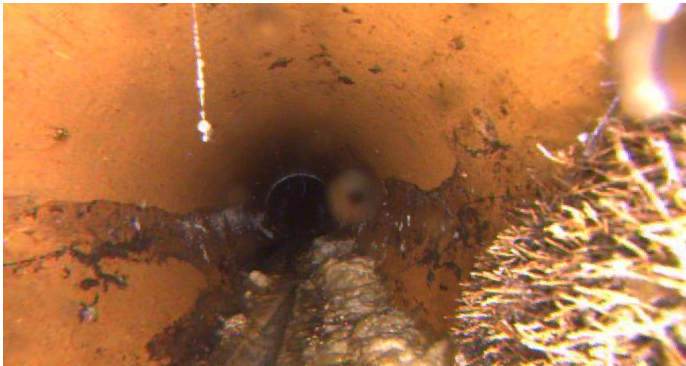
Code:	<b>MSA</b>
Description:	<b>Abandoned Survey</b>
Distance (ft):	<b>74.9</b>
Structural Grade:	<b>0</b>
O&M Grade:	<b>0</b>
Clock Start/From:	
Clock To:	
1st Value:	
2nd Value:	
Value Percent:	
Continuous Index:	
Within 8" of Joint:	<b>NO</b>
Remarks:	<b>RMJ</b>
