Profile/Photo Observation Report

Street:	5th Street	Flow Control:	
City:	Hobart, IN	Year Renewed:	
Location:	Light Highway	Tape/Media #:	899
Purpose:	Routine Assessment	Dia/Height:	8"
Use:	Sanitary	Material:	VCP
Drain Area:		Lining:	
Category:	NA		
Comment:

Location Details:		Direction of Survey:	Downstream
US MH:	M-705-16	DS MH:	M-705-15
		Total Length Surveyed (ft):	46.0

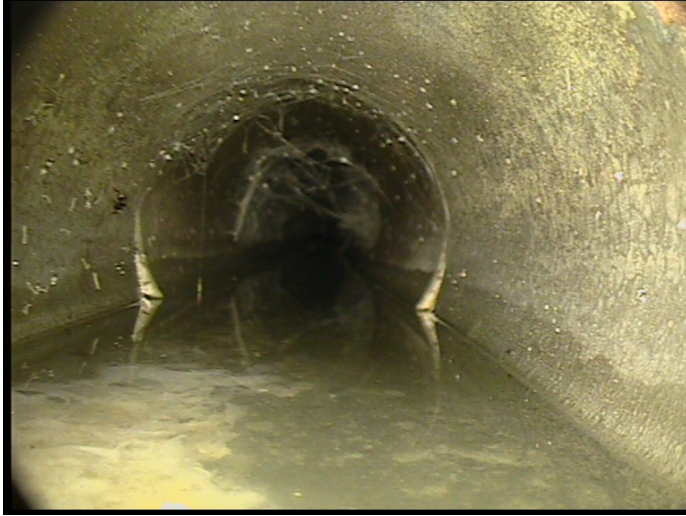
Code: **MWL**
Description: **Water Level**

Distance (ft): **.0**
Structural Grade: **0**
O&M Grade: **0**
Clock Start/From:
Clock To:
1st Value:
2nd Value:
Value Percent: **10.000**
Continuous Index:
Within 8" of Joint: **NO**
Remarks:

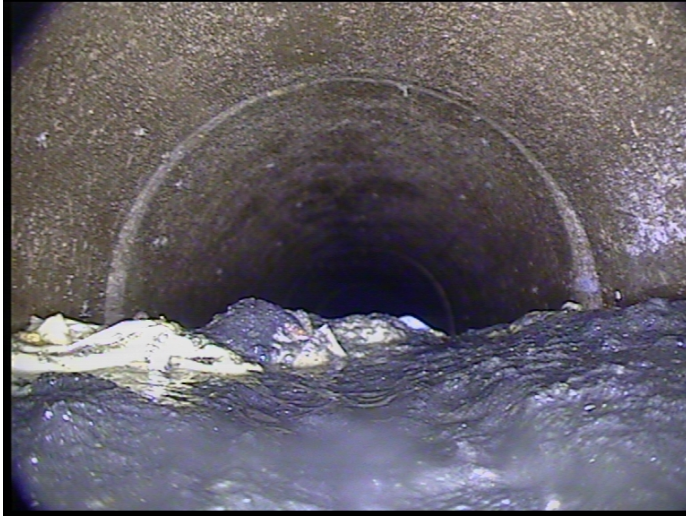
Code: **DSF**
Description: **Deposits Settled Fine**

Distance (ft): **46.0**
Structural Grade: **0**
O&M Grade: **4**
Clock Start/From: **4**
Clock To: **8**
1st Value:
2nd Value:
Value Percent: **30.000**
Continuous Index: **F01**
Within 8" of Joint: **NO**
Remarks:

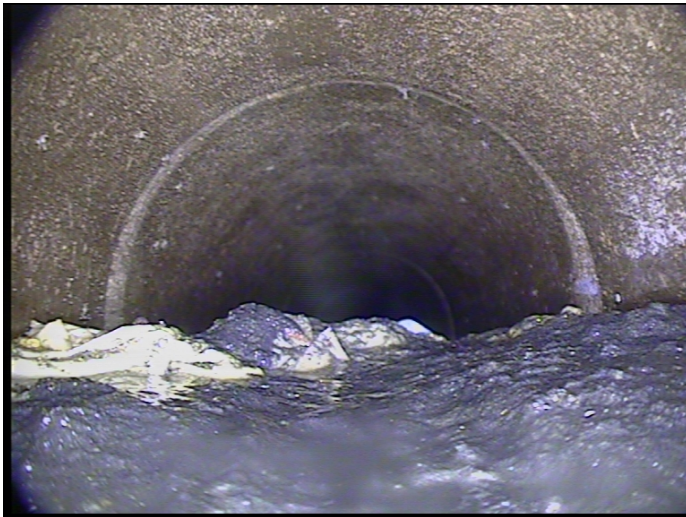
Code: **MSA**
Description: **Abandoned Survey**

Distance (ft): **46.0**
Structural Grade: **0**
O&M Grade: **0**
Clock Start/From:
Clock To:
1st Value:
2nd Value:
Value Percent:
Continuous Index:
Within 8" of Joint: **NO**
Remarks: **deep sediment**
