Profile/Photo Observation Report

Date:	04/19/2018	Weather:		Coding:	PACP 6.0
Pipe Length (ft):	299.7	Owner:	NA	Pre Clean:	Not Known
P.O.#:		Surveyor:	Byrd Fitzgerald	PSR:	P-706-029-018
Customer:		Clean Date:	01/01/1900	Shape:	C

Street:	E 6TH ST & STATE ST	Flow Control:	Not Controlled
City:	Hobart, IN	Year Renewed:	
Location:	Light Highway	Tape/Media #:	
Purpose:	Maintenance Related	Dia/Height:	8"
Use:	Sanitary	Material:	PVC
Drain Area:	NA	Lining:	Cured in Place
Category:	NA		
Comment:	Reverse setup. Roots at 99'.		
Location Details:		Direction of Survey:	Downstream
US MH:	M-705-018	DS MH:	M-706-029
		Total Length Surveyed (ft):	100.5

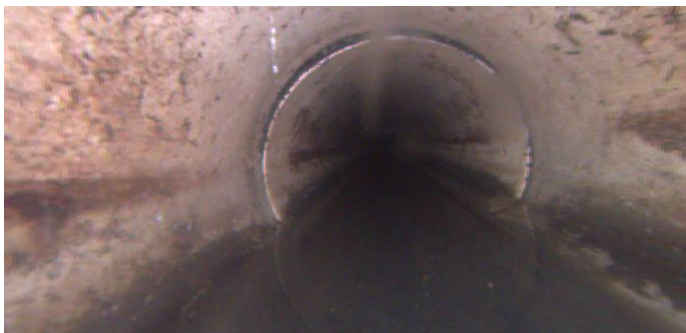
Code: **AMH**
Description: **Manhole**

Distance (ft): **.0**
Structural Grade: **0**
O&M Grade: **0**
Clock Start/From:
Clock To:
1st Value:
2nd Value:
Value Percent:
Continuous Index:
Within 8" of Joint: **NO**
Remarks: **M-705-018**

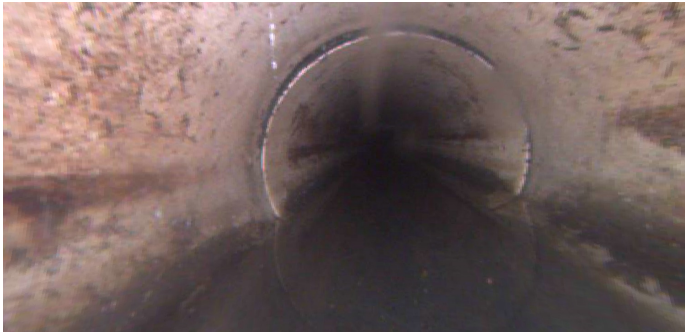
Code:	MWL
Description:	Water Level

Distance (ft):	.0
Structural Grade:	0
O&M Grade:	0
Clock Start/From:	
Clock To:	
1st Value:	
2nd Value:	
Value Percent:	5.000
Continuous Index:	
Within 8" of Joint:	NO
Remarks:

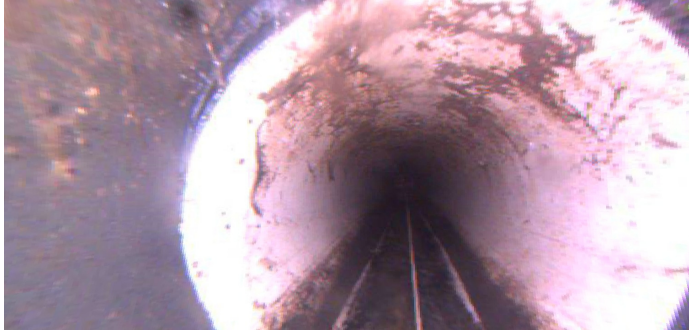
Code:	MGO
Description:	General Observation
Distance (ft):	10.0
Structural Grade:	0
O&M Grade:	0
Clock Start/From:	
Clock To:	
1st Value:	
2nd Value:	
Value Percent:	
Continuous Index:	
Within 8" of Joint:	NO
Remarks:	rear camera/cob webs

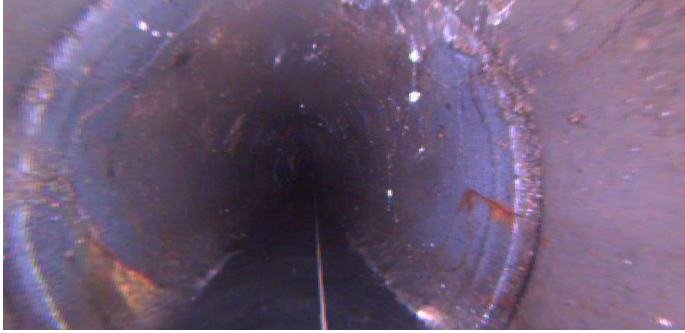
Code: **CM**
Description: **Crack Multiple**

Distance (ft): **26.1**
Structural Grade: **3**
O&M Grade: **0**
Clock Start/From: **7**
Clock To: **5**
1st Value:
2nd Value:
Value Percent:
Continuous Index: **S02**
Within 8" of Joint: **YES**
Remarks: **wandering**

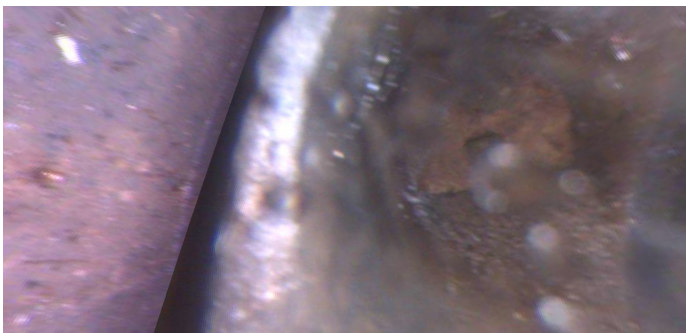
Code: **TFC**
Description: **Tap Factory Capped**

Distance (ft): **56.8**
Structural Grade: **0**
O&M Grade: **0**
Clock Start/From: **10**
Clock To:
1st Value: **4.000**
2nd Value:
Value Percent:
Continuous Index:
Within 8" of Joint: **YES**
Remarks:

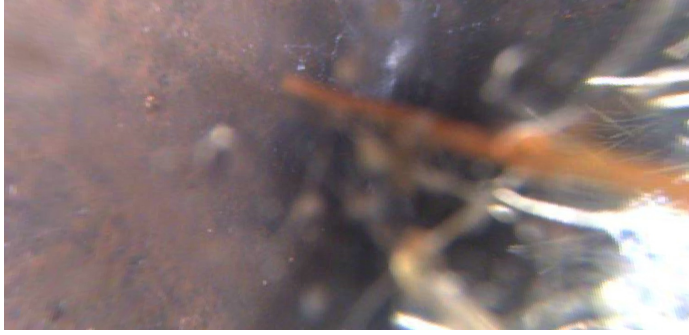
Code: **MSA**
Description: **Abandoned Survey**

Distance (ft): **100.5**
Structural Grade: **0**
O&M Grade: **0**
Clock Start/From:
Clock To:
1st Value:
2nd Value:
Value Percent:
Continuous Index:
Within 8" of Joint: **NO**
Remarks: **rbj**

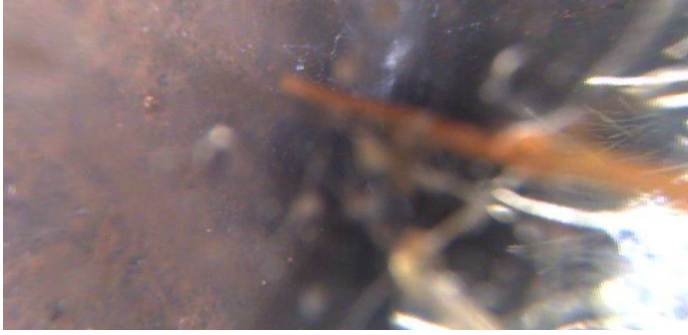
Code:	RFJ
Description:	Roots Fine Joint
Distance (ft):	100.5
Structural Grade:	0
O&M Grade:	1
Clock Start/From:	7
Clock To:	5
1st Value:	
2nd Value:	
Value Percent:	
Continuous Index:	F01
Within 8" of Joint:	YES
Remarks:	wandering
