Profile/Photo Observation Report

Street:	Lake Street	Flow Control:	
City:	Hobart, IN	Year Renewed:	
Location:	Light Highway	Tape/Media #:	926
Purpose:	Routine Assessment	Dia/Height:	8"
Use:	Sanitary	Material:	VCP
Drain Area:		Lining:	
Category:	NA		
Comment:

Location Details:		Direction of Survey:	Downstream
US MH:	M-705-19	DS MH:	M-706-32
		Total Length Surveyed (ft):	116.7

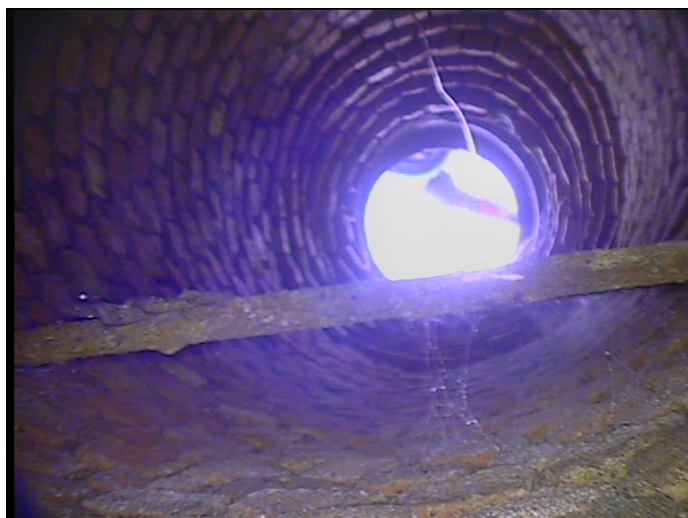
Code: **AMH**
 Description: **Manhole**

Distance (ft): **.0**
 Structural Grade: **0**
 O&M Grade: **0**
 Clock Start/From:
 Clock To:
 1st Value:
 2nd Value:
 Value Percent:
 Continuous Index:
 Within 8" of Joint: **NO**
 Remarks: **M-705-19**

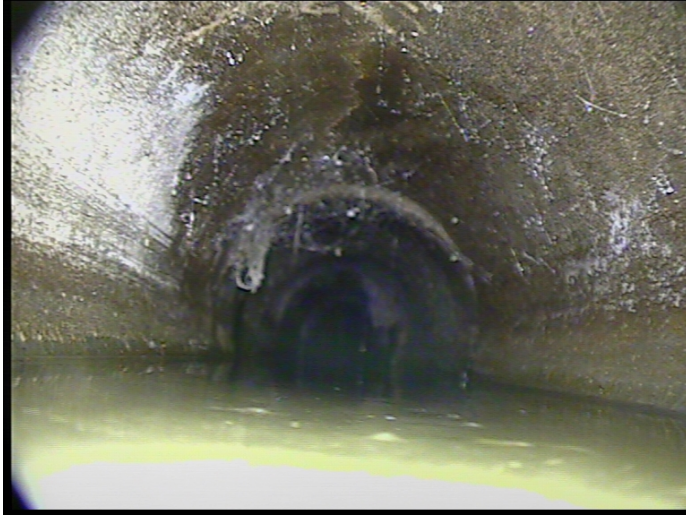
Code: **MWL**
Description: **Water Level**

Distance (ft): **.0**
Structural Grade: **0**
O&M Grade: **0**
Clock Start/From:
Clock To:
1st Value:
2nd Value:
Value Percent: **15.000**
Continuous Index:
Within 8" of Joint: **NO**
Remarks:

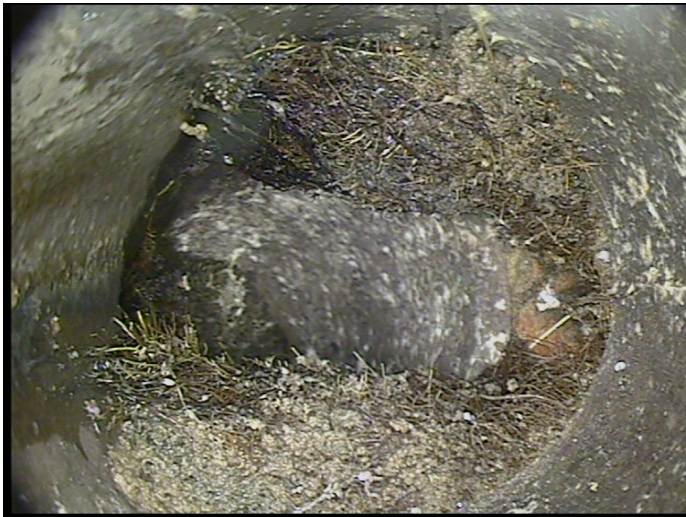
Code: **TFD**
Description: **Tap Factory Defective**

Distance (ft): **4.8**
Structural Grade: **0**
O&M Grade: **2**
Clock Start/From: **9**
Clock To:
1st Value: **4.000**
2nd Value:
Value Percent:
Continuous Index:
Within 8" of Joint: **NO**
Remarks: **roots**

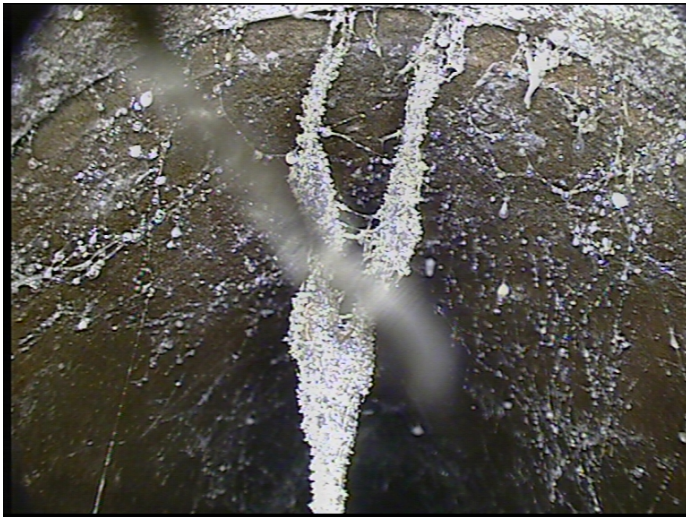
Code: **RFJ**
Description: **Roots Fine Joint**

Distance (ft): **8.3**
Structural Grade: **0**
O&M Grade: **1**
Clock Start/From: **12**
Clock To:
1st Value:
2nd Value:
Value Percent:
Continuous Index:
Within 8" of Joint: **YES**
Remarks:

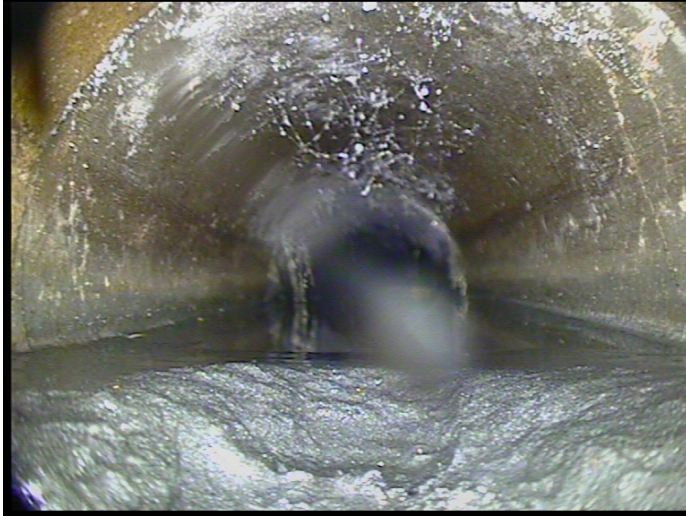
Code: **DSF**
Description: **Deposits Settled Fine**

Distance (ft): **15.4**
Structural Grade: **0**
O&M Grade: **3**
Clock Start/From: **4**
Clock To: **8**
1st Value:
2nd Value:
Value Percent: **20.000**
Continuous Index: **S01**
Within 8" of Joint: **YES**
Remarks:

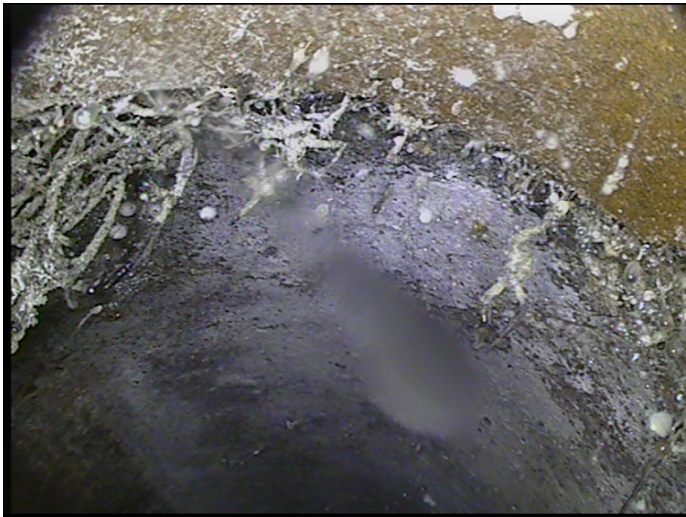
Code: **RFJ**
Description: **Roots Fine Joint**

Distance (ft): **18.4**
Structural Grade: **0**
O&M Grade: **1**
Clock Start/From: **9**
Clock To: **3**
1st Value:
2nd Value:
Value Percent:
Continuous Index: **S02**
Within 8" of Joint: **YES**
Remarks:

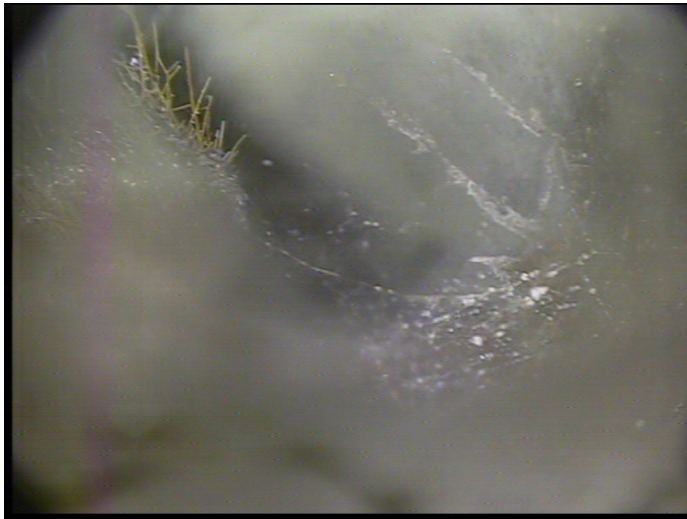
Code:	TFD
Description:	Tap Factory Defective
Distance (ft):	75.3
Structural Grade:	0
O&M Grade:	2
Clock Start/From:	10
Clock To:	
1st Value:	4.000
2nd Value:	
Value Percent:	
Continuous Index:	
Within 8" of Joint:	NO
Remarks:	roots

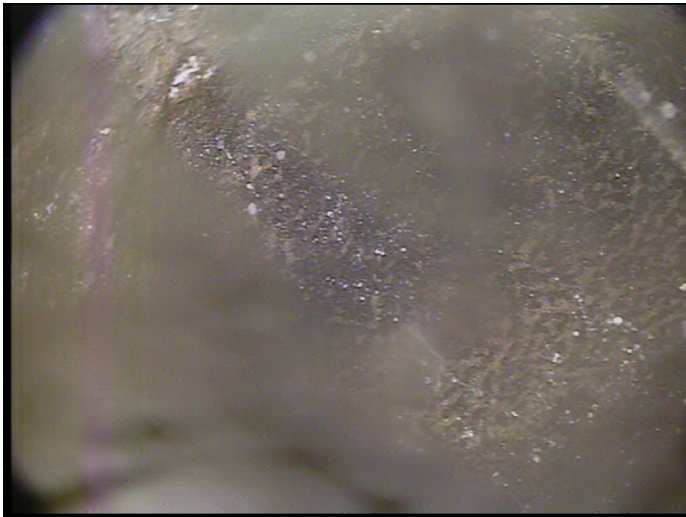
Code: **TFC**
Description: **Tap Factory Capped**

Distance (ft): **97.8**
Structural Grade: **0**
O&M Grade: **0**
Clock Start/From: **9**
Clock To:
1st Value: **4.000**
2nd Value:
Value Percent:
Continuous Index:
Within 8" of Joint: **NO**
Remarks:

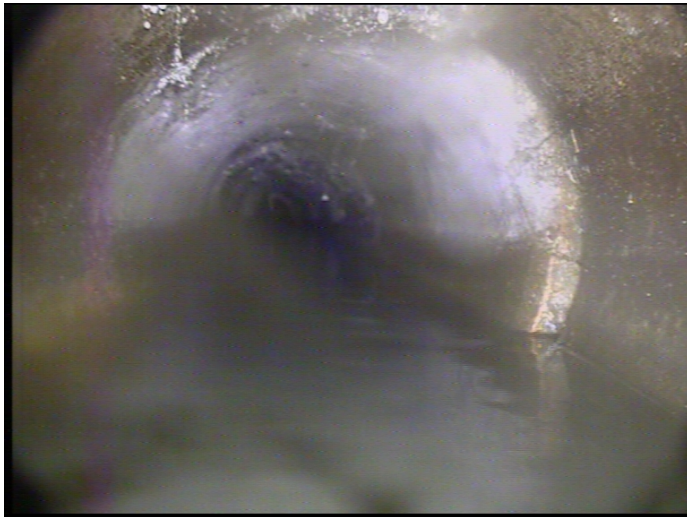
Code: **DSF**
Description: **Deposits Settled Fine**

Distance (ft): **100.3**
Structural Grade: **0**
O&M Grade: **3**
Clock Start/From: **4**
Clock To: **8**
1st Value:
2nd Value:
Value Percent: **20.000**
Continuous Index: **F01**
Within 8" of Joint: **NO**
Remarks:

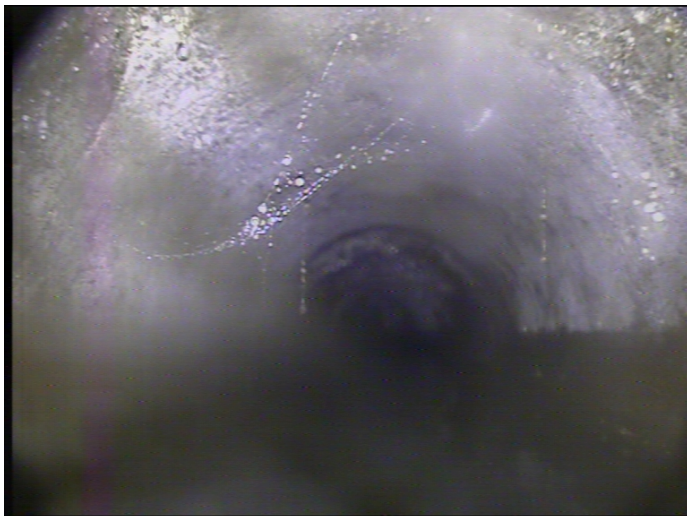
Code: **RMJ**
Description: **Roots Medium Joint**

Distance (ft): **103.6**
Structural Grade: **0**
O&M Grade: **3**
Clock Start/From: **8**
Clock To: **4**
1st Value:
2nd Value:
Value Percent: **15.000**
Continuous Index: **F03**
Within 8" of Joint: **YES**
Remarks:

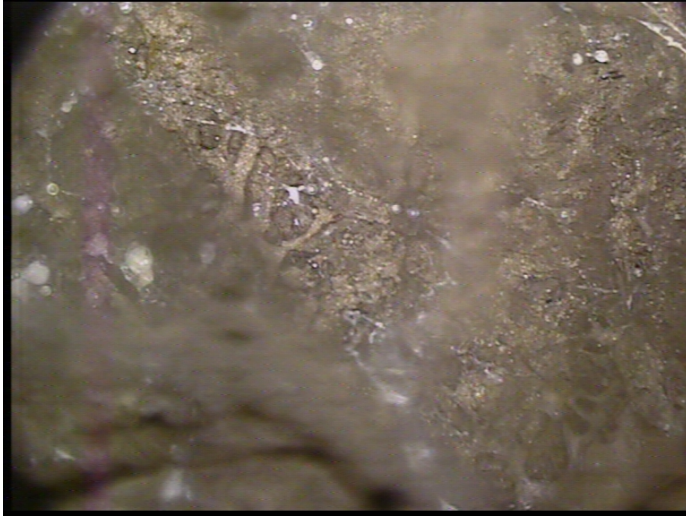
Code: **TFC**
Description: **Tap Factory Capped**

Distance (ft): **107.7**
Structural Grade: **0**
O&M Grade: **0**
Clock Start/From: **3**
Clock To:
1st Value: **4.000**
2nd Value:
Value Percent:
Continuous Index:
Within 8" of Joint: **NO**
Remarks:

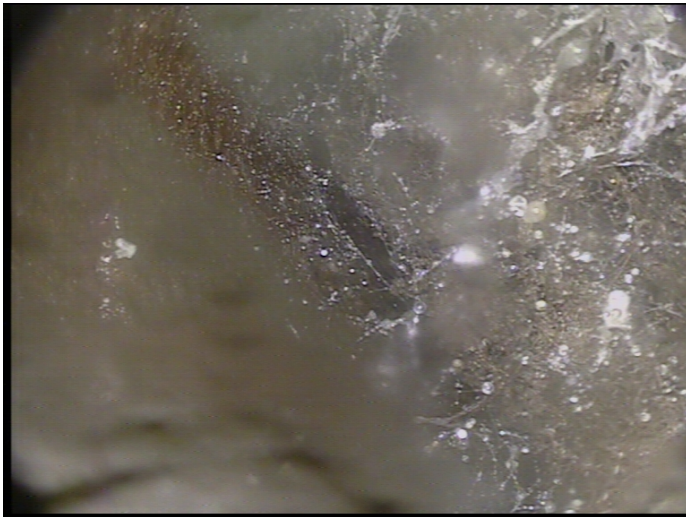
Code: **TFD**
Description: **Tap Factory Defective**

Distance (ft): **111.6**
Structural Grade: **0**
O&M Grade: **2**
Clock Start/From: **3**
Clock To:
1st Value: **4.000**
2nd Value:
Value Percent:
Continuous Index:
Within 8" of Joint: **NO**
Remarks: **roots**

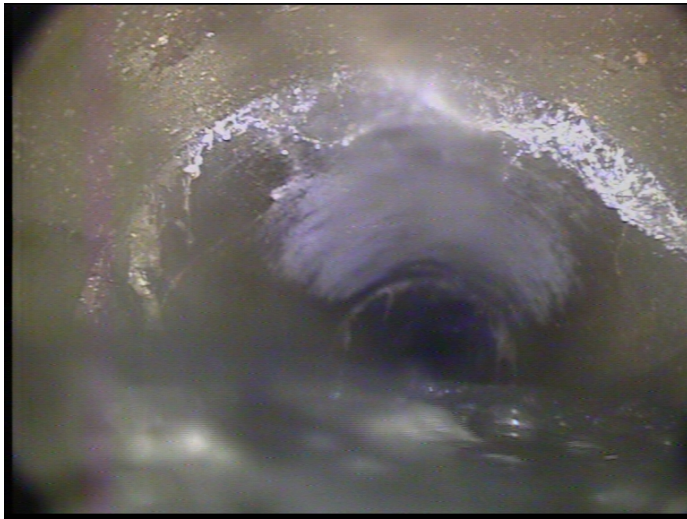
Code: **DSF**
Description: **Deposits Settled Fine**

Distance (ft): **113.3**
Structural Grade: **0**
O&M Grade: **3**
Clock Start/From: **4**
Clock To: **8**
1st Value:
2nd Value:
Value Percent: **20.000**
Continuous Index: **S04**
Within 8" of Joint: **YES**
Remarks:

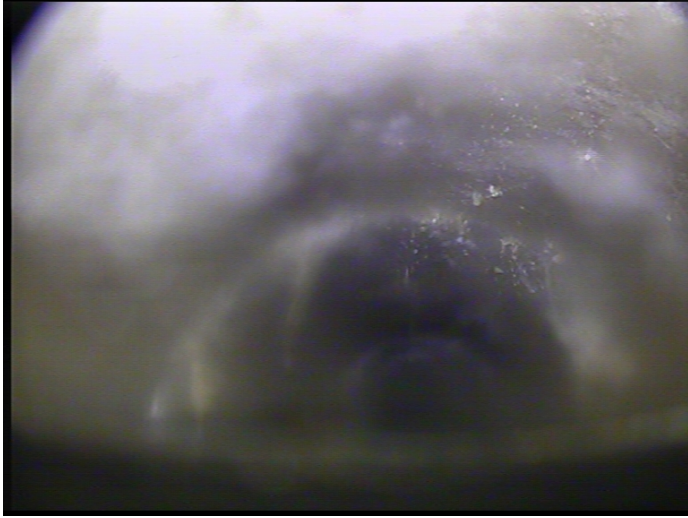
Code:	MSA
Description:	Abandoned Survey
Distance (ft):	116.7
Structural Grade:	0
O&M Grade:	0
Clock Start/From:	
Clock To:	
1st Value:	
2nd Value:	
Value Percent:	
Continuous Index:	
Within 8" of Joint:	NO
Remarks:	deep sediment
