Profile/Photo Observation Report

Date:	05/03/2018	Weather:		Coding:	PACP 6.0
Pipe Length (ft):		Owner:	City of Hobart	Pre Clean:	No Pre-Cleaning
P.O.#:	186	Surveyor:	M. Pielacha	PSR:	P-705-021-020
Customer:	City of Hobart	Clean Date:		Shape:	C

Street:	6th Street	Flow Control:	Not Controlled
City:	Hobart, IN	Year Renewed:	
Location:	Light Highway	Tape/Media #:	DEP 186
Purpose:	Routine Assessment	Dia/Height:	6"
Use:	Sanitary	Material:	VCP
Drain Area:		Lining:	
Category:	NA		
Comment:	5-21-2018		
Location Details:		Direction of Survey:	Downstream
US MH:	M-705-020	DS MH:	M-705-021
		Total Length Surveyed (ft):	33.9

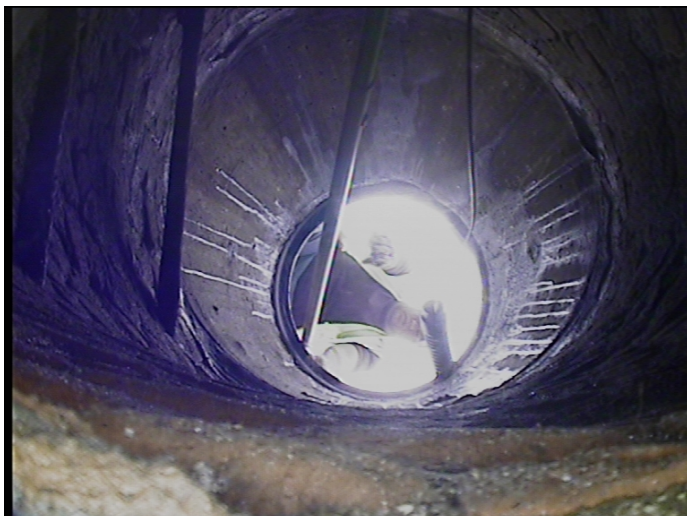
Code: **AMH**
Description: **Manhole**

Distance (ft): **.0**
Structural Grade: **0**
O&M Grade: **0**
Clock Start/From:
Clock To:
1st Value:
2nd Value:
Value Percent:
Continuous Index:
Within 8" of Joint: **NO**
Remarks: **M-705-020**

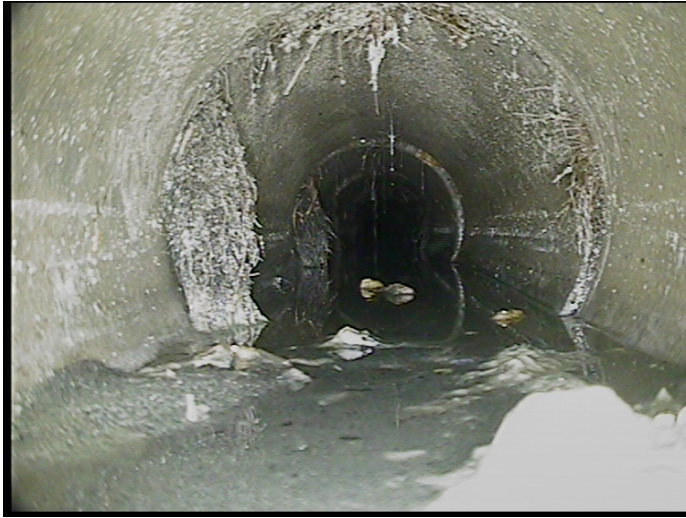
Code: **MWL**
Description: **Water Level**

Distance (ft): **.0**
Structural Grade: **0**
O&M Grade: **0**
Clock Start/From:
Clock To:
1st Value:
2nd Value:
Value Percent: **10.000**
Continuous Index:
Within 8" of Joint: **NO**
Remarks:

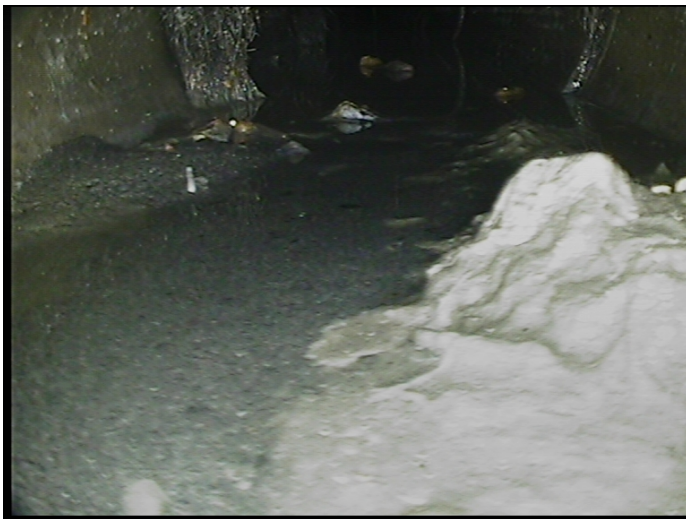
Code: **DSF**
Description: **Deposits Settled Fine**

Distance (ft): **.0**
Structural Grade: **0**
O&M Grade: **3**
Clock Start/From: **4**
Clock To: **8**
1st Value:
2nd Value:
Value Percent: **15.000**
Continuous Index: **S01**
Within 8" of Joint: **YES**
Remarks:

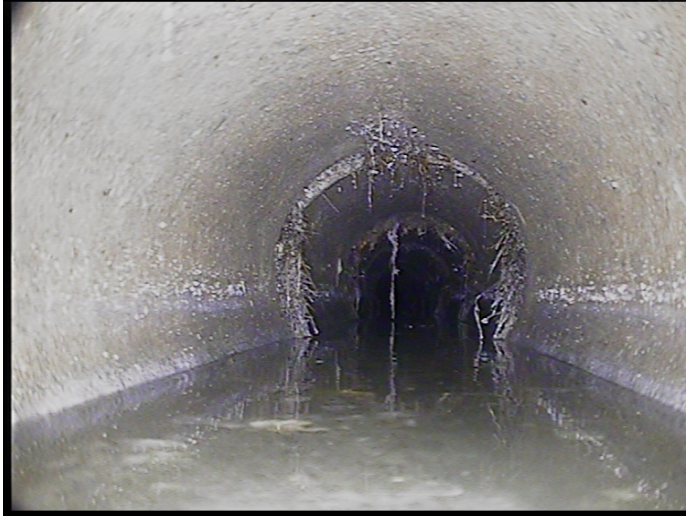
Code: **RFJ**
Description: **Roots Fine Joint**

Distance (ft): **5.0**
Structural Grade: **0**
O&M Grade: **1**
Clock Start/From: **7**
Clock To: **5**
1st Value:
2nd Value:
Value Percent:
Continuous Index: **S02**
Within 8" of Joint: **YES**
Remarks:

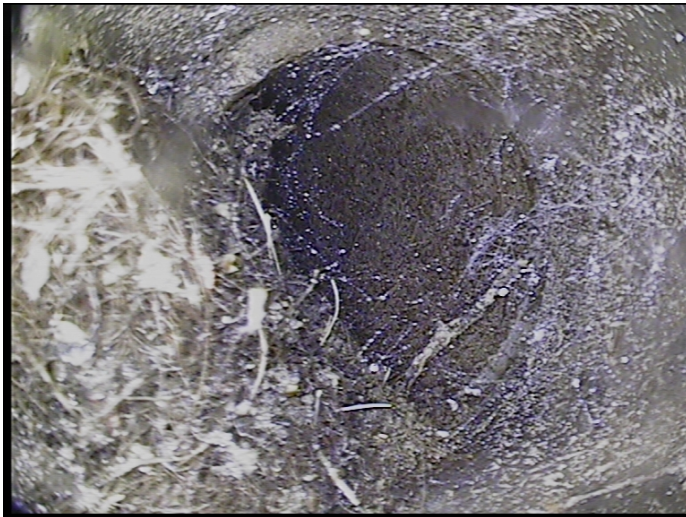
Code: **RFJ**
Description: **Roots Fine Joint**

Distance (ft): **30.6**
Structural Grade: **0**
O&M Grade: **1**
Clock Start/From: **7**
Clock To: **5**
1st Value:
2nd Value:
Value Percent:
Continuous Index: **F02**
Within 8" of Joint: **YES**
Remarks:

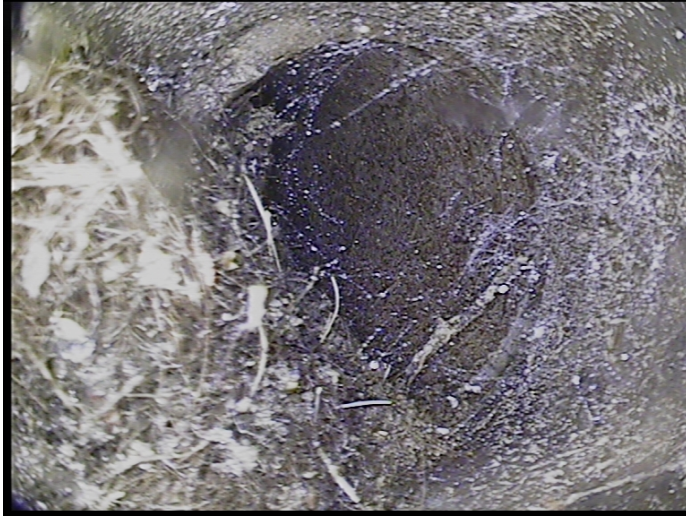
Code: **TF**
Description: **Tap Factory**

Distance (ft): **30.6**
Structural Grade: **0**
O&M Grade: **0**
Clock Start/From: **10**
Clock To:
1st Value: **6.000**
2nd Value:
Value Percent:
Continuous Index:
Within 8" of Joint: **NO**
Remarks:

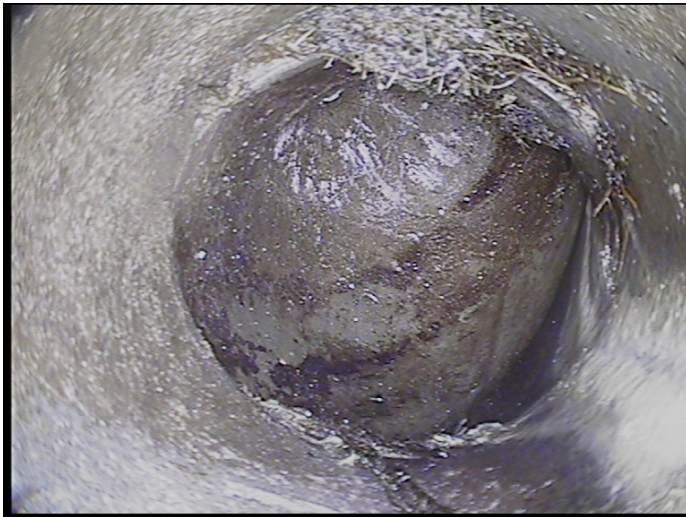
Code: **TF**
Description: **Tap Factory**

Distance (ft): **32.8**
Structural Grade: **0**
O&M Grade: **0**
Clock Start/From: **2**
Clock To:
1st Value: **6.000**
2nd Value:
Value Percent:
Continuous Index:
Within 8" of Joint: **NO**
Remarks:

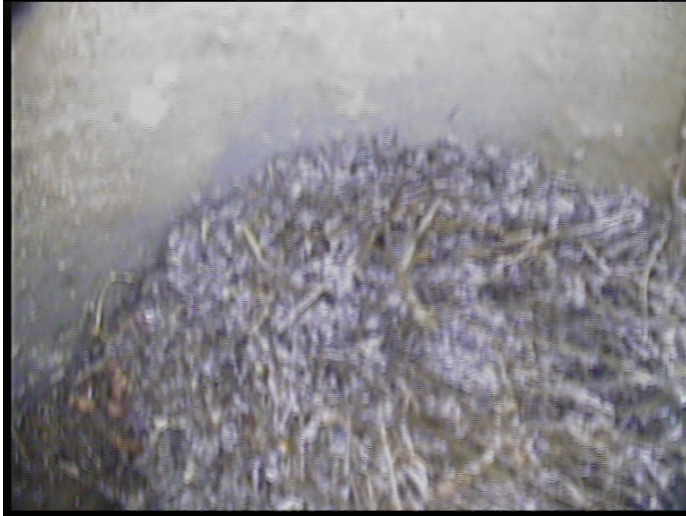
Code: **RMJ**
Description: **Roots Medium Joint**

Distance (ft): **33.1**
Structural Grade: **0**
O&M Grade: **3**
Clock Start/From: **1**
Clock To: **5**
1st Value:
2nd Value:
Value Percent: **20.000**
Continuous Index:
Within 8" of Joint: **YES**
Remarks:

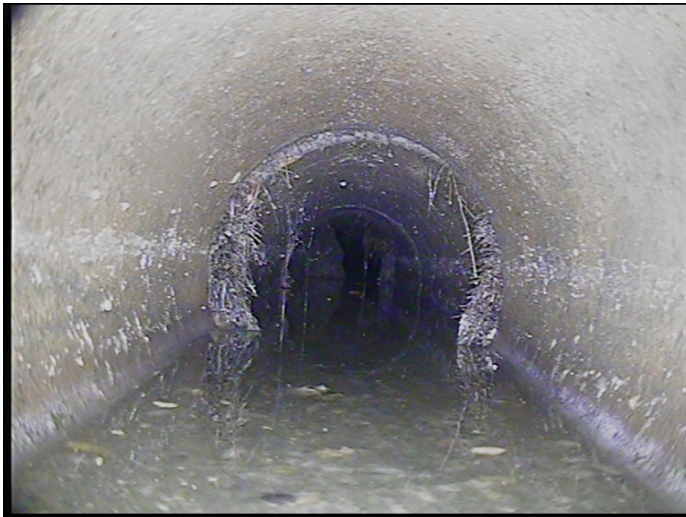
Code: **DSF**
Description: **Deposits Settled Fine**

Distance (ft): **33.9**
Structural Grade: **0**
O&M Grade: **3**
Clock Start/From: **4**
Clock To: **8**
1st Value:
2nd Value:
Value Percent: **15.000**
Continuous Index: **F01**
Within 8" of Joint: **NO**
Remarks:

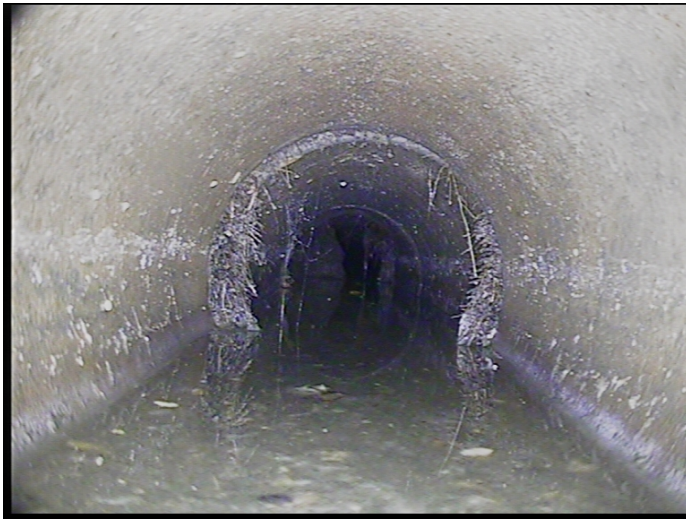
Code:	MSA
Description:	Abandoned Survey
Distance (ft):	33.9
Structural Grade:	0
O&M Grade:	0
Clock Start/From:	
Clock To:	
1st Value:	
2nd Value:	
Value Percent:	
Continuous Index:	
Within 8" of Joint:	NO
Remarks:	RMJ
