## Profile/Photo Observation Report

Date:	<b>05/07/2018</b>	Weather:		Coding:	<b>PACP 6.0</b>
Pipe Length (ft):		Owner:	<b>City of Hobart</b>	Pre Clean:	<b>No Pre-Cleaning</b>
P.O.#:	<b>609</b>	Surveyor:	<b>M. Pielacha</b>	PSR:	<b>P-705-021-020</b>
Customer:	<b>City of Hobart</b>	Clean Date:		Shape:	<b>C</b>

Street:	<b>6th Street</b>	Flow Control:	<b>Not Controlled</b>
City:	<b>Hobart, IN</b>	Year Renewed:	
Location:	<b>Light Highway</b>	Tape/Media #:	<b>DEP 609</b>
Purpose:	<b>Routine Assessment</b>	Dia/Height:	<b>8"</b>
Use:	<b>Sanitary</b>	Material:	<b>PVC</b>
Drain Area:		Lining:	
Category:	<b>NA</b>		
Comment:	<b>5-21-2018</b>		
Location Details:		Direction of Survey:	<b>Upstream</b>
US MH:	<b>M-705-020</b>	DS MH:	<b>M-705-021</b>
		Total Length Surveyed (ft):	<b>4.9</b>

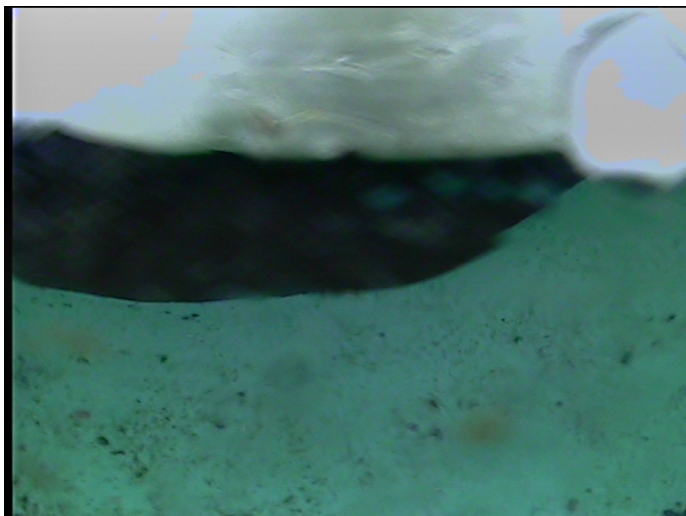
Code: **AMH**  
Description: **Manhole**

Distance (ft): **.0**  
Structural Grade: **0**  
O&M Grade: **0**  
Clock Start/From:  
Clock To:  
1st Value:  
2nd Value:  
Value Percent:  
Continuous Index:  
Within 8" of Joint: **NO**  
Remarks: **M-705-021**

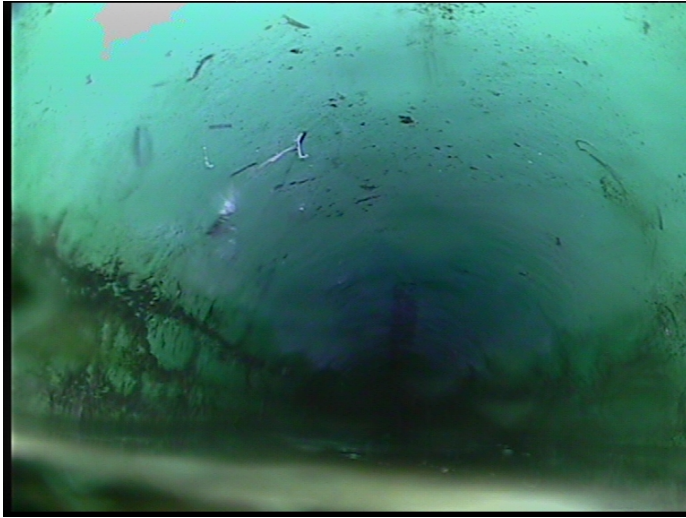
Code: **MWL**  
Description: **Water Level**

Distance (ft): **.0**  
Structural Grade: **0**  
O&M Grade: **0**  
Clock Start/From:  
Clock To:  
1st Value:  
2nd Value:  
Value Percent: **25.000**  
Continuous Index:  
Within 8" of Joint: **NO**  
Remarks:
