Profile/Photo Observation Report

Date:	05/02/2018	Weather:		Coding:	PACP 6.0
Pipe Length (ft):		Owner:	City of Hobart	Pre Clean:	No Pre-Cleaning
P.O.#:	157	Surveyor:	M. Pielacha	PSR:	P-705-023-024
Customer:	City of Hobart	Clean Date:		Shape:	C

Street:	Main Street	Flow Control:	Not Controlled
City:	Hobart, IN	Year Renewed:	
Location:	Light Highway	Tape/Media #:	DEP 157
Purpose:	Routine Assessment	Dia/Height:	18"
Use:	Sanitary	Material:	VCP
Drain Area:		Lining:	
Category:	NA		
Comment:	5-21-2018		
Location Details:		Direction of Survey:	Upstream
US MH:	M-705-024	DS MH:	M-705-023
		Total Length Surveyed (ft):	4.6

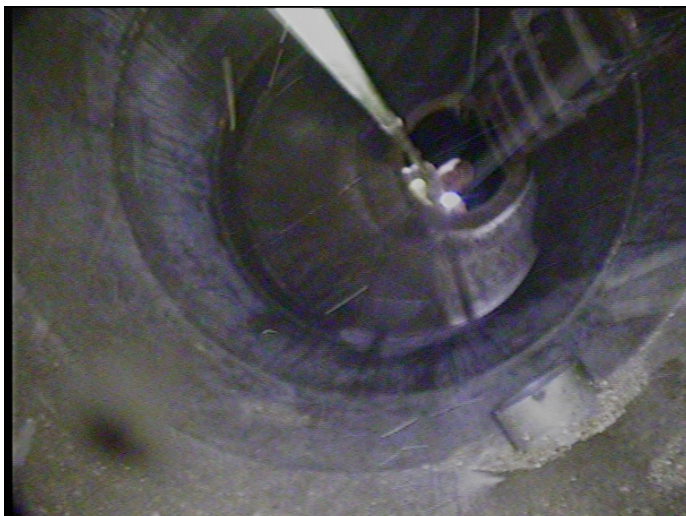
Code: **AMH**
Description: **Manhole**

Distance (ft): **.0**
Structural Grade: **0**
O&M Grade: **0**
Clock Start/From:
Clock To:
1st Value:
2nd Value:
Value Percent:
Continuous Index:
Within 8" of Joint: **NO**
Remarks: **M-705-024**

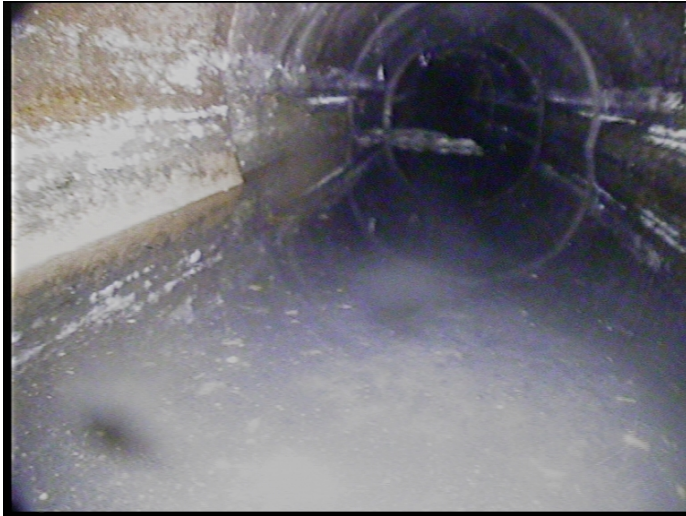
Code: **MWL**
Description: **Water Level**

Distance (ft): **.0**
Structural Grade: **0**
O&M Grade: **0**
Clock Start/From:
Clock To:
1st Value:
2nd Value:
Value Percent: **10.000**
Continuous Index:
Within 8" of Joint: **NO**
Remarks:

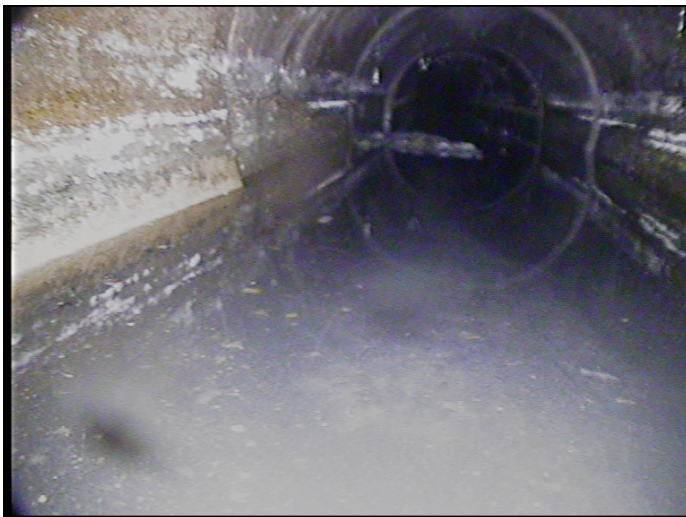
Code: **DSF**
Description: **Deposits Settled Fine**

Distance (ft): **.0**
Structural Grade: **0**
O&M Grade: **3**
Clock Start/From: **4**
Clock To: **8**
1st Value:
2nd Value:
Value Percent: **15.000**
Continuous Index: **S01**
Within 8" of Joint: **YES**
Remarks:

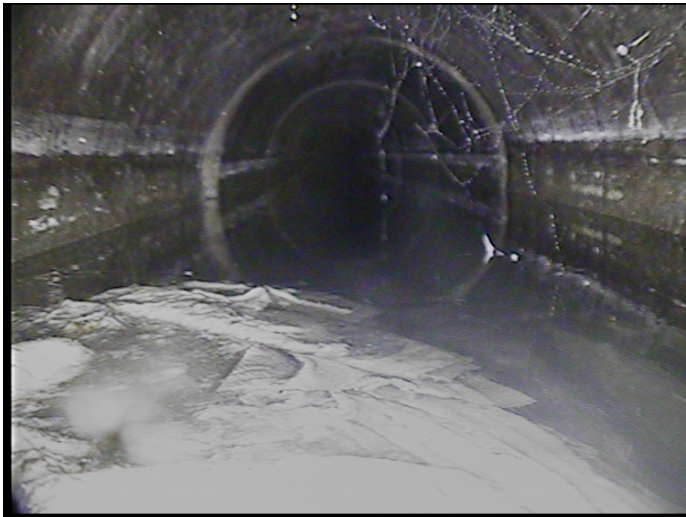
Code: **DSF**
Description: **Deposits Settled Fine**

Distance (ft): **4.6**
Structural Grade: **0**
O&M Grade: **3**
Clock Start/From: **4**
Clock To: **8**
1st Value:
2nd Value:
Value Percent: **20.000**
Continuous Index: **F01**
Within 8" of Joint: **NO**
Remarks:

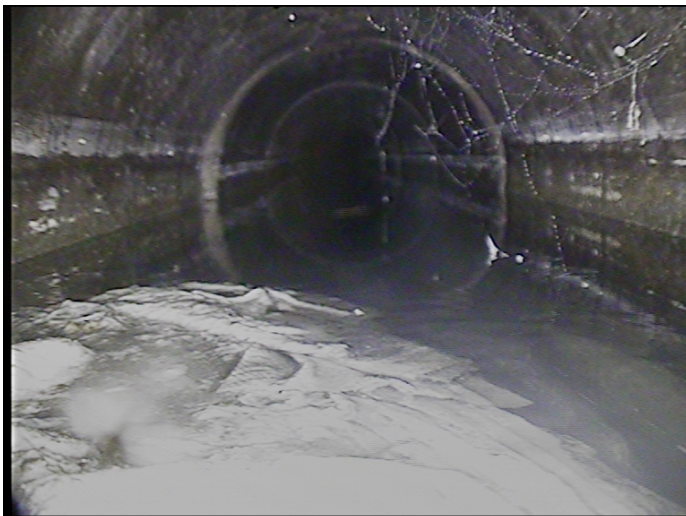
Code: **MSA**
Description: **Abandoned Survey**

Distance (ft): **4.6**
Structural Grade: **0**
O&M Grade: **0**
Clock Start/From:
Clock To:
1st Value:
2nd Value:
Value Percent:
Continuous Index:
Within 8" of Joint: **NO**
Remarks: **sediment**
