Profile/Photo Observation Report

Street:	Main Street	Flow Control:	
City:	Hobart, IN	Year Renewed:	
Location:	Light Highway	Tape/Media #:	954
Purpose:	Routine Assessment	Dia/Height:	8"
Use:	Sanitary	Material:	PVC
Drain Area:		Lining:	
Category:	NA		
Comment:

Location Details:		Direction of Survey:	Upstream
US MH:	M-705-024A	DS MH:	M-705-024
		Total Length Surveyed (ft):	229.7

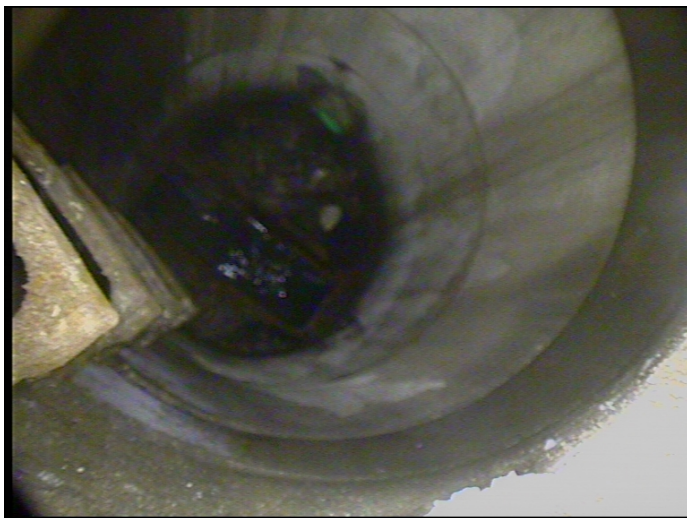
Code: **AMH**
 Description: **Manhole**

Distance (ft): **.0**
 Structural Grade: **0**
 O&M Grade: **0**
 Clock Start/From:
 Clock To:
 1st Value:
 2nd Value:
 Value Percent:
 Continuous Index:
 Within 8" of Joint: **NO**
 Remarks: **M-705-024**

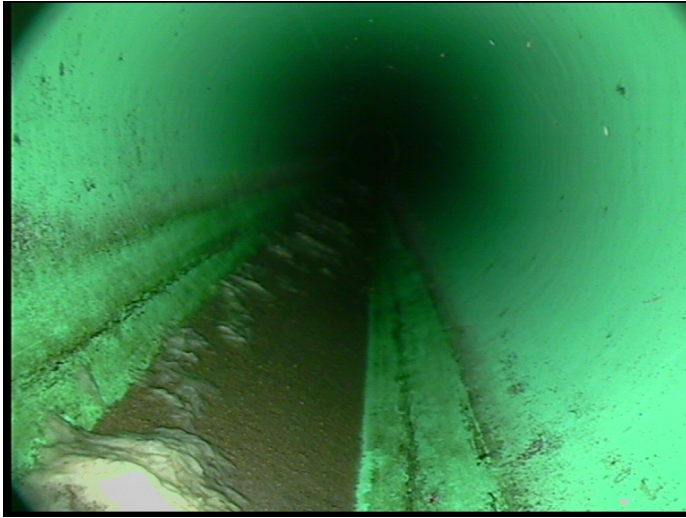
Code:	MWL
Description:	Water Level
Distance (ft):	.0
Structural Grade:	0
O&M Grade:	0
Clock Start/From:	
Clock To:	
1st Value:	
2nd Value:	
Value Percent:	5.000
Continuous Index:	
Within 8" of Joint:	NO
Remarks:

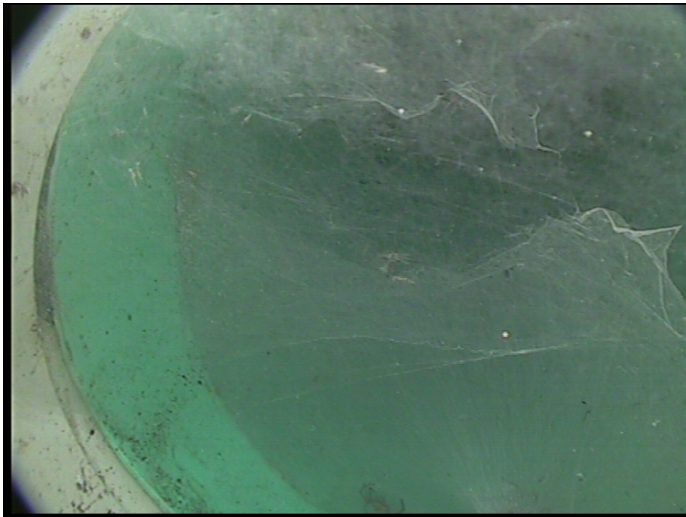
Code:	TF
Description:	Tap Factory
Distance (ft):	76.5
Structural Grade:	0
O&M Grade:	0
Clock Start/From:	10
Clock To:	
1st Value:	4.000
2nd Value:	
Value Percent:	
Continuous Index:	
Within 8" of Joint:	NO
Remarks:

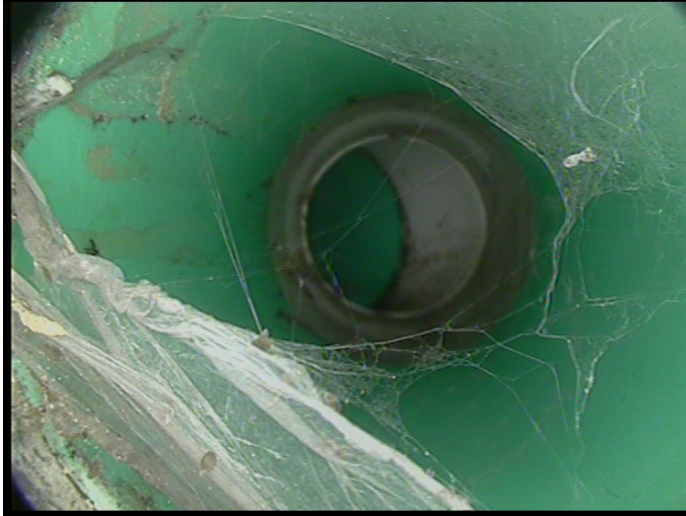
Code: **TF**
Description: **Tap Factory**

Distance (ft): **137.2**
Structural Grade: **0**
O&M Grade: **0**
Clock Start/From: **10**
Clock To:
1st Value: **4.000**
2nd Value:
Value Percent:
Continuous Index:
Within 8" of Joint: **NO**
Remarks:

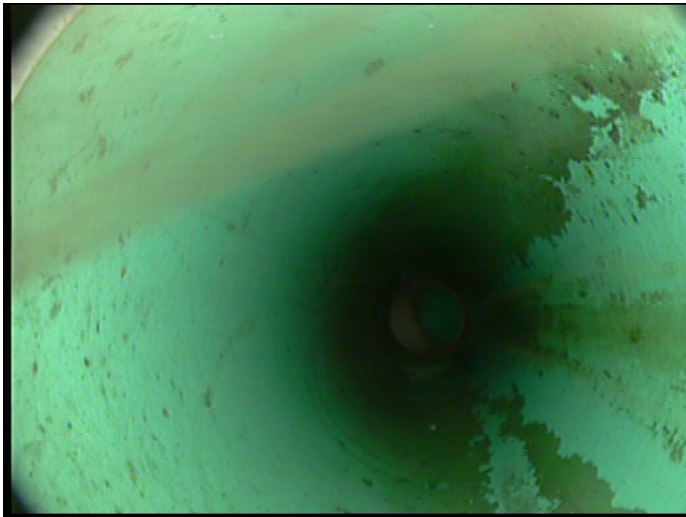
Code: **TF**
Description: **Tap Factory**

Distance (ft): **188.1**
Structural Grade: **0**
O&M Grade: **0**
Clock Start/From: **2**
Clock To:
1st Value: **4.000**
2nd Value:
Value Percent:
Continuous Index:
Within 8" of Joint: **NO**
Remarks:

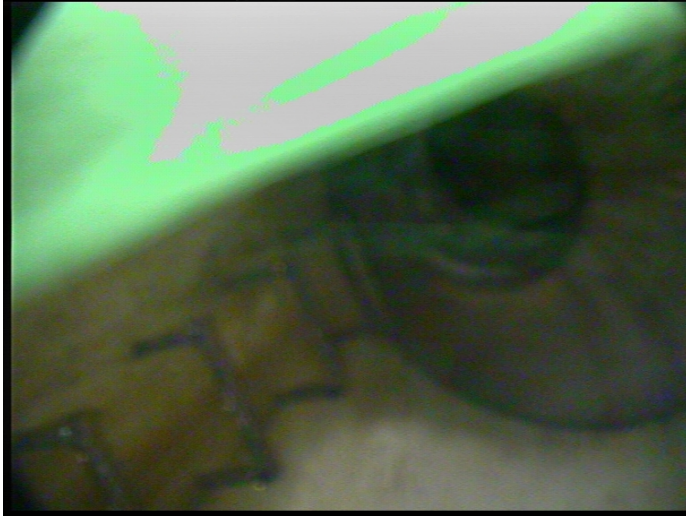
Code:	AMH
Description:	Manhole
Distance (ft):	229.6
Structural Grade:	0
O&M Grade:	0
Clock Start/From:	
Clock To:	
1st Value:	
2nd Value:	
Value Percent:	
Continuous Index:	
Within 8" of Joint:	NO
Remarks:	M-705-024A
