Profile/Photo Observation Report

Date:	05/02/2018	Weather:		Coding:	PACP 6.0
Pipe Length (ft):		Owner:	City of Hobart	Pre Clean:	No Pre-Cleaning
P.O.#:	159	Surveyor:	M. Pielacha	PSR:	P-705-024-025
Customer:	City of Hobart	Clean Date:		Shape:	C

Street:	Main Street	Flow Control:	Not Controlled
City:	Hobart, IN	Year Renewed:	
Location:	Light Highway	Tape/Media #:	DEP 159
Purpose:	Routine Assessment	Dia/Height:	18"
Use:	Sanitary	Material:	VCP
Drain Area:		Lining:	
Category:	NA		
Comment:	5-21-2018		
Location Details:		Direction of Survey:	Upstream
US MH:	M-705-025	DS MH:	M-705-024.1
		Total Length Surveyed (ft):	156.5

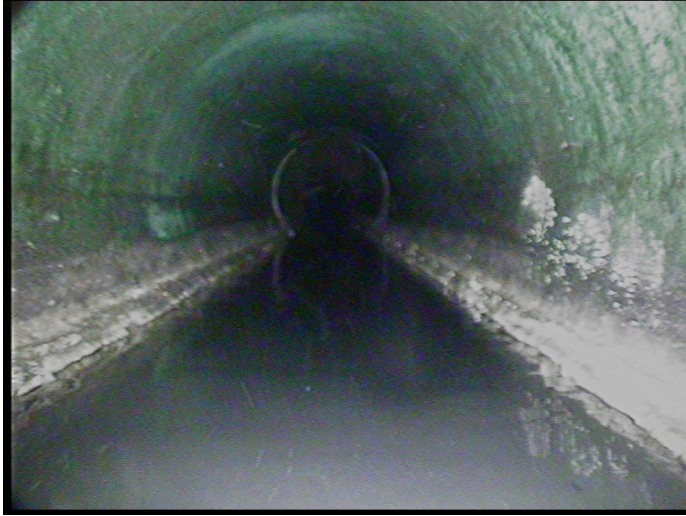
Code:	AMH
Description:	Manhole
Distance (ft):	.0
Structural Grade:	0
O&M Grade:	0
Clock Start/From:	
Clock To:	
1st Value:	
2nd Value:	
Value Percent:	
Continuous Index:	
Within 8" of Joint:	NO
Remarks:	M-705-025

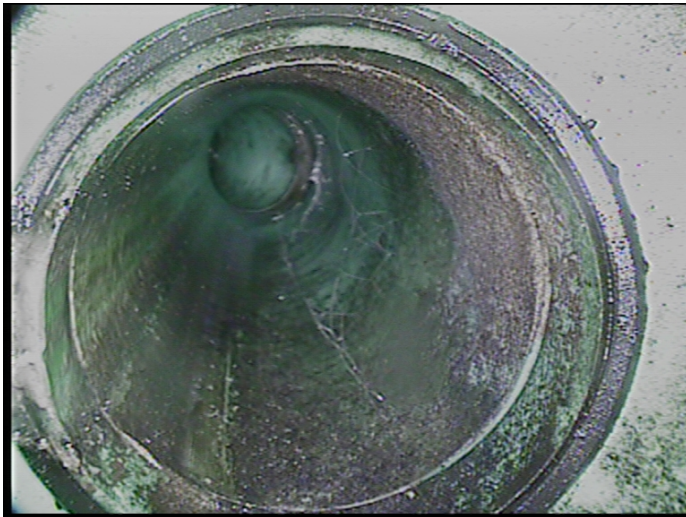
Code:	MWL
Description:	Water Level
Distance (ft):	.0
Structural Grade:	0
O&M Grade:	0
Clock Start/From:	
Clock To:	
1st Value:	
2nd Value:	
Value Percent:	10.000
Continuous Index:	
Within 8" of Joint:	NO
Remarks:

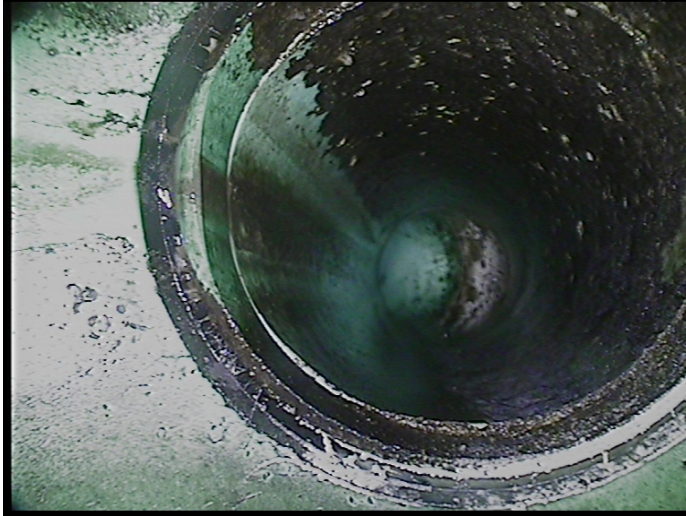
Code:	TF
Description:	Tap Factory
Distance (ft):	39.0
Structural Grade:	0
O&M Grade:	0
Clock Start/From:	10
Clock To:	
1st Value:	4.000
2nd Value:	
Value Percent:	
Continuous Index:	
Within 8" of Joint:	NO
Remarks:

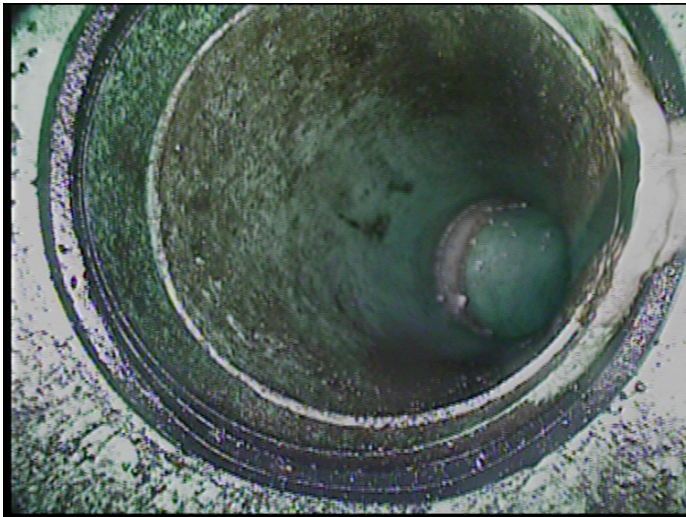
Code: **TF**
Description: **Tap Factory**

Distance (ft): **77.7**
Structural Grade: **0**
O&M Grade: **0**
Clock Start/From: **10**
Clock To:
1st Value: **4.000**
2nd Value:
Value Percent:
Continuous Index:
Within 8" of Joint: **NO**
Remarks:

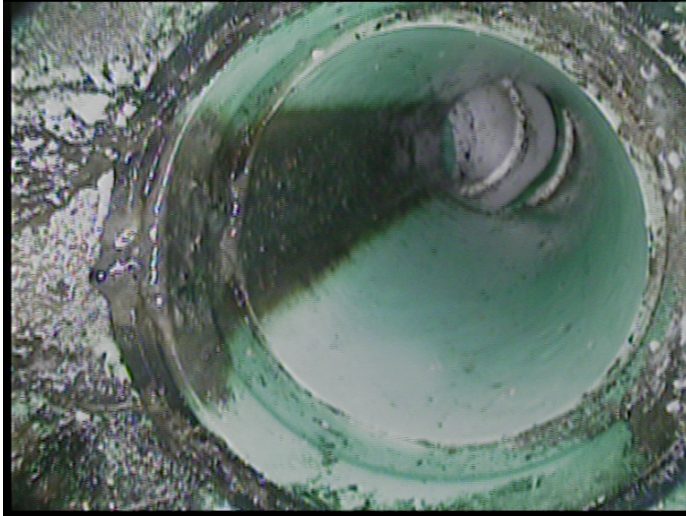
Code: **TFA**
Description: **Tap Factory Active**

Distance (ft): **87.0**
Structural Grade: **0**
O&M Grade: **0**
Clock Start/From: **2**
Clock To:
1st Value: **4.000**
2nd Value:
Value Percent:
Continuous Index:
Within 8" of Joint: **NO**
Remarks:

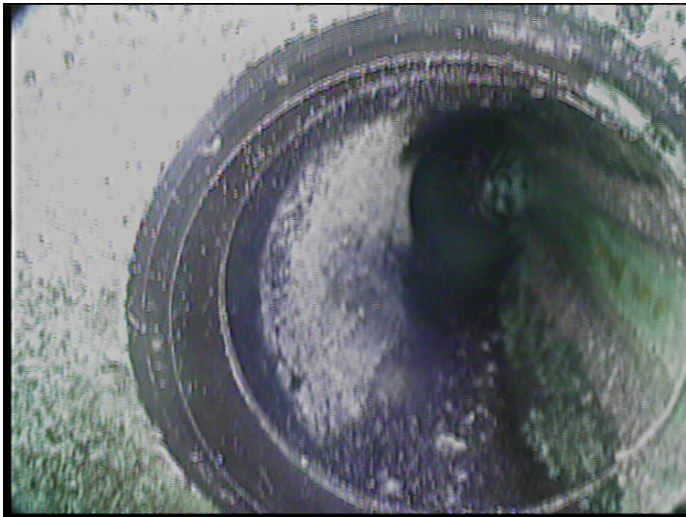
Code: **TB**
Description: **Tap Break-in**

Distance (ft): **106.4**
Structural Grade: **0**
O&M Grade: **0**
Clock Start/From: **10**
Clock To:
1st Value: **4.000**
2nd Value:
Value Percent:
Continuous Index:
Within 8" of Joint: **NO**
Remarks:
