## Profile/Photo Observation Report

Date:	<b>05/02/2018</b>	Weather:		Coding:	<b>PACP 6.0</b>
Pipe Length (ft):		Owner:	<b>City of Hobart</b>	Pre Clean:	<b>No Pre-Cleaning</b>
P.O.#:	<b>160</b>	Surveyor:	<b>M. Pielacha</b>	PSR:	<b>P-705-025-026</b>
Customer:	<b>City of Hobart</b>	Clean Date:		Shape:	<b>C</b>

Street:	<b>Main Street</b>	Flow Control:	<b>Not Controlled</b>
City:	<b>Hobart, IN</b>	Year Renewed:	
Location:	<b>Light Highway</b>	Tape/Media #:	<b>DEP 160</b>
Purpose:	<b>Routine Assessment</b>	Dia/Height:	<b>18"</b>
Use:	<b>Sanitary</b>	Material:	<b>PVC</b>
Drain Area:		Lining:	
Category:	<b>NA</b>		
Comment:	<b>5-21-2018</b>		
Location Details:		Direction of Survey:	<b>Downstream</b>
US MH:	<b>M-705-026</b>	DS MH:	<b>M-705-025</b>
		Total Length Surveyed (ft):	<b>400.3</b>

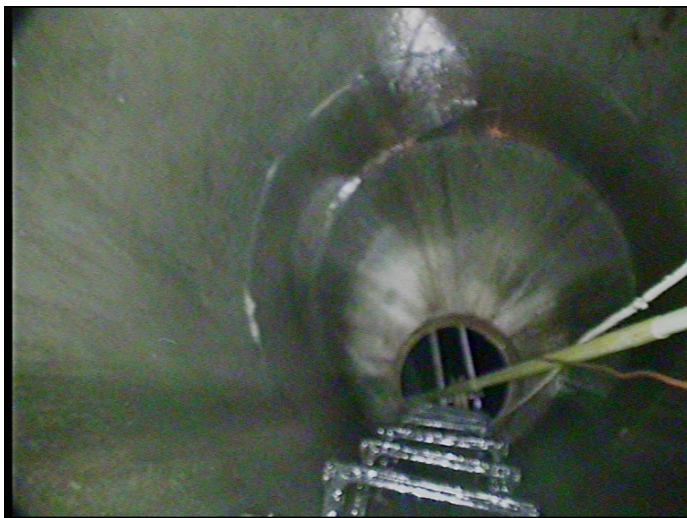
Code: **AMH**  
 Description: **Manhole**

Distance (ft): **.0**  
 Structural Grade: **0**  
 O&M Grade: **0**  
 Clock Start/From:  
 Clock To:  
 1st Value:  
 2nd Value:  
 Value Percent:  
 Continuous Index:  
 Within 8" of Joint: **NO**  
 Remarks: **M-705-025**

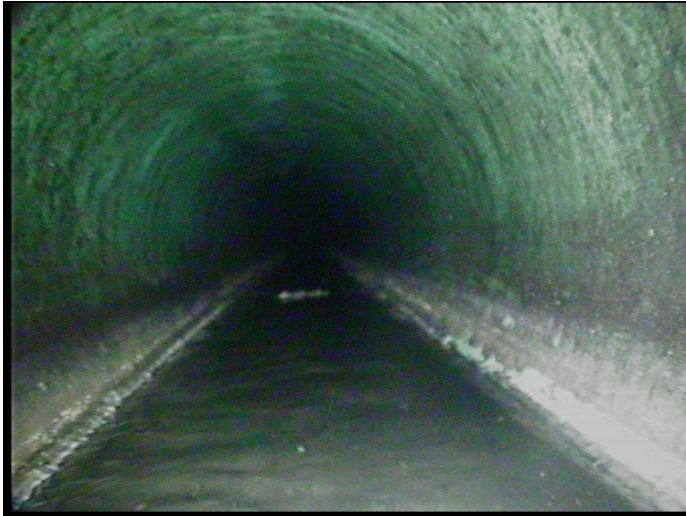
Code: **MWL**  
Description: **Water Level**

Distance (ft): **.0**  
Structural Grade: **0**  
O&M Grade: **0**  
Clock Start/From:  
Clock To:  
1st Value:  
2nd Value:  
Value Percent: **10.000**  
Continuous Index:  
Within 8" of Joint: **NO**  
Remarks:

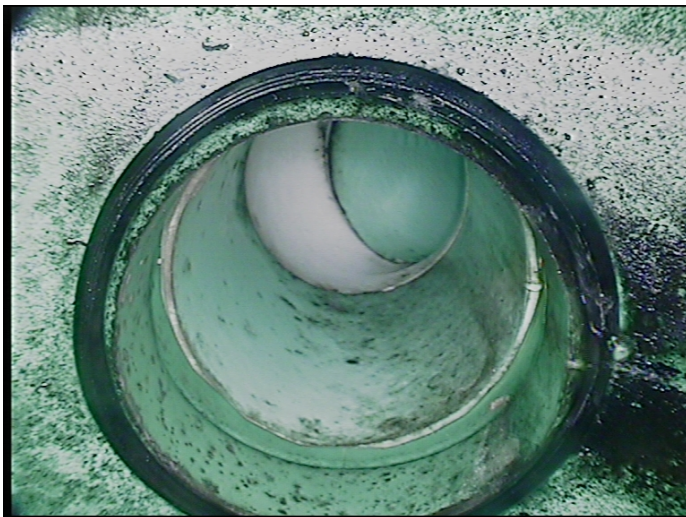
Code: **TFA**  
Description: **Tap Factory Active**

Distance (ft): **39.7**  
Structural Grade: **0**  
O&M Grade: **0**  
Clock Start/From: **2**  
Clock To:  
1st Value: **4.000**  
2nd Value:  
Value Percent:  
Continuous Index:  
Within 8" of Joint: **NO**  
Remarks:

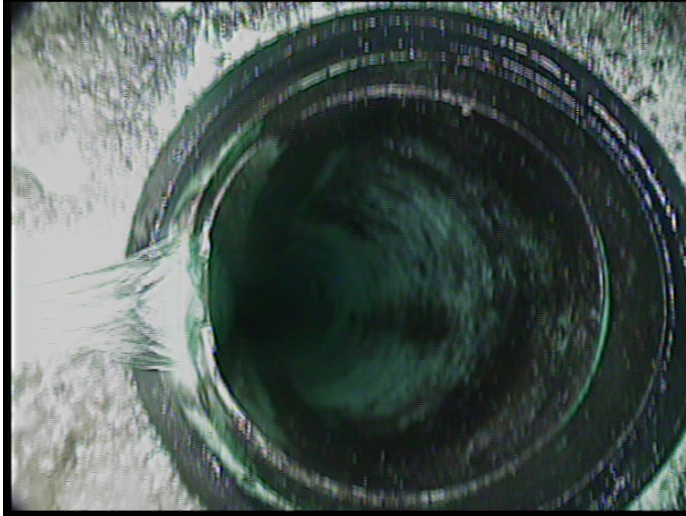
Code:	<b>TBA</b>
Description:	<b>Tap Break-in Active</b>
Distance (ft):	<b>45.2</b>
Structural Grade:	<b>0</b>
O&M Grade:	<b>0</b>
Clock Start/From:	<b>10</b>
Clock To:	
1st Value:	<b>4.000</b>
2nd Value:	
Value Percent:	
Continuous Index:	
Within 8" of Joint:	<b>NO</b>
Remarks:

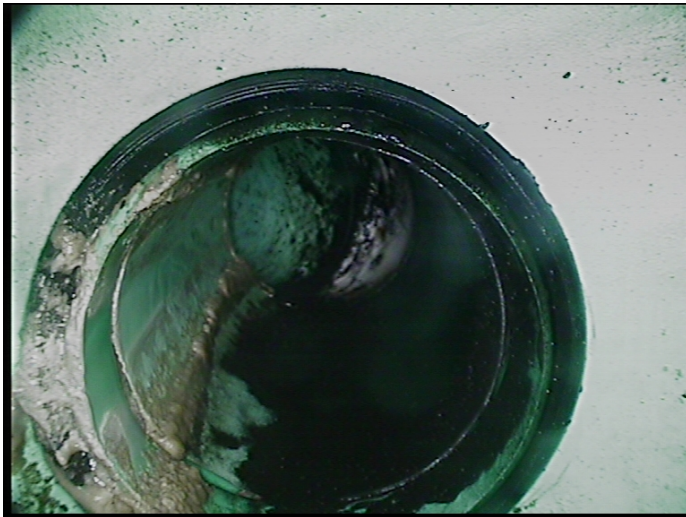
Code:	<b>TB</b>
Description:	<b>Tap Break-in</b>
Distance (ft):	<b>67.6</b>
Structural Grade:	<b>0</b>
O&M Grade:	<b>0</b>
Clock Start/From:	<b>10</b>
Clock To:	
1st Value:	<b>4.000</b>
2nd Value:	
Value Percent:	
Continuous Index:	
Within 8" of Joint:	<b>NO</b>
Remarks:

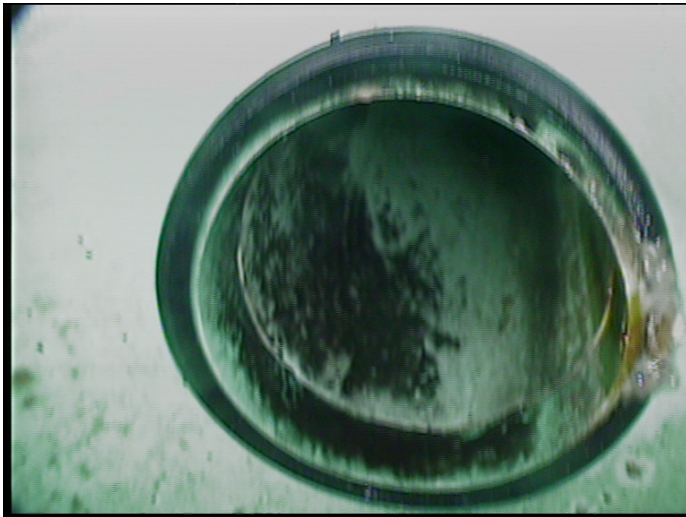
Code: **TBA**  
Description: **Tap Break-in Active**

Distance (ft): **72.0**  
Structural Grade: **0**  
O&M Grade: **0**  
Clock Start/From: **2**  
Clock To:  
1st Value: **4.000**  
2nd Value:  
Value Percent:  
Continuous Index:  
Within 8" of Joint: **NO**  
Remarks:

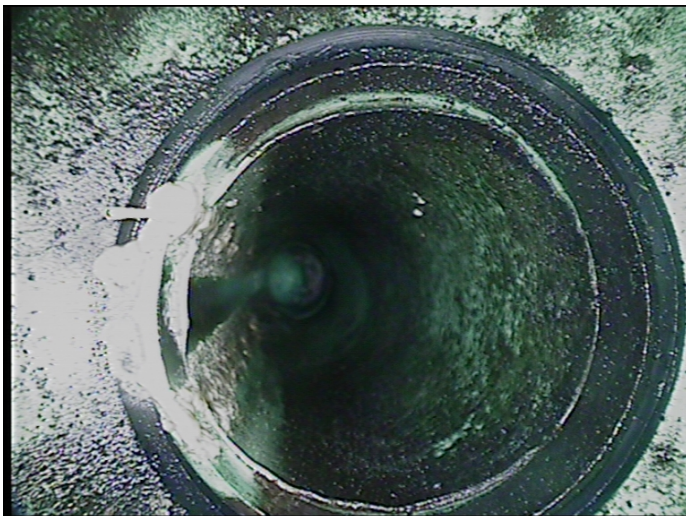
Code: **TB**  
Description: **Tap Break-in**

Distance (ft): **95.3**  
Structural Grade: **0**  
O&M Grade: **0**  
Clock Start/From: **10**  
Clock To:  
1st Value: **4.000**  
2nd Value:  
Value Percent:  
Continuous Index:  
Within 8" of Joint: **NO**  
Remarks:

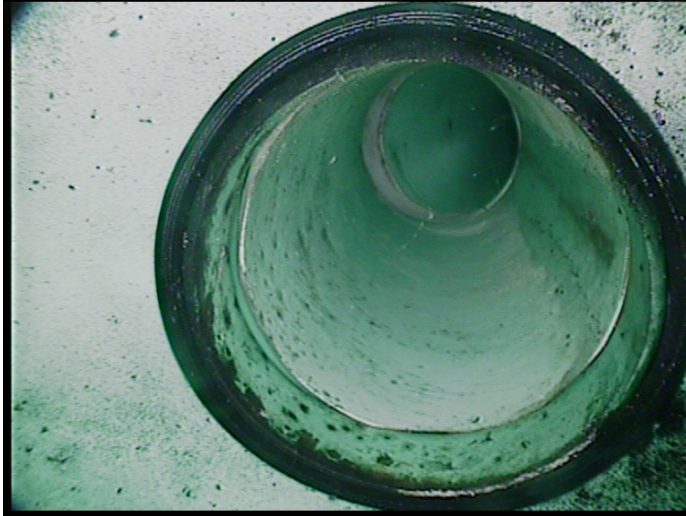
Code: **TB**  
Description: **Tap Break-in**

Distance (ft): **99.0**  
Structural Grade: **0**  
O&M Grade: **0**  
Clock Start/From: **2**  
Clock To:  
1st Value: **4.000**  
2nd Value:  
Value Percent:  
Continuous Index:  
Within 8" of Joint: **NO**  
Remarks:

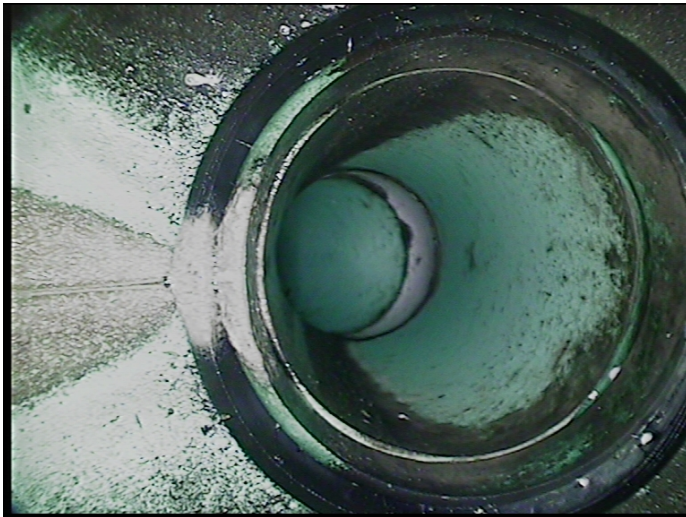
Code: **TB**  
Description: **Tap Break-in**

Distance (ft): **141.2**  
Structural Grade: **0**  
O&M Grade: **0**  
Clock Start/From: **10**  
Clock To:  
1st Value: **4.000**  
2nd Value:  
Value Percent:  
Continuous Index:  
Within 8" of Joint: **NO**  
Remarks:

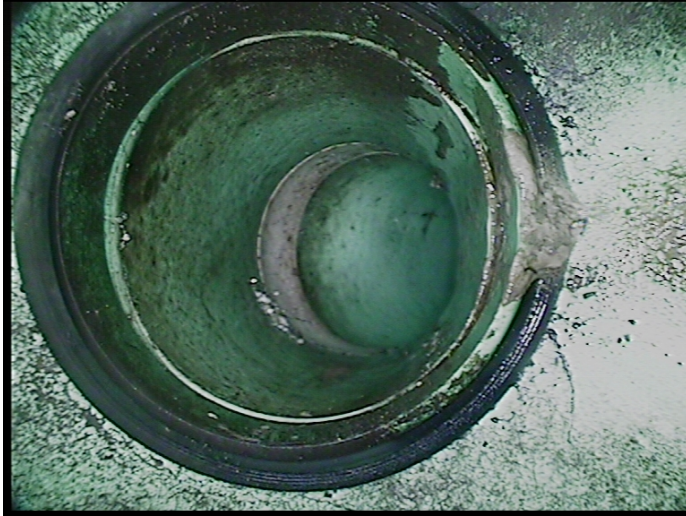
Code: **TBA**  
Description: **Tap Break-in Active**

Distance (ft): **149.9**  
Structural Grade: **0**  
O&M Grade: **0**  
Clock Start/From: **2**  
Clock To:  
1st Value: **4.000**  
2nd Value:  
Value Percent:  
Continuous Index:  
Within 8" of Joint: **NO**  
Remarks:

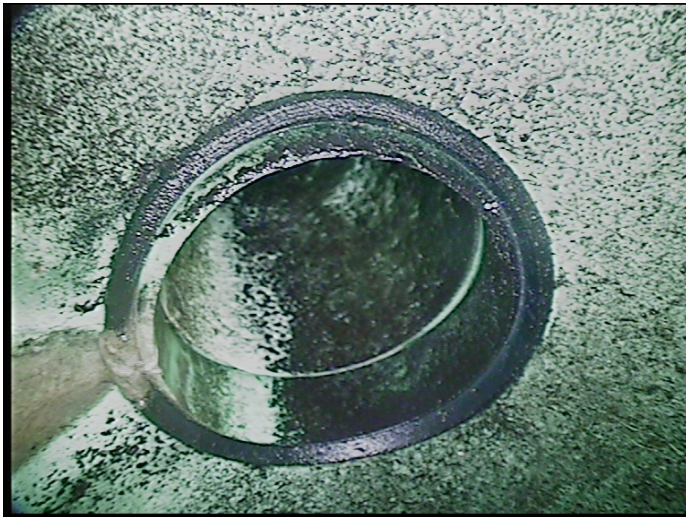
Code: **TBA**  
Description: **Tap Break-in Active**

Distance (ft): **179.0**  
Structural Grade: **0**  
O&M Grade: **0**  
Clock Start/From: **10**  
Clock To:  
1st Value: **4.000**  
2nd Value:  
Value Percent:  
Continuous Index:  
Within 8" of Joint: **NO**  
Remarks:

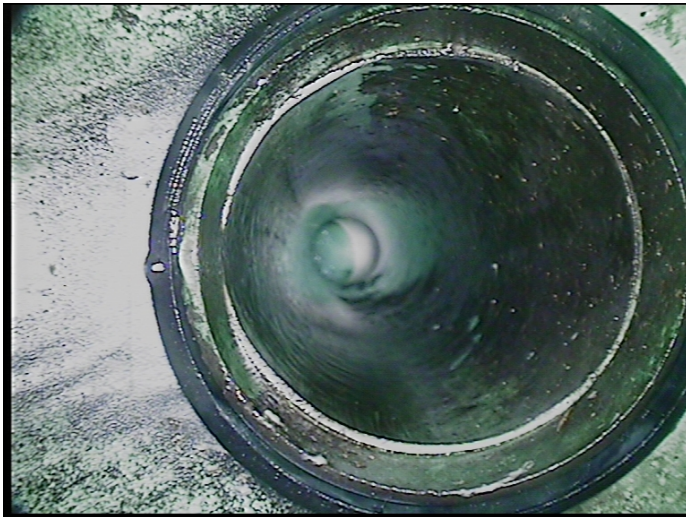
Code: **TB**  
Description: **Tap Break-in**

Distance (ft): **224.8**  
Structural Grade: **0**  
O&M Grade: **0**  
Clock Start/From: **10**  
Clock To:  
1st Value: **4.000**  
2nd Value:  
Value Percent:  
Continuous Index:  
Within 8" of Joint: **NO**  
Remarks:

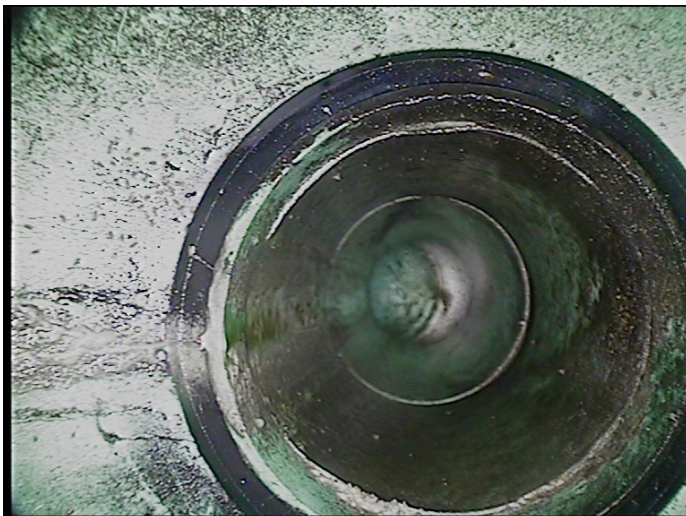
Code: **TBA**  
Description: **Tap Break-in Active**

Distance (ft): **266.0**  
Structural Grade: **0**  
O&M Grade: **0**  
Clock Start/From: **10**  
Clock To:  
1st Value: **4.000**  
2nd Value:  
Value Percent:  
Continuous Index:  
Within 8" of Joint: **NO**  
Remarks:

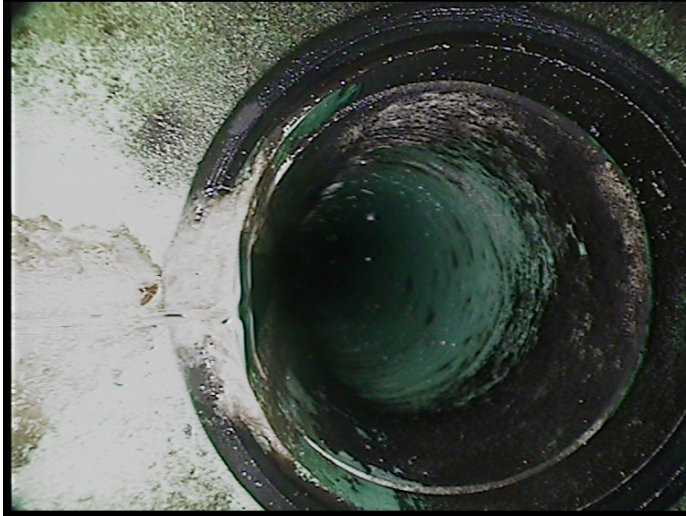
Code: **TBA**  
Description: **Tap Break-in Active**

Distance (ft): **296.8**  
Structural Grade: **0**  
O&M Grade: **0**  
Clock Start/From: **10**  
Clock To:  
1st Value: **4.000**  
2nd Value:  
Value Percent:  
Continuous Index:  
Within 8" of Joint: **NO**  
Remarks:

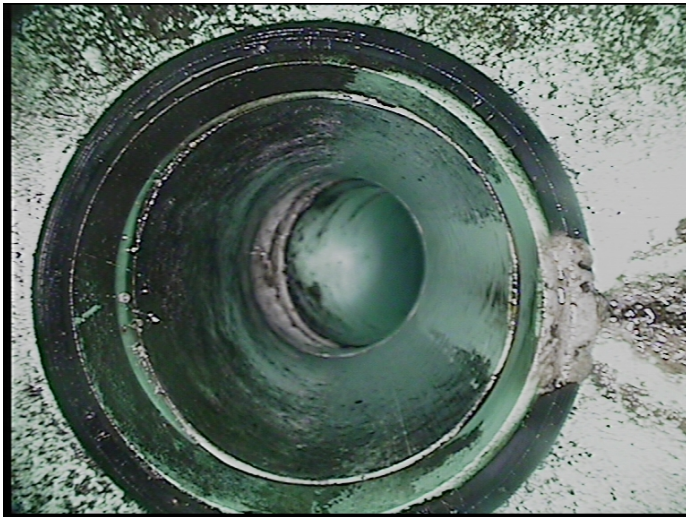
Code: **TB**  
Description: **Tap Break-in**

Distance (ft): **345.7**  
Structural Grade: **0**  
O&M Grade: **0**  
Clock Start/From: **2**  
Clock To:  
1st Value: **4.000**  
2nd Value:  
Value Percent:  
Continuous Index:  
Within 8" of Joint: **NO**  
Remarks:

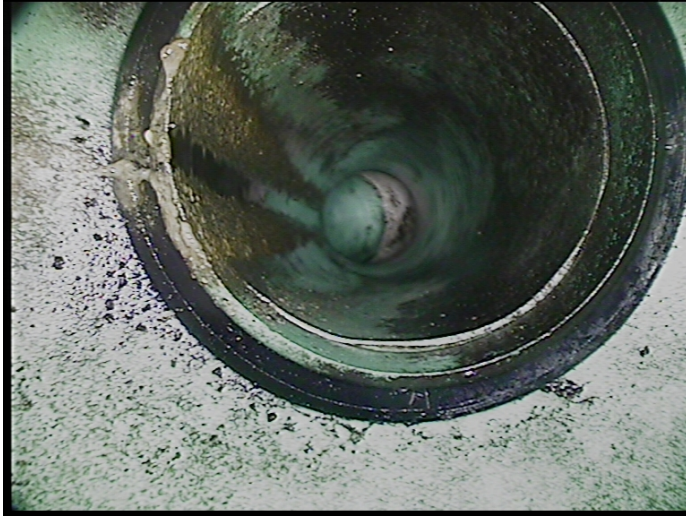
Code: **TB**  
Description: **Tap Break-in**

Distance (ft): **351.1**  
Structural Grade: **0**  
O&M Grade: **0**  
Clock Start/From: **10**  
Clock To:  
1st Value: **4.000**  
2nd Value:  
Value Percent:  
Continuous Index:  
Within 8" of Joint: **NO**  
Remarks:

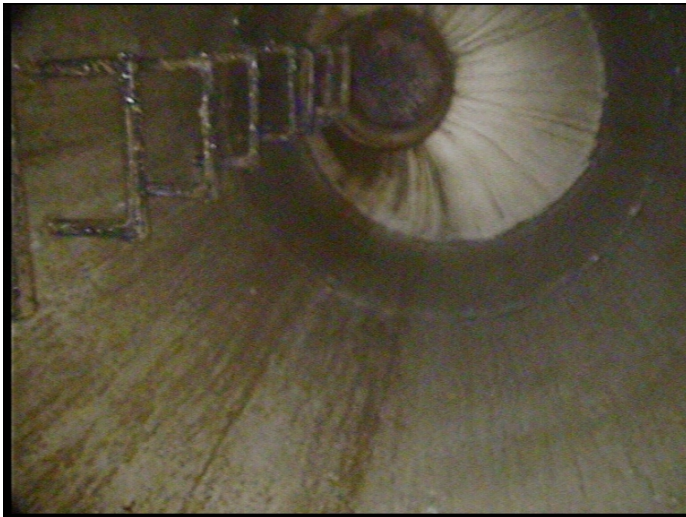
Code: **AMH**  
Description: **Manhole**

Distance (ft): **400.3**  
Structural Grade: **0**  
O&M Grade: **0**  
Clock Start/From:  
Clock To:  
1st Value:  
2nd Value:  
Value Percent:  
Continuous Index:  
Within 8" of Joint: **NO**  
Remarks: **M-705-026**
