Profile/Photo Observation Report

Date:	05/02/2018	Weather:		Coding:	PACP 6.0
Pipe Length (ft):		Owner:	City of Hobart	Pre Clean:	No Pre-Cleaning
P.O.#:	161	Surveyor:	M. Pielacha	PSR:	P-705-026-027
Customer:	City of Hobart	Clean Date:		Shape:	C

Street:	Main Street	Flow Control:	Not Controlled
City:	Hobart, IN	Year Renewed:	
Location:	Light Highway	Tape/Media #:	DEP 161
Purpose:	Routine Assessment	Dia/Height:	20"
Use:	Sanitary	Material:	PVC
Drain Area:		Lining:	
Category:	NA		
Comment:	5-21-2018		
Location Details:		Direction of Survey:	Downstream
US MH:	M-705-027	DS MH:	M-705-026
		Total Length Surveyed (ft):	356.9

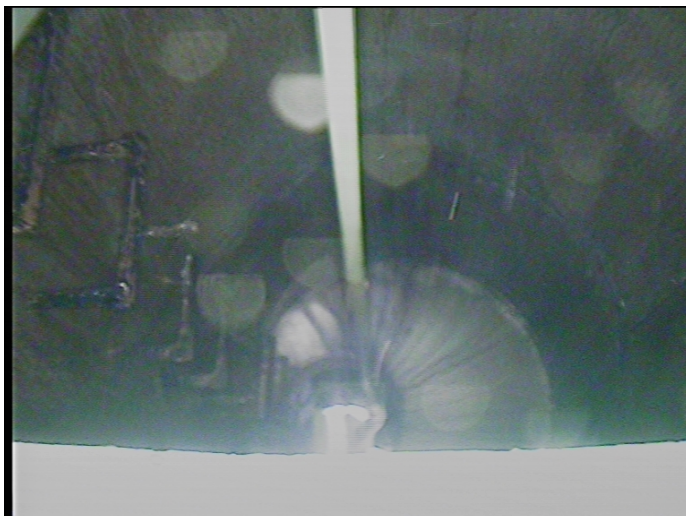
Code: **AMH**
 Description: **Manhole**

Distance (ft): **.0**
 Structural Grade: **0**
 O&M Grade: **0**
 Clock Start/From:
 Clock To:
 1st Value:
 2nd Value:
 Value Percent:
 Continuous Index:
 Within 8" of Joint: **NO**
 Remarks: **M-705-026**

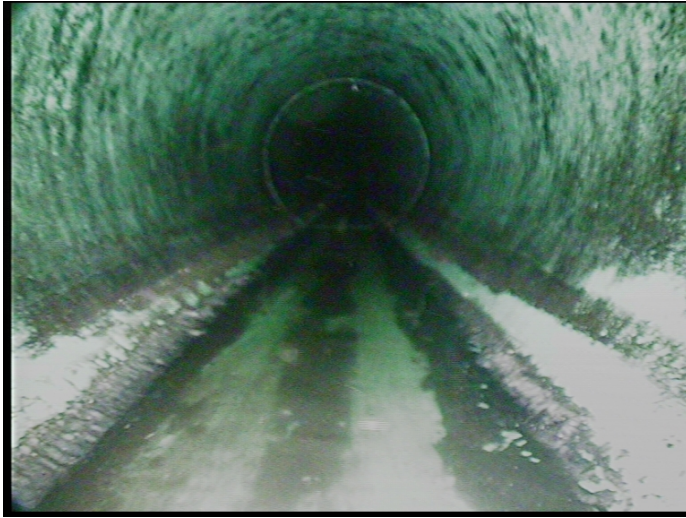
Code: **MWL**
Description: **Water Level**

Distance (ft): **.0**
Structural Grade: **0**
O&M Grade: **0**
Clock Start/From:
Clock To:
1st Value:
2nd Value:
Value Percent: **10.000**
Continuous Index:
Within 8" of Joint: **NO**
Remarks:

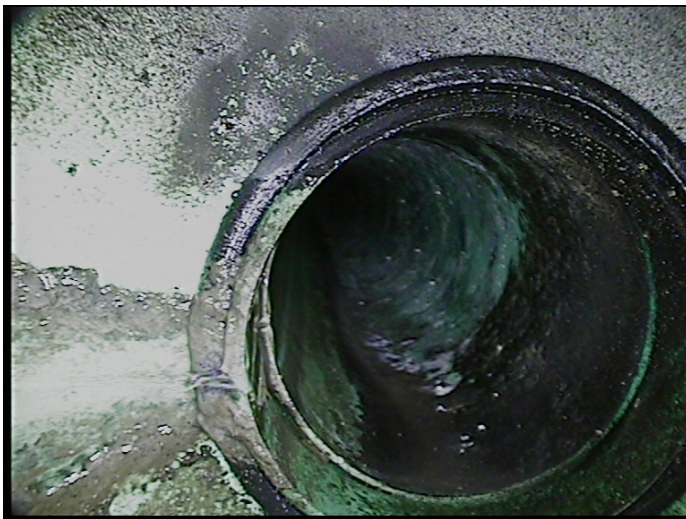
Code: **TBA**
Description: **Tap Break-in Active**

Distance (ft): **53.8**
Structural Grade: **0**
O&M Grade: **0**
Clock Start/From: **10**
Clock To:
1st Value: **4.000**
2nd Value:
Value Percent:
Continuous Index:
Within 8" of Joint: **NO**
Remarks:

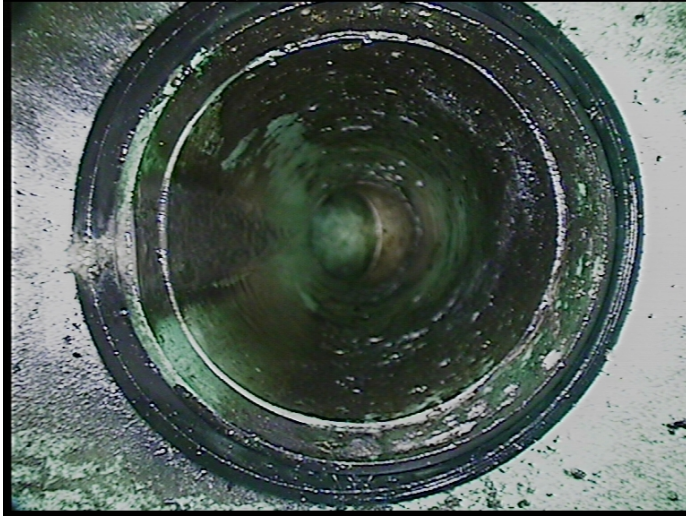
Code: **TB**
Description: **Tap Break-in**

Distance (ft): **113.0**
Structural Grade: **0**
O&M Grade: **0**
Clock Start/From: **10**
Clock To:
1st Value: **4.000**
2nd Value:
Value Percent:
Continuous Index:
Within 8" of Joint: **NO**
Remarks:

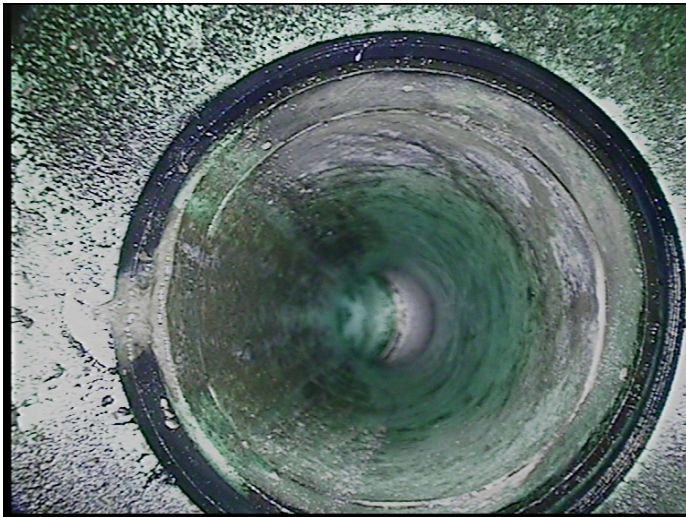
Code: **TB**
Description: **Tap Break-in**

Distance (ft): **142.0**
Structural Grade: **0**
O&M Grade: **0**
Clock Start/From: **10**
Clock To:
1st Value: **4.000**
2nd Value:
Value Percent:
Continuous Index:
Within 8" of Joint: **NO**
Remarks:

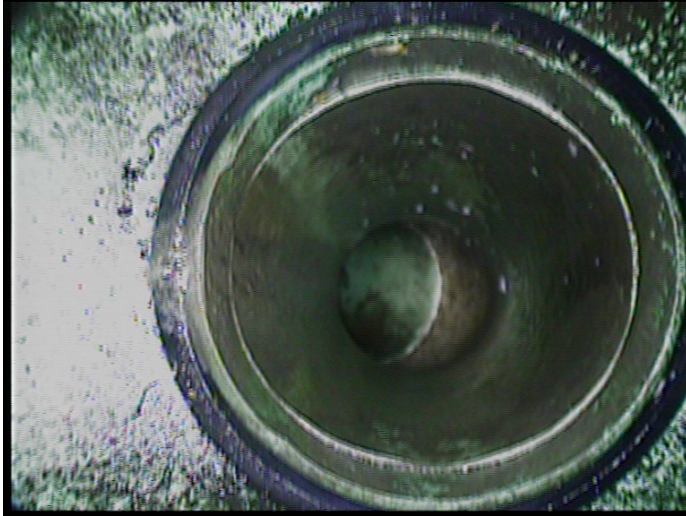
Code: **TB**
Description: **Tap Break-in**

Distance (ft): **255.0**
Structural Grade: **0**
O&M Grade: **0**
Clock Start/From: **10**
Clock To:
1st Value: **4.000**
2nd Value:
Value Percent:
Continuous Index:
Within 8" of Joint: **NO**
Remarks:

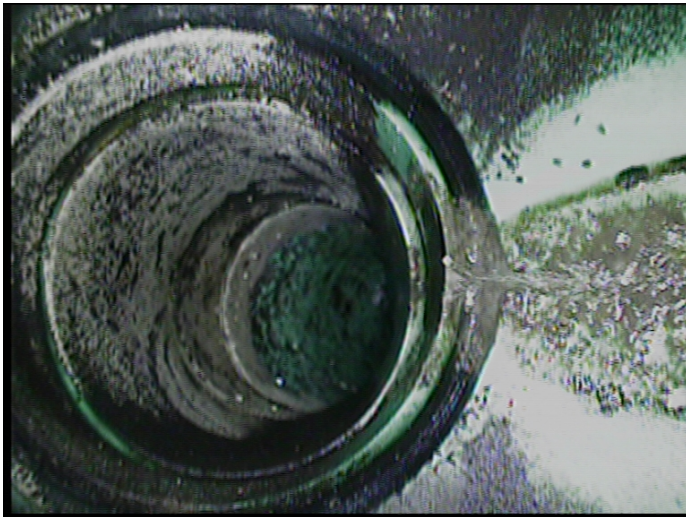
Code: **TFA**
Description: **Tap Factory Active**

Distance (ft): **266.4**
Structural Grade: **0**
O&M Grade: **0**
Clock Start/From: **2**
Clock To:
1st Value: **4.000**
2nd Value:
Value Percent:
Continuous Index:
Within 8" of Joint: **NO**
Remarks:

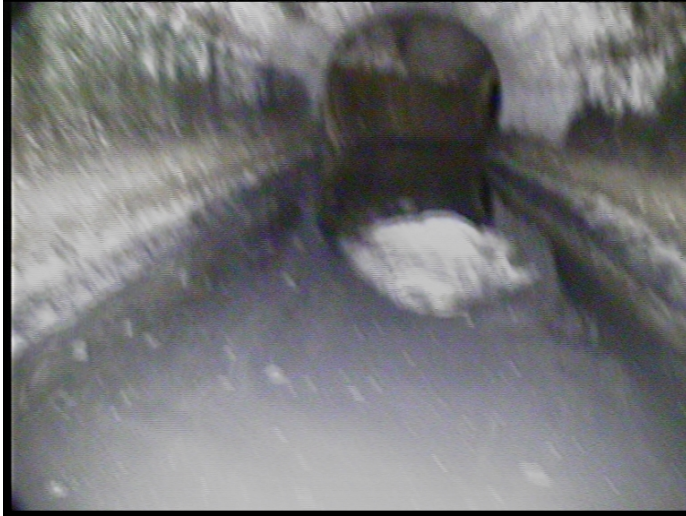
Code: **DSF**
Description: **Deposits Settled Fine**

Distance (ft): **349.9**
Structural Grade: **0**
O&M Grade: **3**
Clock Start/From: **4**
Clock To: **8**
1st Value:
2nd Value:
Value Percent: **15.000**
Continuous Index: **S01**
Within 8" of Joint: **YES**
Remarks:

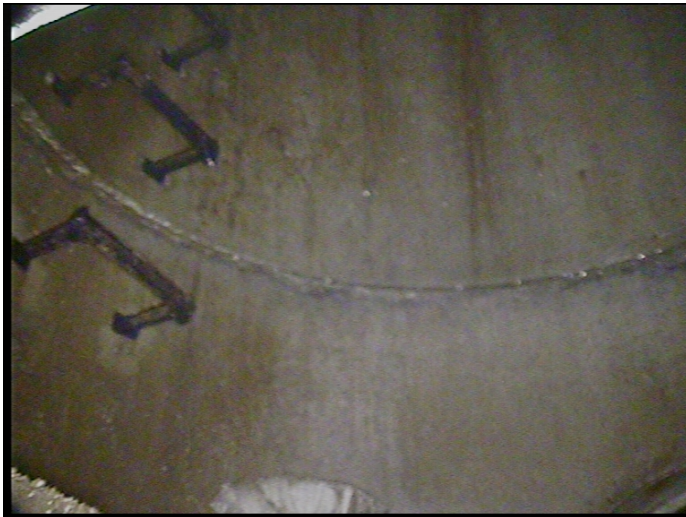
Code: **DSF**
Description: **Deposits Settled Fine**

Distance (ft): **356.8**
Structural Grade: **0**
O&M Grade: **3**
Clock Start/From: **4**
Clock To: **8**
1st Value:
2nd Value:
Value Percent: **15.000**
Continuous Index: **F01**
Within 8" of Joint: **NO**
Remarks:

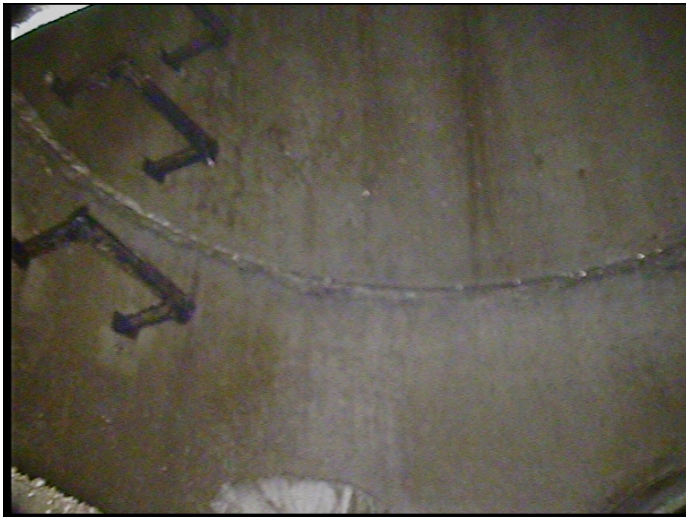
Code:	AMH
Description:	Manhole
Distance (ft):	356.9
Structural Grade:	0
O&M Grade:	0
Clock Start/From:	
Clock To:	
1st Value:	
2nd Value:	
Value Percent:	
Continuous Index:	
Within 8" of Joint:	NO
Remarks:	M-705-027
