## Profile/Photo Observation Report

| P.O.#: | <b>162</b> | Surveyor: | <b>M. Pielacha</b> | PSR: | <b>P-705-027-028</b> |

| Street: | <b>Main Street</b> | Flow Control: | <b>Not Controlled</b> |
| Use: | <b>Sanitary</b> | Material: | <b>PVC</b> |

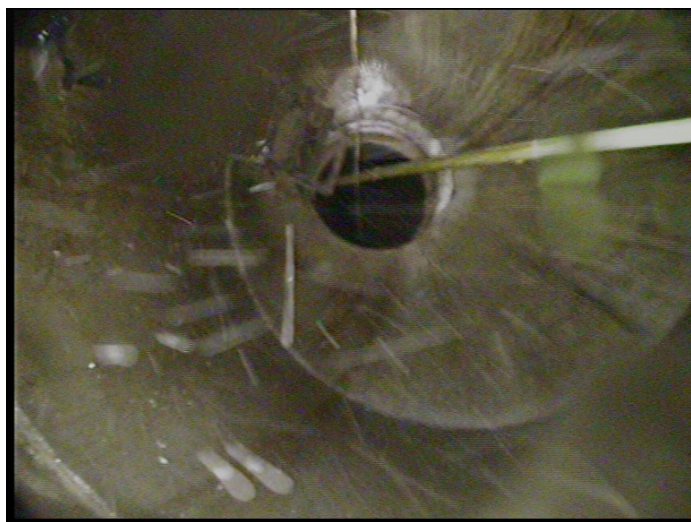
Code: **AMH**  
 Description: **Manhole**

Distance (ft): **.0**  
 Structural Grade: **0**  
 O&M Grade: **0**  
 Clock Start/From:  
 Clock To:  
 1st Value:  
 2nd Value:  
 Value Percent:  
 Continuous Index:  
 Within 8" of Joint: **NO**  
 Remarks: **M-705-027**

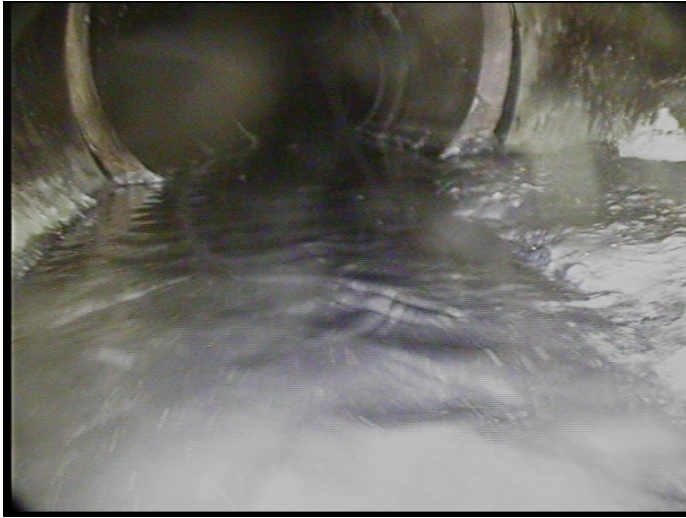
Code: **MWL**  
Description: **Water Level**

Distance (ft): **.0**  
Structural Grade: **0**  
O&M Grade: **0**  
Clock Start/From:  
Clock To:  
1st Value:  
2nd Value:  
Value Percent: **15.000**  
Continuous Index:  
Within 8" of Joint: **NO**  
Remarks:

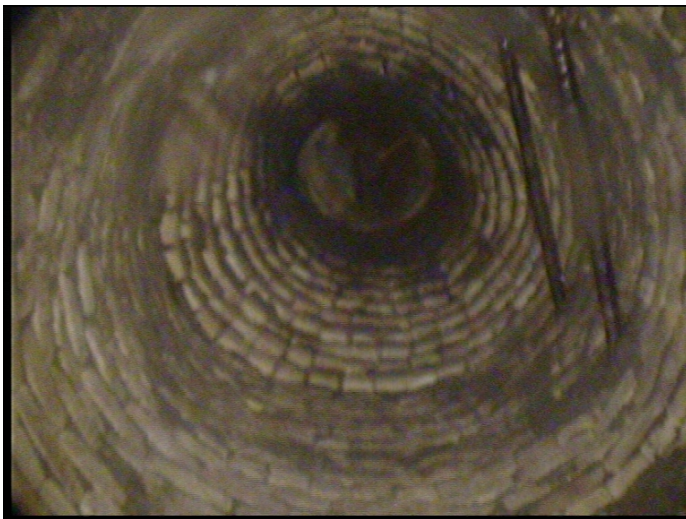
Code: **AMH**  
Description: **Manhole**

Distance (ft): **39.5**  
Structural Grade: **0**  
O&M Grade: **0**  
Clock Start/From:  
Clock To:  
1st Value:  
2nd Value:  
Value Percent:  
Continuous Index:  
Within 8" of Joint: **NO**  
Remarks: **M-705-028**
