## Profile/Photo Observation Report

Date:	<b>09/17/2022</b>	Weather:		Coding:	<b>PACP 7.0</b>
Pipe Length (ft):	<b>224.0</b>	Owner:	<b>City of Hobart</b>	Pre Clean:	<b>No Pre-Cleaning</b>
P.O.#:	<b>YES502259</b>	Surveyor:	<b>S. Bucklin</b>	PSR:	<b>M-705-030-M-705-029</b>
Customer:	<b>City of Hobart</b>	Clean Date:		Shape:	<b>C</b>

Street:	<b>Center Street</b>	Flow Control:	<b>Not Controlled</b>
City:	<b>Hobart, IN</b>	Year Renewed:	
Location:	<b>Local rural streets with light traffic, t</b>	Tape/Media #:	
Purpose:	<b>Routine Assessment</b>	Dia/Height:	<b>8"</b>
Use:	<b>Sanitary Sewage Pipe</b>	Material:	<b>PVC</b>
Drain Area:		Lining:	<b>None</b>
Category:	<b>NA</b>		
Comment:			
Location Details:		Direction of Survey:	<b>Upstream</b>
US MH:	<b>M-705-030</b>	DS MH:	<b>M-705-029</b>
		Total Length Surveyed (ft):	<b>218.3</b>

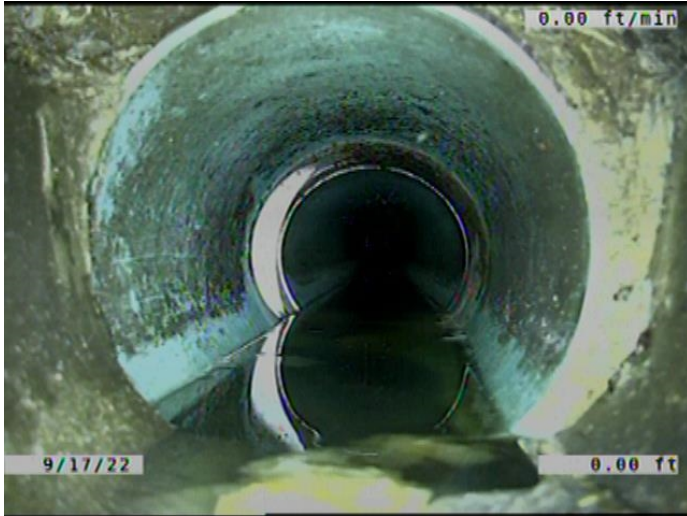
Code:	<b>MWL</b>
Description:	<b>Miscellaneous Water Level</b>
Distance (ft):	<b>.0</b>
Structural Grade:	<b>0</b>
O&M Grade:	<b>0</b>
Clock Start/From:	
Clock To:	
1st Value:	
2nd Value:	
Value Percent:	<b>10.000</b>
Continuous Index:	
Within 8" of Joint:	<b>NO</b>
Remarks:

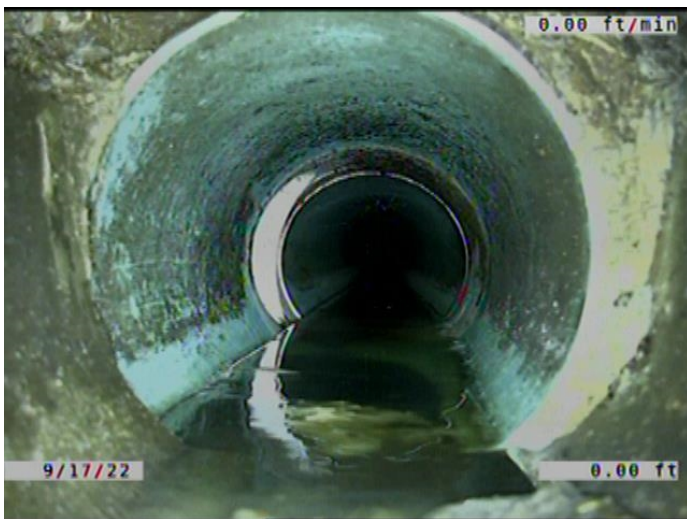
Code:	<b>DSF</b>
Description:	<b>Deposits Settled Fine</b>
Distance (ft):	<b>.0</b>
Structural Grade:	<b>0</b>
O&M Grade:	<b>2</b>
Clock Start/From:	<b>5</b>
Clock To:	<b>7</b>
1st Value:	
2nd Value:	
Value Percent:	<b>5.000</b>
Continuous Index:	<b>S01</b>
Within 8" of Joint:	<b>YES</b>
Remarks:

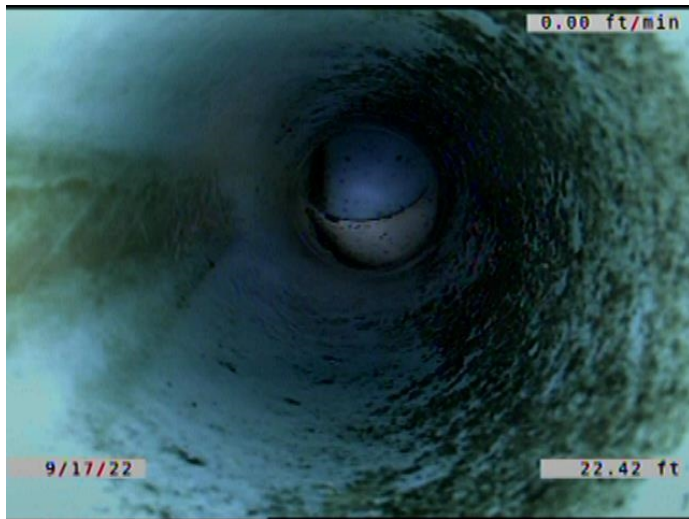
Code: **TF**  
Description: **Tap Factory**

Distance (ft): **22.4**  
Structural Grade: **0**  
O&M Grade: **0**  
Clock Start/From: **9**  
Clock To:  
1st Value: **6.000**  
2nd Value:  
Value Percent:  
Continuous Index:  
Within 8" of Joint: **YES**  
Remarks:

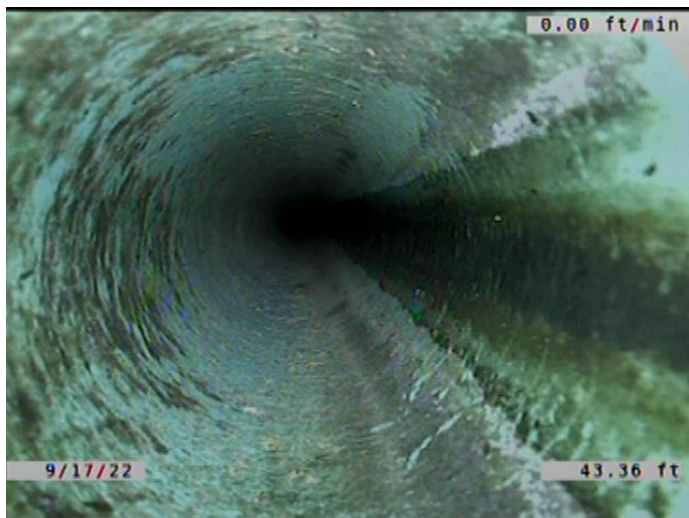
Code: **TF**  
Description: **Tap Factory**

Distance (ft): **43.4**  
Structural Grade: **0**  
O&M Grade: **0**  
Clock Start/From: **3**  
Clock To:  
1st Value: **6.000**  
2nd Value:  
Value Percent:  
Continuous Index:  
Within 8" of Joint: **YES**  
Remarks:

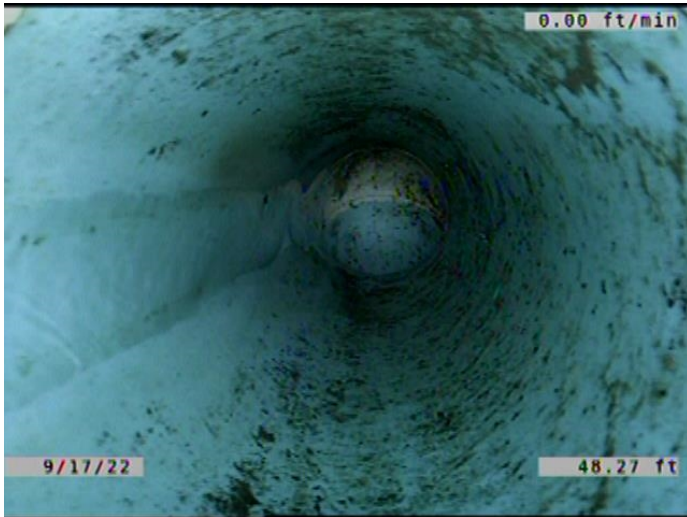
Code: **TF**  
Description: **Tap Factory**

Distance (ft): **48.3**  
Structural Grade: **0**  
O&M Grade: **0**  
Clock Start/From: **9**  
Clock To:  
1st Value: **6.000**  
2nd Value:  
Value Percent:  
Continuous Index:  
Within 8" of Joint: **YES**  
Remarks:

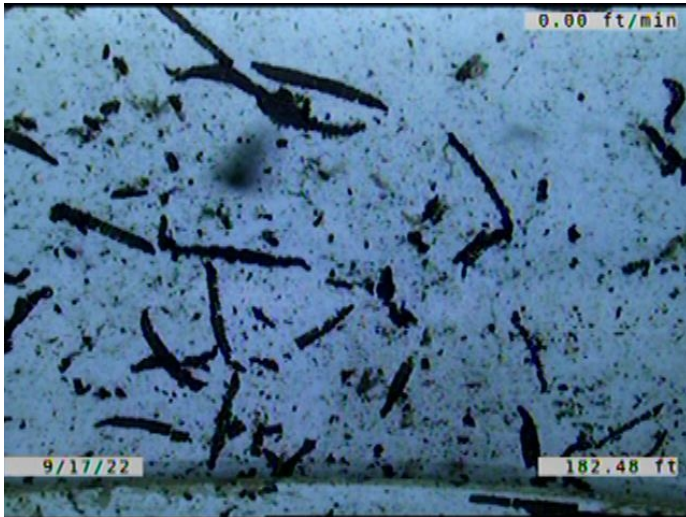
Code: **MGO**  
Description: **Miscellaneous General Observation**

Distance (ft): **182.5**  
Structural Grade: **0**  
O&M Grade: **0**  
Clock Start/From:  
Clock To:  
1st Value:  
2nd Value:  
Value Percent:  
Continuous Index:  
Within 8" of Joint: **NO**  
Remarks: **JOINT/ PIPES NOT PUSHED ALL THE WAY TOGETHER WHEN INSTALLED**

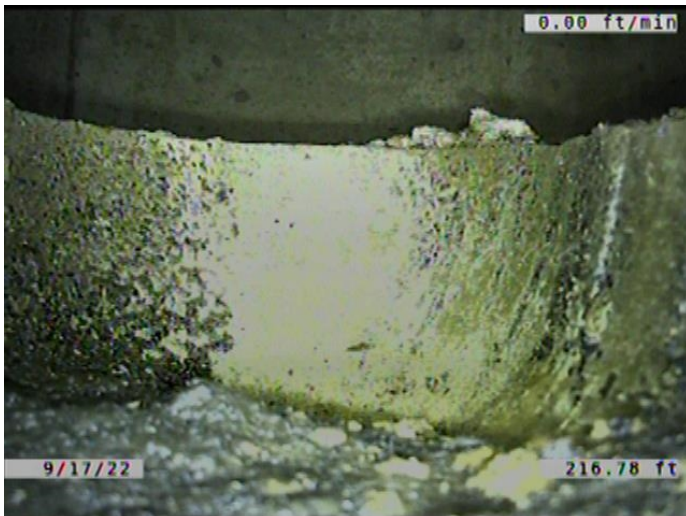
Code: **DSF**  
 Description: **Deposits Settled Fine**

Distance (ft): **216.8**  
 Structural Grade: **0**  
 O&M Grade: **2**  
 Clock Start/From: **5**  
 Clock To: **7**  
 1st Value:  
 2nd Value:  
 Value Percent: **5.000**  
 Continuous Index: **F01**  
 Within 8" of Joint: **YES**  
 Remarks:
