Profile/Photo Observation Report

Date:	10/20/2021	Weather:		Coding:	PACP 6.0
Pipe Length (ft):		Owner:	Hobart, IN	Pre Clean:	Not Known
P.O.#:	914_1	Surveyor:	M. Pielacha	PSR:	P-705-029-030
Customer:	Hobart, IN	Clean Date:		Shape:	C

Street:	Center Street	Flow Control:	
City:	Hobart, IN	Year Renewed:	
Location:	Light Highway	Tape/Media #:	914
Purpose:	Routine Assessment	Dia/Height:	8"
Use:	Sanitary	Material:	PVC
Drain Area:		Lining:

US MH: **M-705-30** DS MH: **M-705-29** Total Length Surveyed (ft): **216.1**

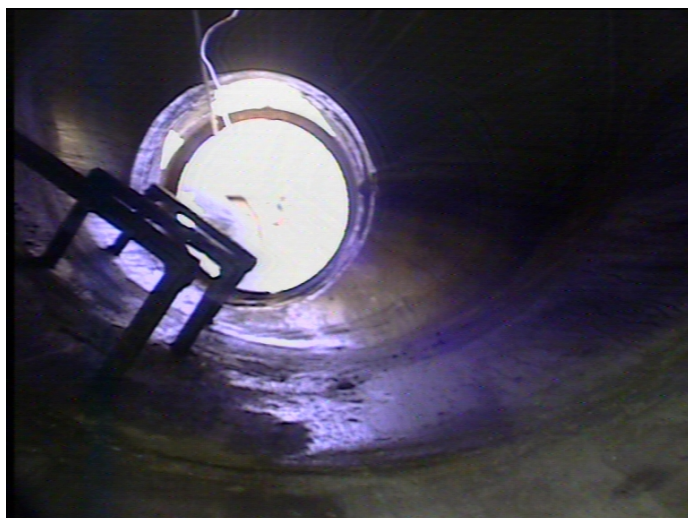
Code: **AMH**
 Description: **Manhole**

Distance (ft): **.0**
 Structural Grade: **0**
 O&M Grade: **0**
 Clock Start/From:
 Clock To:
 1st Value:
 2nd Value:
 Value Percent:
 Continuous Index:
 Within 8" of Joint: **NO**
 Remarks: **M-705-29**

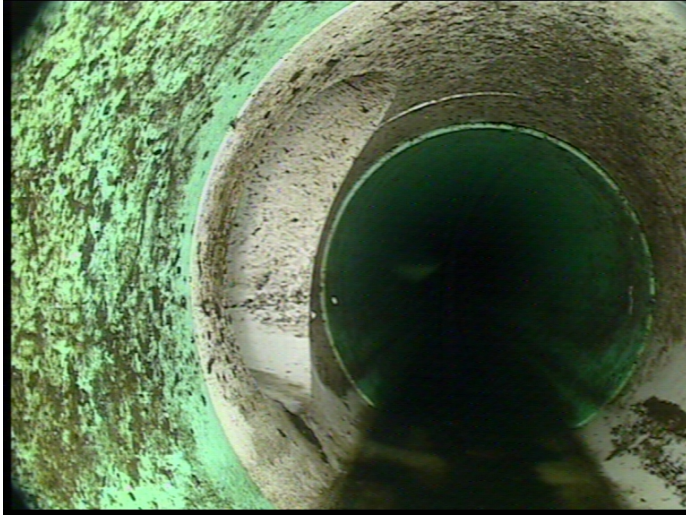
Code:	MWL
Description:	Water Level
Distance (ft):	.0
Structural Grade:	0
O&M Grade:	0
Clock Start/From:	
Clock To:	
1st Value:	
2nd Value:	
Value Percent:	5.000
Continuous Index:	
Within 8" of Joint:	NO
Remarks:

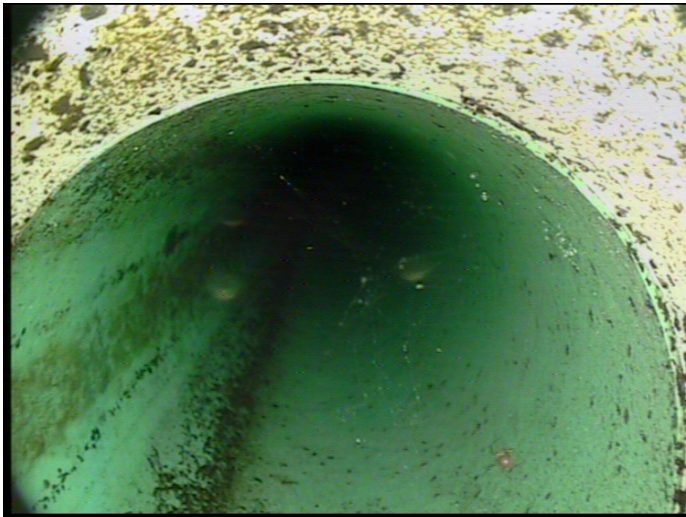
Code:	TF
Description:	Tap Factory
Distance (ft):	1.9
Structural Grade:	0
O&M Grade:	0
Clock Start/From:	9
Clock To:	
1st Value:	4.000
2nd Value:	
Value Percent:	
Continuous Index:	
Within 8" of Joint:	NO
Remarks:

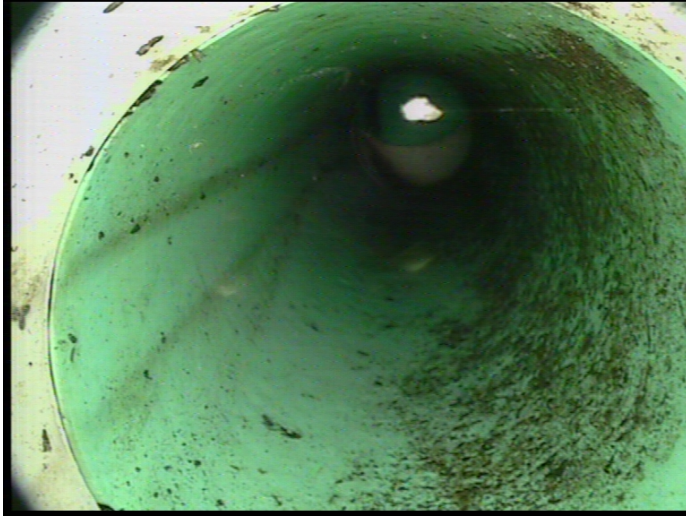
Code: **TF**
Description: **Tap Factory**

Distance (ft): **19.5**
Structural Grade: **0**
O&M Grade: **0**
Clock Start/From: **9**
Clock To:
1st Value: **4.000**
2nd Value:
Value Percent:
Continuous Index:
Within 8" of Joint: **NO**
Remarks:

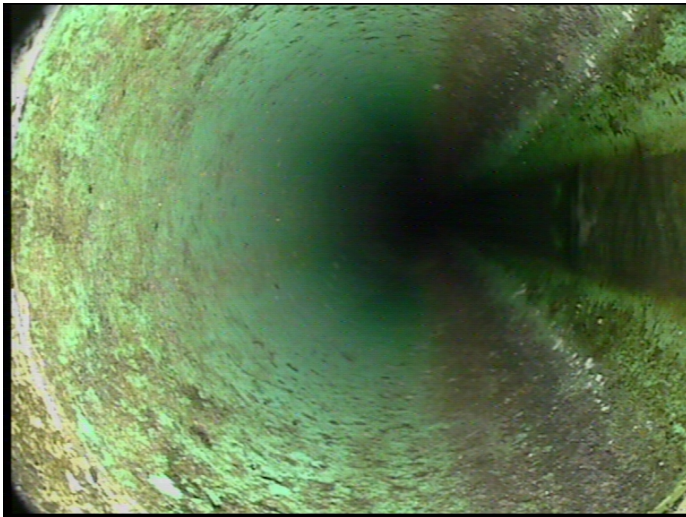
Code: **TF**
Description: **Tap Factory**

Distance (ft): **42.6**
Structural Grade: **0**
O&M Grade: **0**
Clock Start/From: **3**
Clock To:
1st Value: **4.000**
2nd Value:
Value Percent:
Continuous Index:
Within 8" of Joint: **NO**
Remarks:

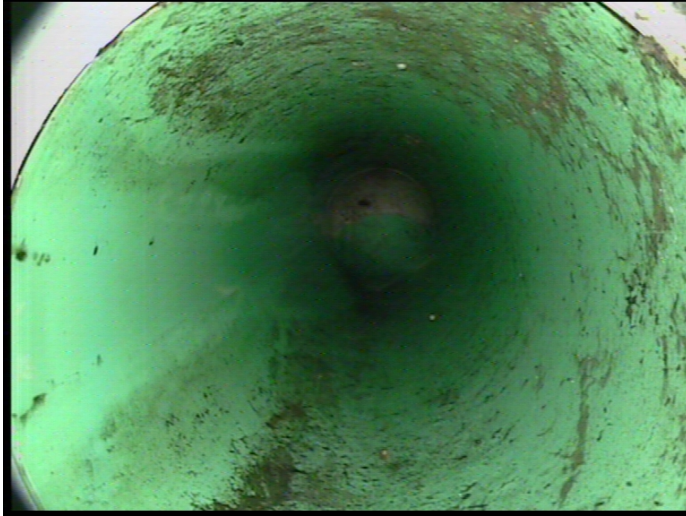
Code: **TF**
Description: **Tap Factory**

Distance (ft): **47.3**
Structural Grade: **0**
O&M Grade: **0**
Clock Start/From: **9**
Clock To:
1st Value: **4.000**
2nd Value:
Value Percent:
Continuous Index:
Within 8" of Joint: **NO**
Remarks:

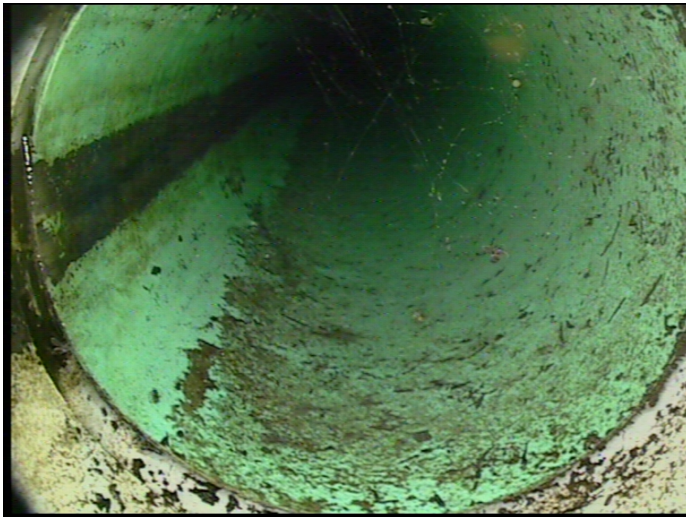
Code: **TF**
Description: **Tap Factory**

Distance (ft): **71.5**
Structural Grade: **0**
O&M Grade: **0**
Clock Start/From: **9**
Clock To:
1st Value: **4.000**
2nd Value:
Value Percent:
Continuous Index:
Within 8" of Joint: **NO**
Remarks:

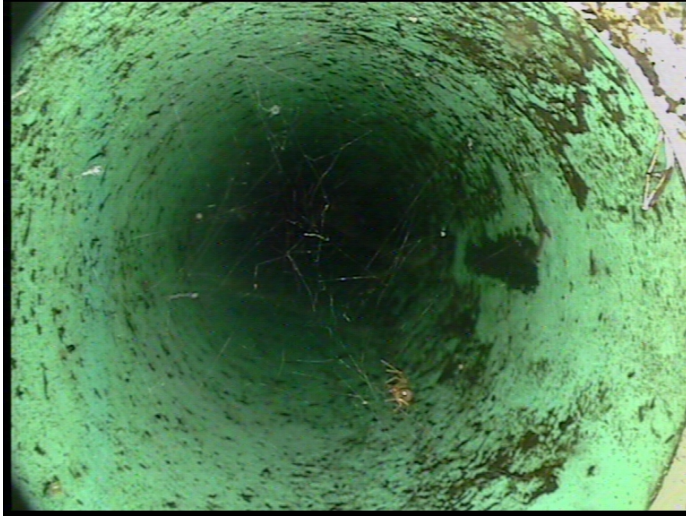
Code: **TF**
Description: **Tap Factory**

Distance (ft): **95.2**
Structural Grade: **0**
O&M Grade: **0**
Clock Start/From: **3**
Clock To:
1st Value: **4.000**
2nd Value:
Value Percent:
Continuous Index:
Within 8" of Joint: **NO**
Remarks:

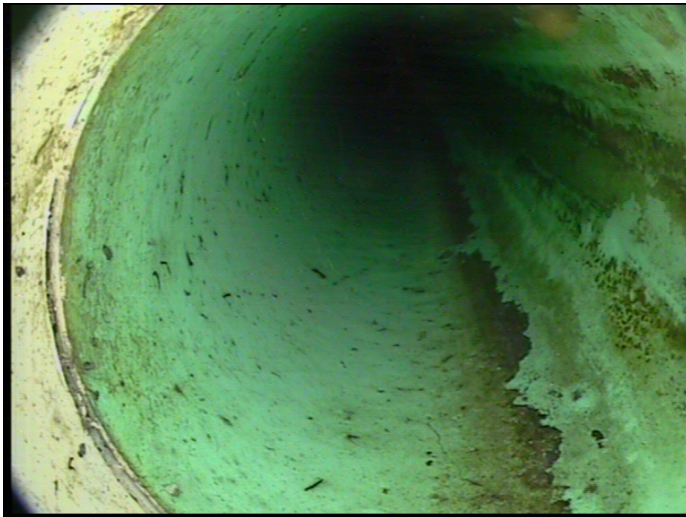
Code: **TF**
Description: **Tap Factory**

Distance (ft): **122.1**
Structural Grade: **0**
O&M Grade: **0**
Clock Start/From: **3**
Clock To:
1st Value: **4.000**
2nd Value:
Value Percent:
Continuous Index:
Within 8" of Joint: **NO**
Remarks:

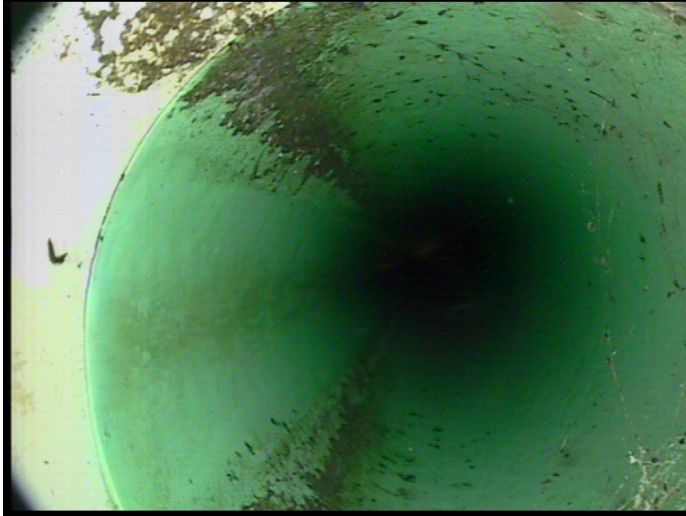
Code: **TF**
Description: **Tap Factory**

Distance (ft): **123.9**
Structural Grade: **0**
O&M Grade: **0**
Clock Start/From: **9**
Clock To:
1st Value: **4.000**
2nd Value:
Value Percent:
Continuous Index:
Within 8" of Joint: **NO**
Remarks:

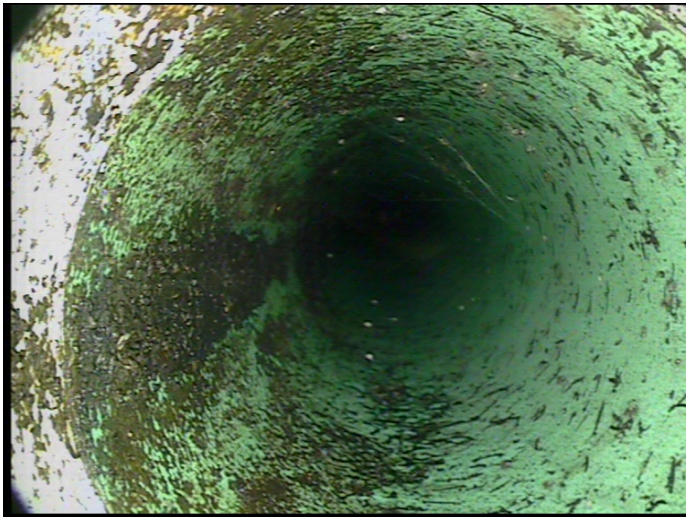
Code: **TF**
Description: **Tap Factory**

Distance (ft): **166.1**
Structural Grade: **0**
O&M Grade: **0**
Clock Start/From: **9**
Clock To:
1st Value: **4.000**
2nd Value:
Value Percent:
Continuous Index:
Within 8" of Joint: **NO**
Remarks:

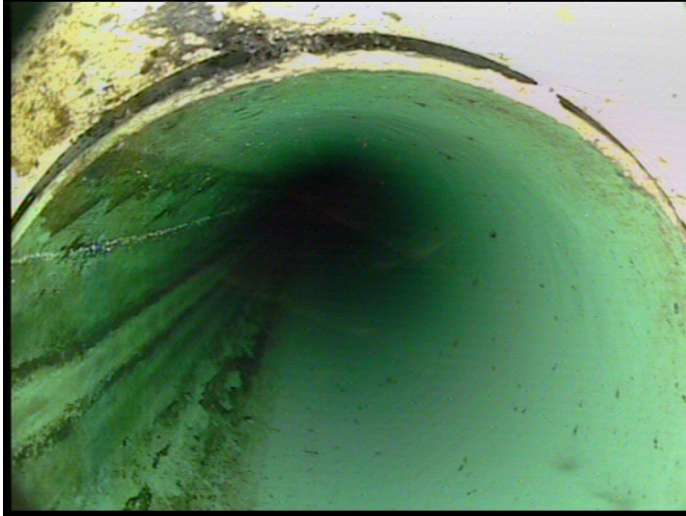
Code:	TF
Description:	Tap Factory
Distance (ft):	209.8
Structural Grade:	0
O&M Grade:	0
Clock Start/From:	9
Clock To:	
1st Value:	4.000
2nd Value:	
Value Percent:	
Continuous Index:	
Within 8" of Joint:	NO
Remarks:

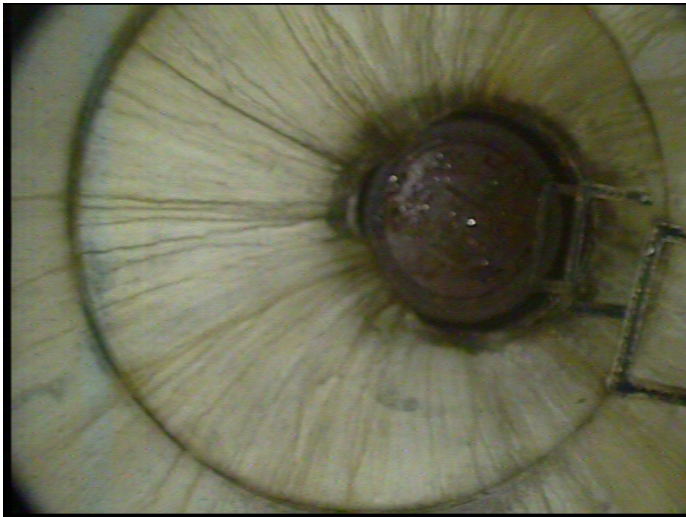
Code:	AMH
Description:	Manhole
Distance (ft):	216.1
Structural Grade:	0
O&M Grade:	0
Clock Start/From:	
Clock To:	
1st Value:	
2nd Value:	
Value Percent:	
Continuous Index:	
Within 8" of Joint:	NO
Remarks:	M-705-30
