Profile/Photo Observation Report

Date:	09/17/2022	Weather:		Coding:	PACP 7.0
Pipe Length (ft):	224.7	Owner:	City of Hobart	Pre Clean:	No Pre-Cleaning
P.O.#:	YES502259	Surveyor:	S. Bucklin	PSR:	M-705-031-M-705-030
Customer:	City of Hobart	Clean Date:		Shape:	C

Street:	Center Street	Flow Control:	Not Controlled
City:	Hobart, IN	Year Renewed:	
Location:	Local rural streets with light traffic, t	Tape/Media #:	
Purpose:	Routine Assessment	Dia/Height:	8"
Use:	Sanitary Sewage Pipe	Material:	PVC
Drain Area:		Lining:	None
Category:	NA		
Comment:			
Location Details:		Direction of Survey:	Upstream
US MH:	M-705-031	DS MH:	M-705-030
		Total Length Surveyed (ft):	195.0

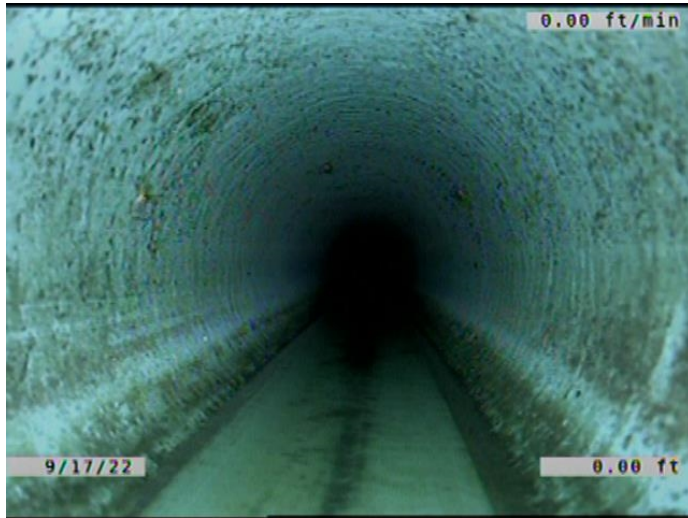
Code:	MWL
Description:	Miscellaneous Water Level
Distance (ft):	.0
Structural Grade:	0
O&M Grade:	0
Clock Start/From:	
Clock To:	
1st Value:	
2nd Value:	
Value Percent:	10.000
Continuous Index:	
Within 8" of Joint:	NO
Remarks:

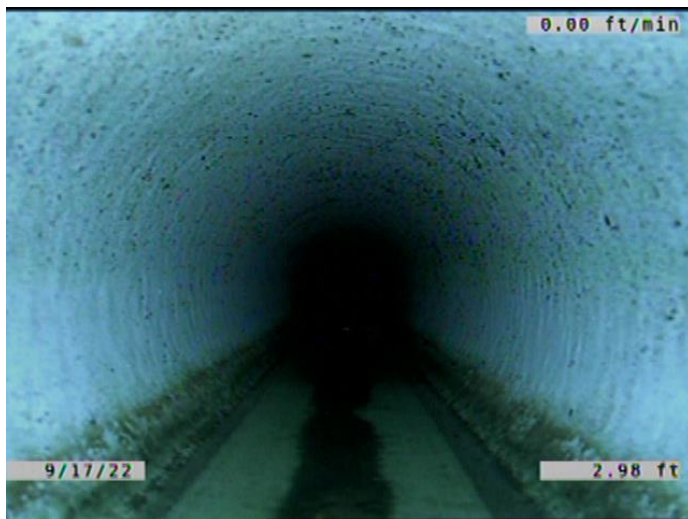
Code:	DSF
Description:	Deposits Settled Fine
Distance (ft):	3.0
Structural Grade:	0
O&M Grade:	2
Clock Start/From:	5
Clock To:	7
1st Value:	
2nd Value:	
Value Percent:	5.000
Continuous Index:	S01
Within 8" of Joint:	YES
Remarks:

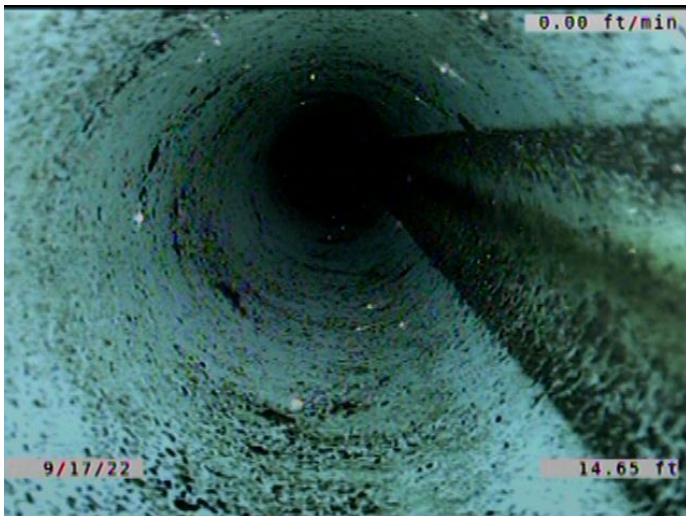
Code:	TF
Description:	Tap Factory
Distance (ft):	14.6
Structural Grade:	0
O&M Grade:	0
Clock Start/From:	3
Clock To:	
1st Value:	6.000
2nd Value:	
Value Percent:	
Continuous Index:	
Within 8" of Joint:	YES
Remarks:

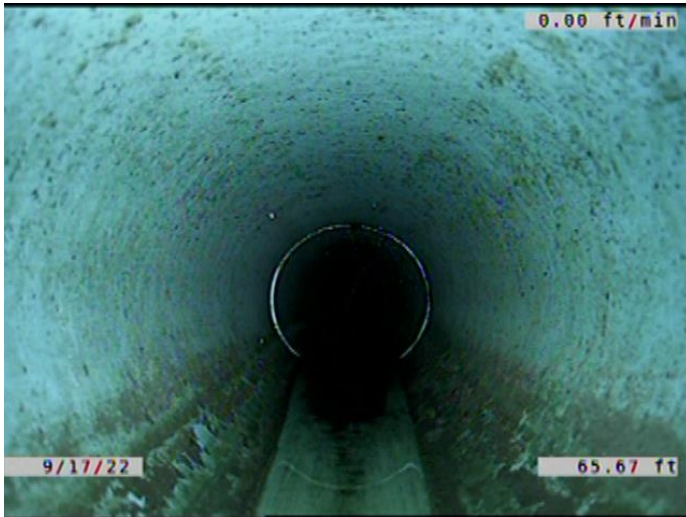
Code: **MWLS**
Description: **Miscellaneous Water Level Sag**

Distance (ft): **65.7**
Structural Grade: **2**
O&M Grade: **0**
Clock Start/From:
Clock To:
1st Value:
2nd Value:
Value Percent: **10.000**
Continuous Index: **S02**
Within 8" of Joint: **NO**
Remarks:

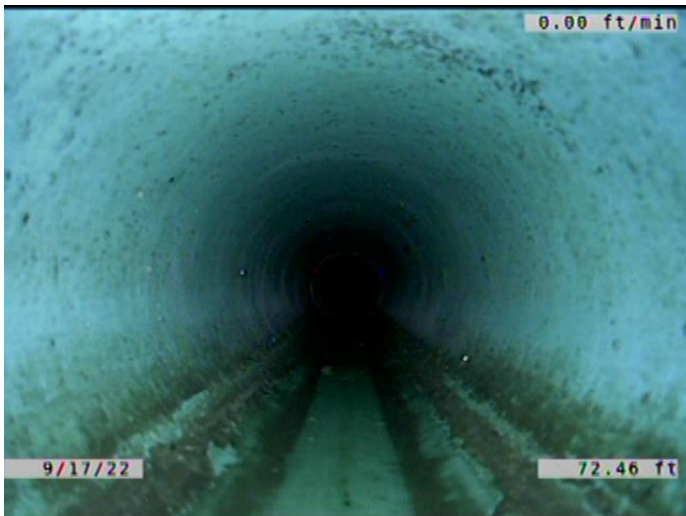
Code: **MWLS**
Description: **Miscellaneous Water Level Sag**

Distance (ft): **72.5**
Structural Grade: **2**
O&M Grade: **0**
Clock Start/From:
Clock To:
1st Value:
2nd Value:
Value Percent: **10.000**
Continuous Index: **F02**
Within 8" of Joint: **NO**
Remarks:

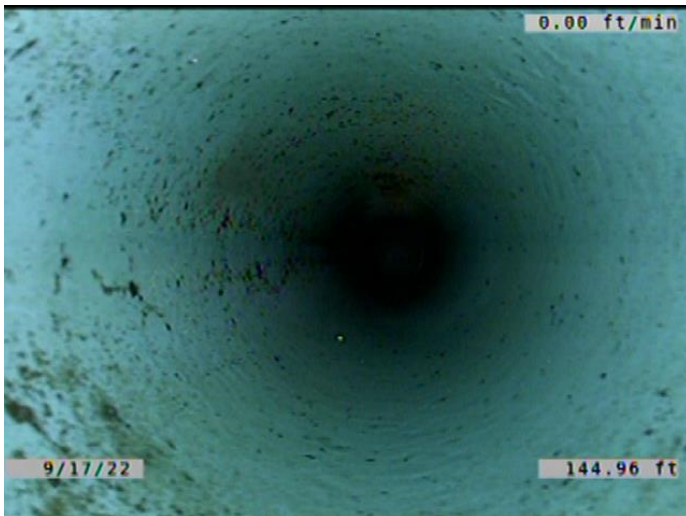
Code: **TF**
Description: **Tap Factory**

Distance (ft): **145.0**
Structural Grade: **0**
O&M Grade: **0**
Clock Start/From: **10**
Clock To:
1st Value: **6.000**
2nd Value:
Value Percent:
Continuous Index:
Within 8" of Joint: **YES**
Remarks:

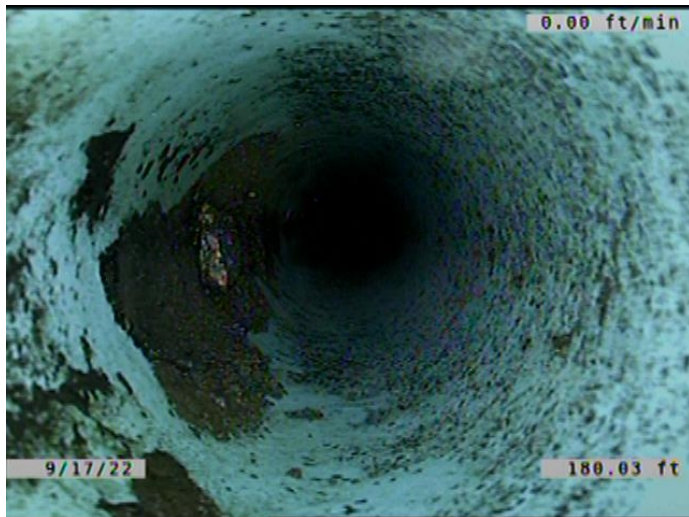
Code: **TF**
 Description: **Tap Factory**

Distance (ft): **180.0**
 Structural Grade: **0**
 O&M Grade: **0**
 Clock Start/From: **9**
 Clock To:
 1st Value: **6.000**
 2nd Value:
 Value Percent:
 Continuous Index:
 Within 8" of Joint: **YES**
 Remarks:
