Profile/Photo Observation Report

Date:	09/17/2022	Weather:		Coding:	PACP 7.0
Pipe Length (ft):	188.0	Owner:	City of Hobart	Pre Clean:	No Pre-Cleaning
P.O.#:	YES502259	Surveyor:	S. Bucklin	PSR:	M-705-032-M-705-031
Customer:	City of Hobart	Clean Date:		Shape:	C

Street:	Center Street	Flow Control:	Not Controlled
City:	Hobart, IN	Year Renewed:	
Location:	Local rural streets with light traffic, t	Tape/Media #:	
Purpose:	Routine Assessment	Dia/Height:	8"
Use:	Sanitary Sewage Pipe	Material:	PVC
Drain Area:		Lining:	None
Category:	NA

US MH:	M-705-032	DS MH:	M-705-031	Total Length Surveyed (ft):	260.9
--------	------------------	--------	------------------	-----------------------------	--------------

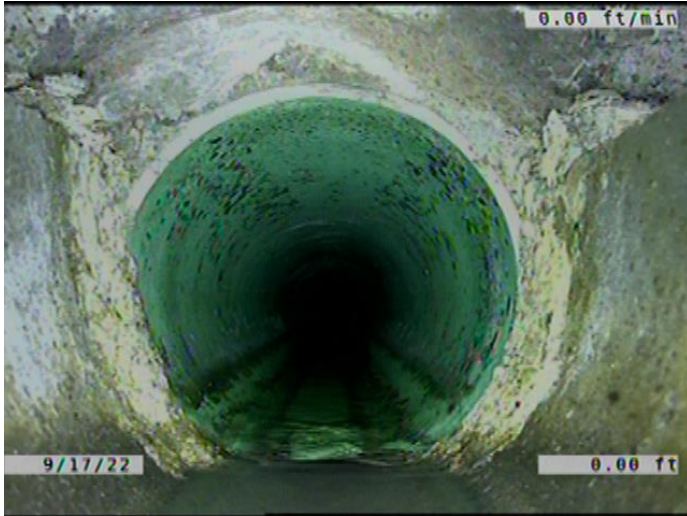
Code:	MWL
Description:	Miscellaneous Water Level
Distance (ft):	.0
Structural Grade:	0
O&M Grade:	0
Clock Start/From:	
Clock To:	
1st Value:	
2nd Value:	
Value Percent:	5.000
Continuous Index:	
Within 8" of Joint:	NO
Remarks:

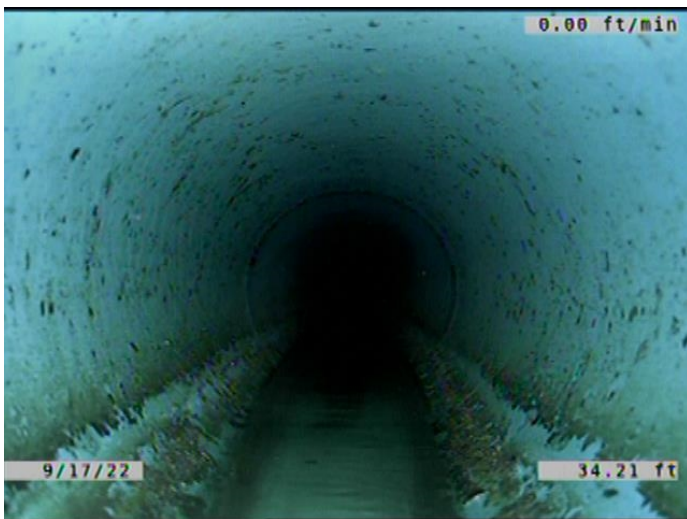
Code:	MWLS
Description:	Miscellaneous Water Level Sag
Distance (ft):	34.2
Structural Grade:	2
O&M Grade:	0
Clock Start/From:	
Clock To:	
1st Value:	
2nd Value:	
Value Percent:	10.000
Continuous Index:	S01
Within 8" of Joint:	NO
Remarks:

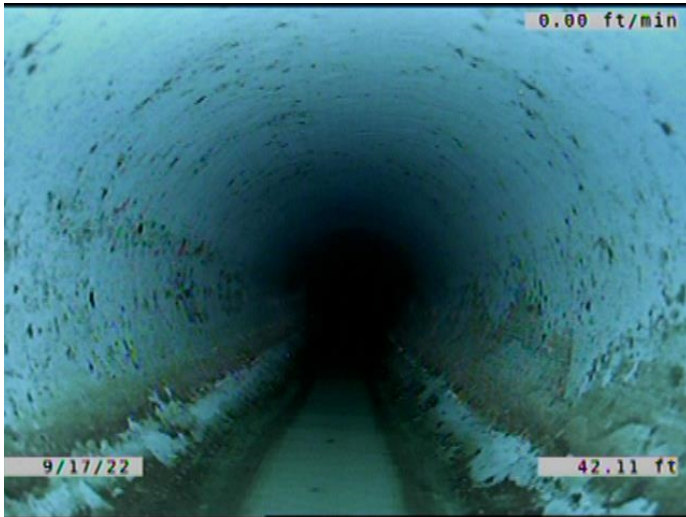
Code: **MWLS**
Description: **Miscellaneous Water Level Sag**

Distance (ft): **42.1**
Structural Grade: **2**
O&M Grade: **0**
Clock Start/From:
Clock To:
1st Value:
2nd Value:
Value Percent: **10.000**
Continuous Index: **F01**
Within 8" of Joint: **NO**
Remarks:

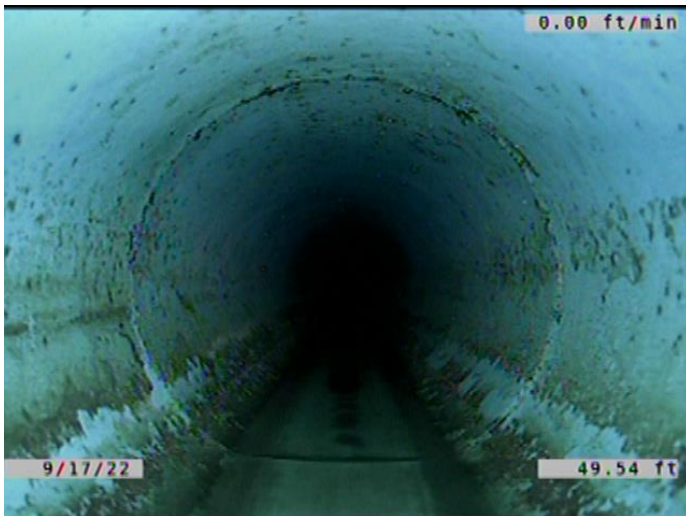
Code: **MWLS**
Description: **Miscellaneous Water Level Sag**

Distance (ft): **49.5**
Structural Grade: **2**
O&M Grade: **0**
Clock Start/From:
Clock To:
1st Value:
2nd Value:
Value Percent: **5.000**
Continuous Index:
Within 8" of Joint: **NO**
Remarks:

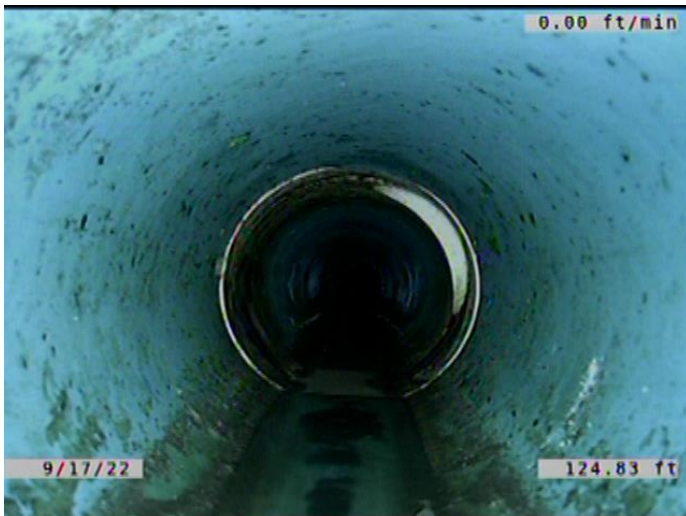
Code: **MWLS**
 Description: **Miscellaneous Water Level Sag**

Distance (ft): **124.8**
 Structural Grade: **2**
 O&M Grade: **0**
 Clock Start/From:
 Clock To:
 1st Value:
 2nd Value:
 Value Percent: **10.000**
 Continuous Index:
 Within 8" of Joint: **NO**
 Remarks:

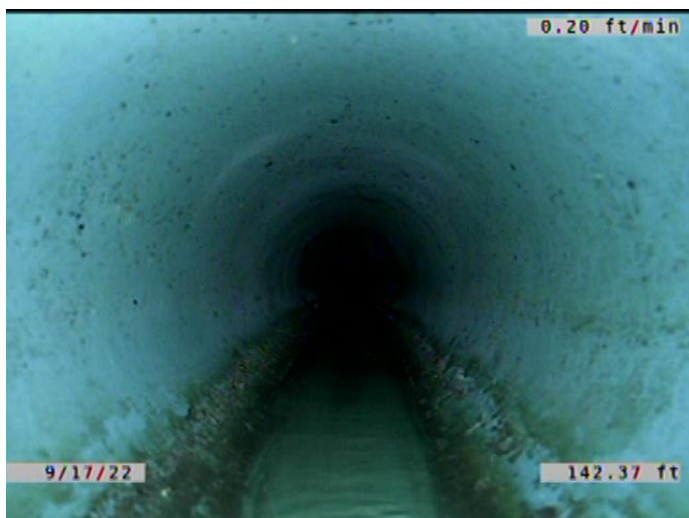
Code: **MWLS**
 Description: **Miscellaneous Water Level Sag**

Distance (ft): **142.4**
 Structural Grade: **2**
 O&M Grade: **0**
 Clock Start/From:
 Clock To:
 1st Value:
 2nd Value:
 Value Percent: **10.000**
 Continuous Index: **S02**
 Within 8" of Joint: **NO**
 Remarks:

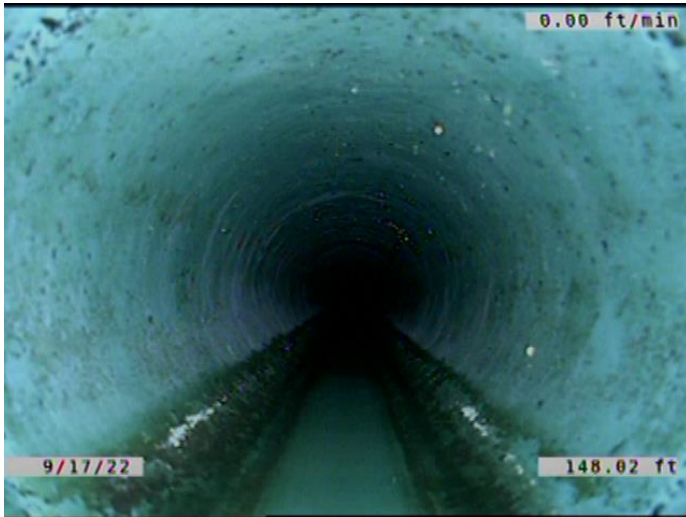
Code:	MWLS
Description:	Miscellaneous Water Level Sag
Distance (ft):	148.0
Structural Grade:	2
O&M Grade:	0
Clock Start/From:	
Clock To:	
1st Value:	
2nd Value:	
Value Percent:	10.000
Continuous Index:	F02
Within 8" of Joint:	NO
Remarks:

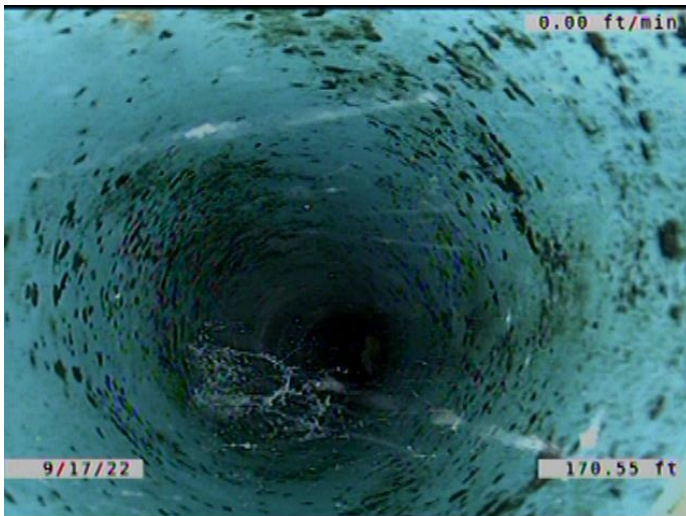
Code:	TF
Description:	Tap Factory
Distance (ft):	170.5
Structural Grade:	0
O&M Grade:	0
Clock Start/From:	3
Clock To:	
1st Value:	6.000
2nd Value:	
Value Percent:	
Continuous Index:	
Within 8" of Joint:	YES
Remarks:
