## Profile/Photo Observation Report

Street:	<b>Center Street</b>	Flow Control:	
City:	<b>Hobart, IN</b>	Year Renewed:	
Location:	<b>Light Highway</b>	Tape/Media #:	<b>912</b>
Purpose:	<b>Routine Assessment</b>	Dia/Height:	<b>8"</b>
Use:	<b>Sanitary</b>	Material:	<b>PVC</b>
Drain Area:		Lining:	
Category:	<b>NA</b>		
Comment:

Location Details:		Direction of Survey:	<b>Downstream</b>
US MH:	<b>M-705-34</b>	DS MH:	<b>M-705-33</b>
		Total Length Surveyed (ft):	<b>127.2</b>

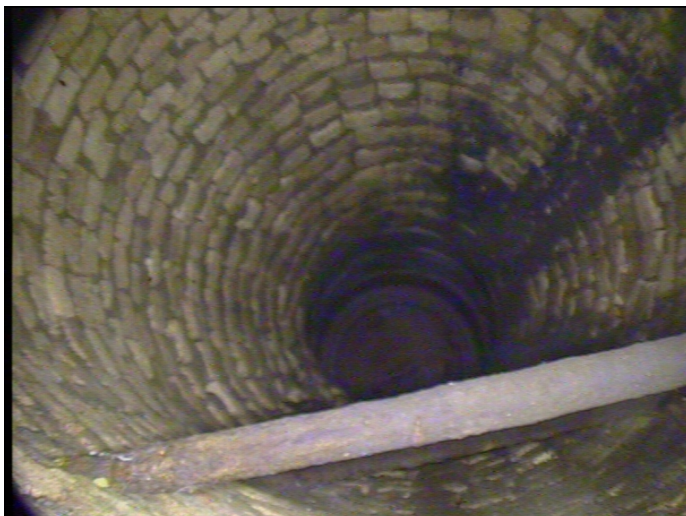
Code:	AMH
Description:	Manhole
Distance (ft):	.0
Structural Grade:	0
O&M Grade:	0
Clock Start/From:	
Clock To:	
1st Value:	
2nd Value:	
Value Percent:	
Continuous Index:	
Within 8" of Joint:	NO
Remarks:	M-705-34

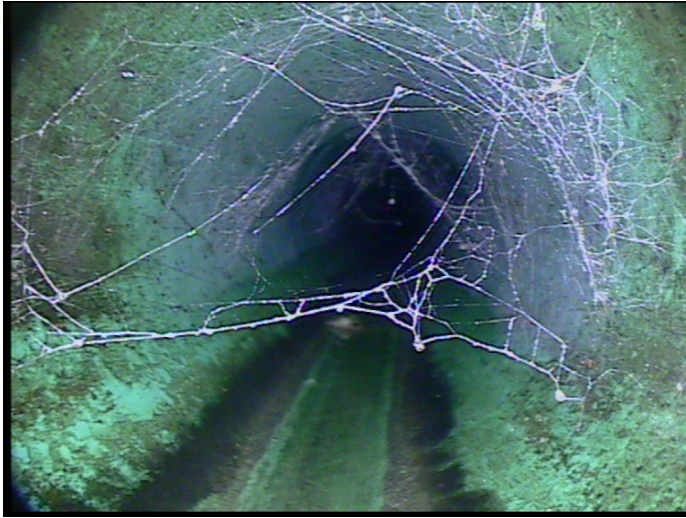
Code:	<b>MWL</b>
Description:	<b>Water Level</b>
Distance (ft):	<b>.0</b>
Structural Grade:	<b>0</b>
O&M Grade:	<b>0</b>
Clock Start/From:	
Clock To:	
1st Value:	
2nd Value:	
Value Percent:	<b>5.000</b>
Continuous Index:	
Within 8" of Joint:	<b>NO</b>
Remarks:

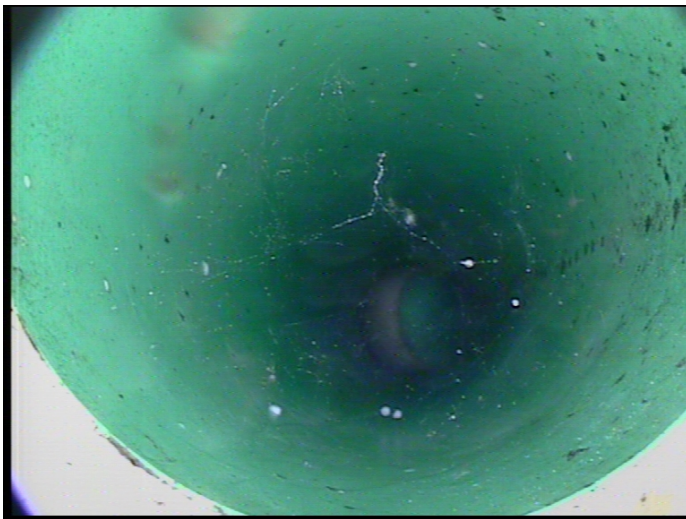
Code:	<b>TF</b>
Description:	<b>Tap Factory</b>
Distance (ft):	<b>86.3</b>
Structural Grade:	<b>0</b>
O&M Grade:	<b>0</b>
Clock Start/From:	<b>2</b>
Clock To:	
1st Value:	<b>4.000</b>
2nd Value:	
Value Percent:	
Continuous Index:	
Within 8" of Joint:	<b>NO</b>
Remarks:

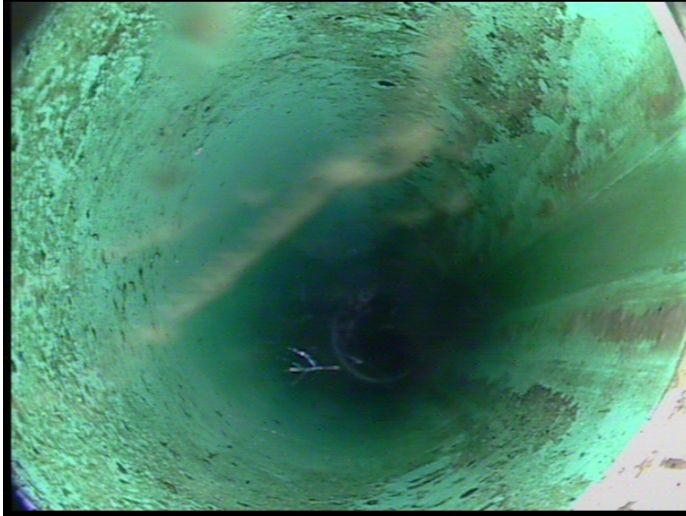
Code: **TF**  
Description: **Tap Factory**

Distance (ft): **104.1**  
Structural Grade: **0**  
O&M Grade: **0**  
Clock Start/From: **3**  
Clock To:  
1st Value: **4.000**  
2nd Value:  
Value Percent:  
Continuous Index:  
Within 8" of Joint: **NO**  
Remarks:

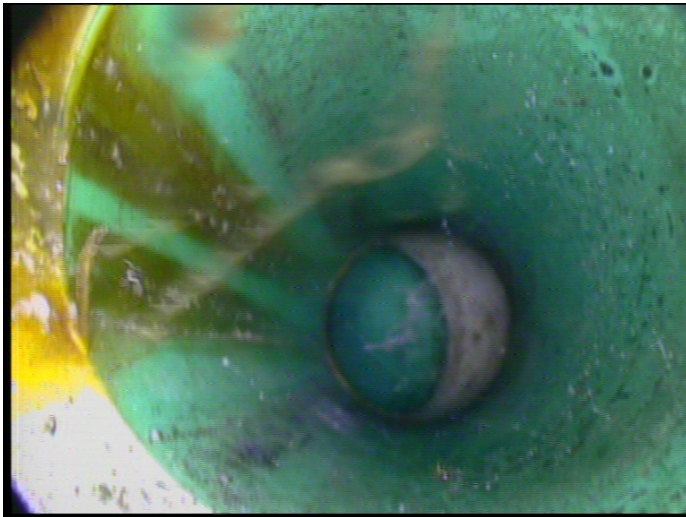
Code: **TF**  
Description: **Tap Factory**

Distance (ft): **118.1**  
Structural Grade: **0**  
O&M Grade: **0**  
Clock Start/From: **10**  
Clock To:  
1st Value: **4.000**  
2nd Value:  
Value Percent:  
Continuous Index:  
Within 8" of Joint: **NO**  
Remarks:

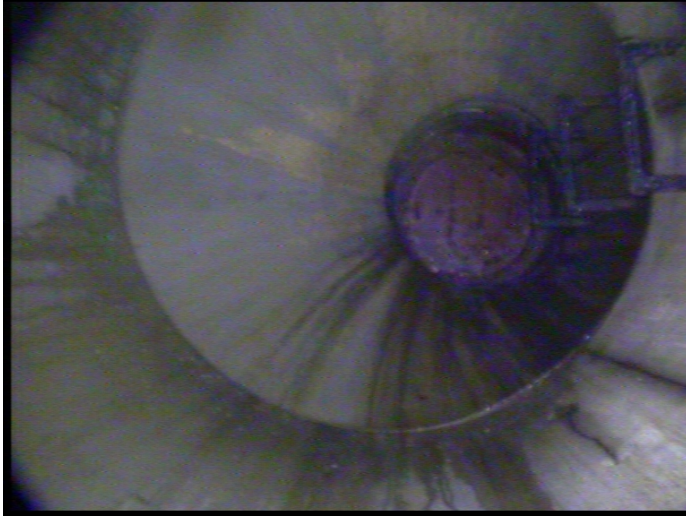
Code:	<b>AMH</b>
Description:	<b>Manhole</b>
Distance (ft):	<b>127.2</b>
Structural Grade:	<b>0</b>
O&M Grade:	<b>0</b>
Clock Start/From:	
Clock To:	
1st Value:	
2nd Value:	
Value Percent:	
Continuous Index:	
Within 8" of Joint:	<b>NO</b>
Remarks:	<b>M-705-33</b>
