## Profile/Photo Observation Report

Date:	<b>08/11/2022</b>	Weather:		Coding:	<b>PACP 7.0</b>
Pipe Length (ft):	<b>29.0</b>	Owner:	<b>City of Hobart</b>	Pre Clean:	<b>Heavy Cleaning</b>
P.O.#:	<b>YES502259</b>	Surveyor:	<b>S. Bucklin</b>	PSR:	<b>M-705-035-M-705-035.1</b>
Customer:	<b>City of Hobart</b>	Clean Date:	<b>08/04/2022</b>	Shape:	<b>C</b>

Street:	<b>Center Street</b>	Flow Control:	<b>Not Controlled</b>
City:	<b>Hobart, IN</b>	Year Renewed:	
Location:	<b>Local rural streets with light traffic, t</b>	Tape/Media #:	
Purpose:	<b>Routine Assessment</b>	Dia/Height:	<b>20"</b>
Use:	<b>Sanitary Sewage Pipe</b>	Material:	<b>PVC</b>
Drain Area:		Lining:	<b>None</b>
Category:	<b>NA</b>

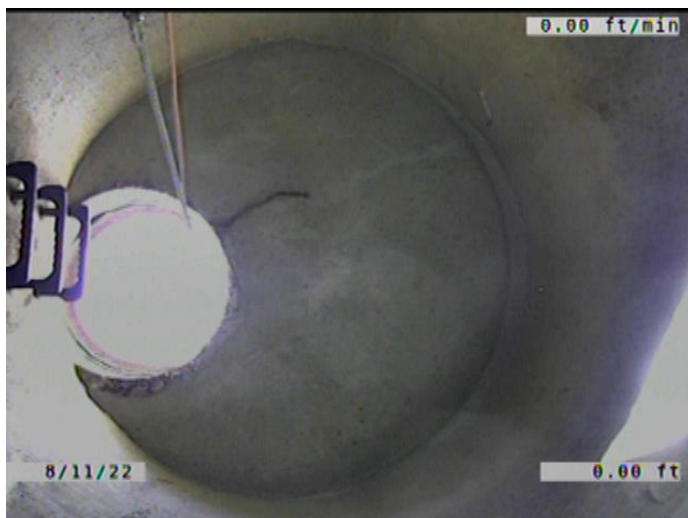
Code:	AMH
Description:	Manhole
Distance (ft):	.0
Structural Grade:	0
O&M Grade:	0
Clock Start/From:	
Clock To:	
1st Value:	
2nd Value:	
Value Percent:	
Continuous Index:	
Within 8" of Joint:	NO
Remarks:	M-705-035.1

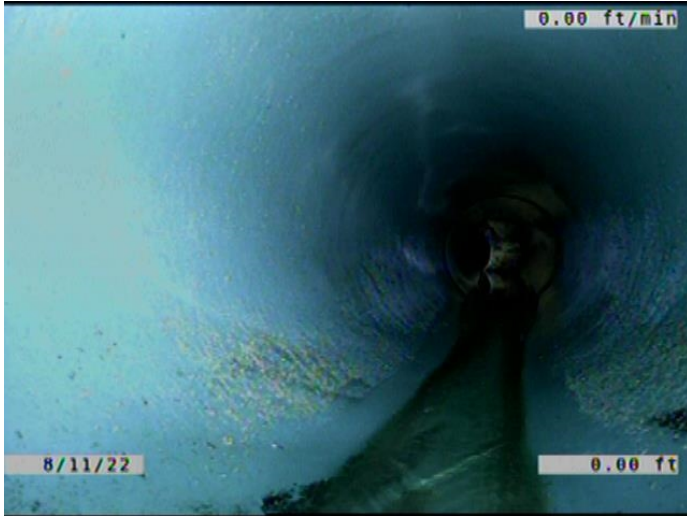
Code: **MWL**  
Description: **Miscellaneous Water Level**

Distance (ft): **.0**  
Structural Grade: **0**  
O&M Grade: **0**  
Clock Start/From:  
Clock To:  
1st Value:  
2nd Value:  
Value Percent: **5.000**  
Continuous Index:  
Within 8" of Joint: **NO**  
Remarks:

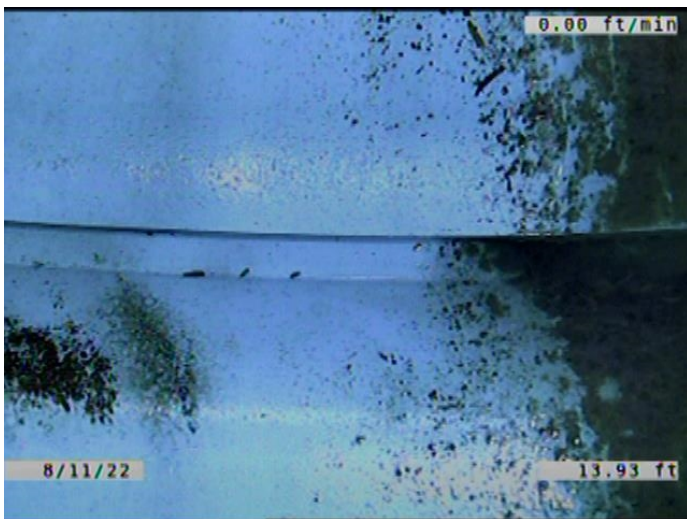
Code: **MGO**  
Description: **Miscellaneous General Observation**

Distance (ft): **13.9**  
Structural Grade: **0**  
O&M Grade: **0**  
Clock Start/From:  
Clock To:  
1st Value:  
2nd Value:  
Value Percent:  
Continuous Index:  
Within 8" of Joint: **NO**  
Remarks: **JOINT/ PIPES NOT PUSHED ALL THE WAY TOGETHER WHEN INSTALLED**

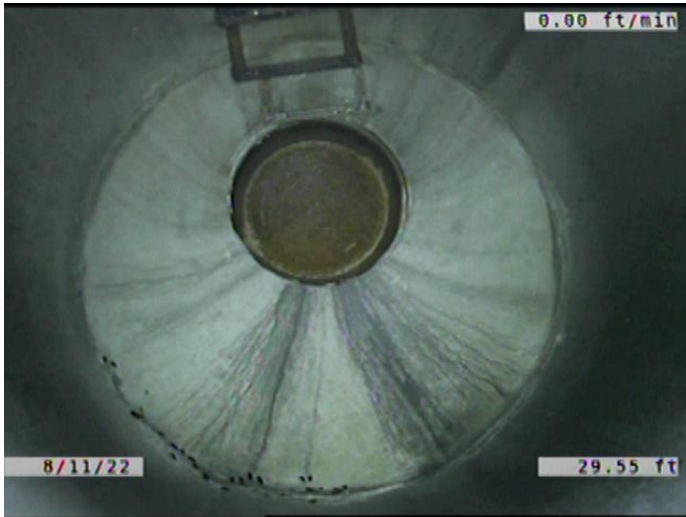
Code:	<b>AMH</b>
Description:	<b>Manhole</b>
Distance (ft):	<b>29.6</b>
Structural Grade:	<b>0</b>
O&M Grade:	<b>0</b>
Clock Start/From:	
Clock To:	
1st Value:	
2nd Value:	
Value Percent:	
Continuous Index:	
Within 8" of Joint:	<b>NO</b>
Remarks:	<b>M-705-035</b>
