Profile/Photo Observation Report

Street:	Main Street	Flow Control:	Not Controlled
City:	Hobart, IN	Year Renewed:	
Location:	Light Highway	Tape/Media #:	DEP 162
Purpose:	Routine Assessment	Dia/Height:	20"
Use:	Sanitary	Material:	PVC
Drain Area:		Lining:	
Category:	NA		
Comment:	5-21-2018

Location Details:		Direction of Survey:	Downstream
US MH:	M-705-037	DS MH:	M-705-028
		Total Length Surveyed (ft):	123.9

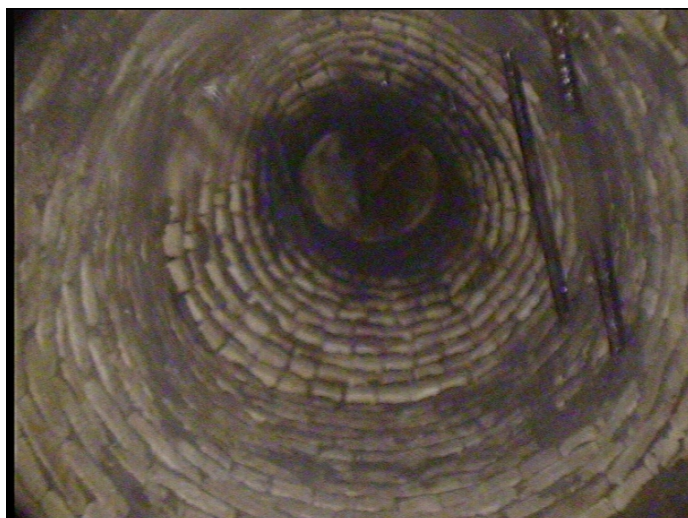
Code: **AMH**
Description: **Manhole**

Distance (ft): **.0**
Structural Grade: **0**
O&M Grade: **0**
Clock Start/From:
Clock To:
1st Value:
2nd Value:
Value Percent:
Continuous Index:
Within 8" of Joint: **NO**
Remarks: **M-705-028**

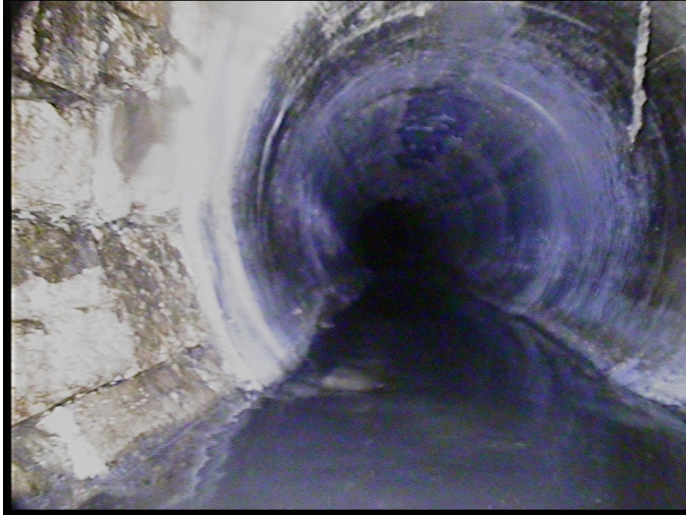
Code:	MWL
Description:	Water Level
Distance (ft):	.0
Structural Grade:	0
O&M Grade:	0
Clock Start/From:	
Clock To:	
1st Value:	
2nd Value:	
Value Percent:	15.000
Continuous Index:	
Within 8" of Joint:	NO
Remarks:

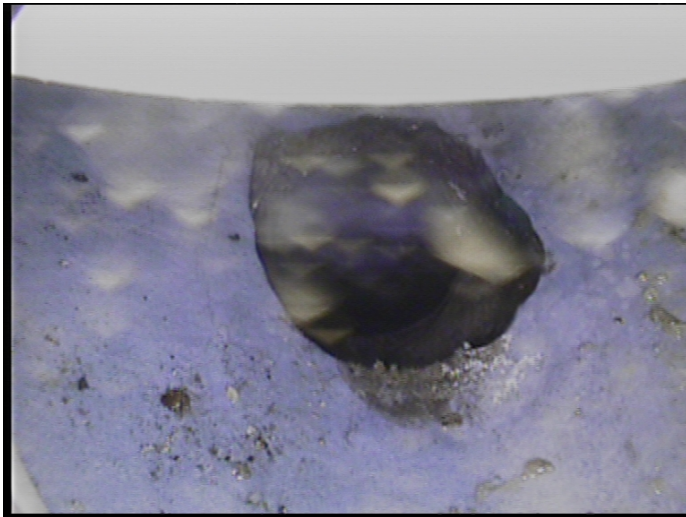
Code:	TB
Description:	Tap Break-in
Distance (ft):	94.3
Structural Grade:	0
O&M Grade:	0
Clock Start/From:	10
Clock To:	
1st Value:	4.000
2nd Value:	
Value Percent:	
Continuous Index:	
Within 8" of Joint:	NO
Remarks:

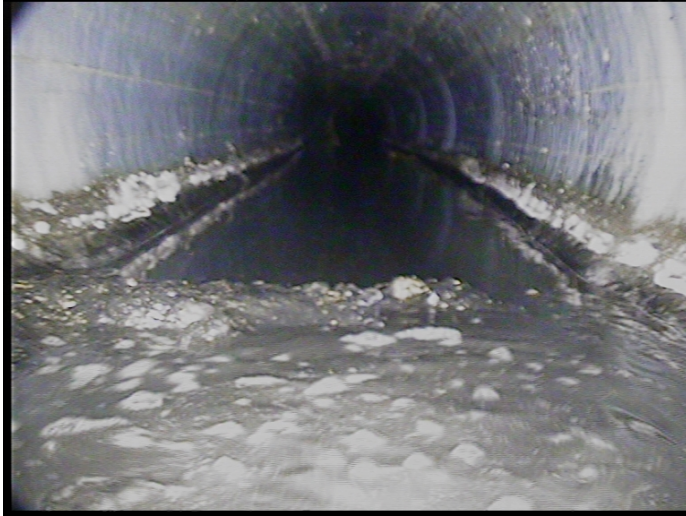
Code: **DSF**
Description: **Deposits Settled Fine**

Distance (ft): **118.4**
Structural Grade: **0**
O&M Grade: **3**
Clock Start/From: **4**
Clock To: **8**
1st Value:
2nd Value:
Value Percent: **20.000**
Continuous Index: **S01**
Within 8" of Joint: **YES**
Remarks:

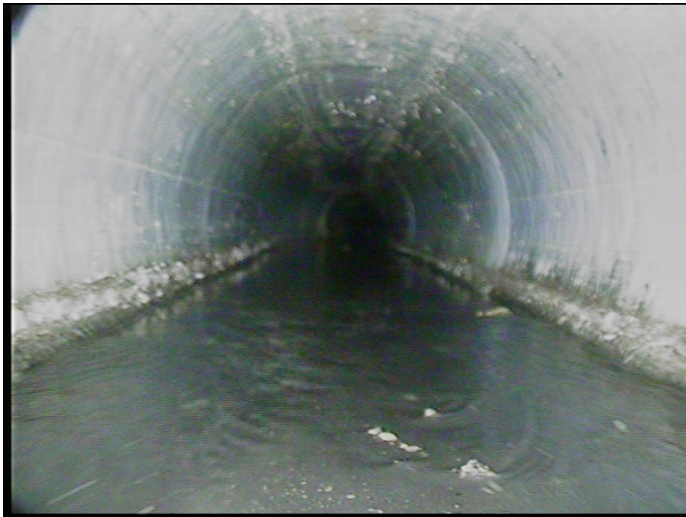
Code: **DSF**
Description: **Deposits Settled Fine**

Distance (ft): **123.9**
Structural Grade: **0**
O&M Grade: **3**
Clock Start/From: **4**
Clock To: **8**
1st Value:
2nd Value:
Value Percent: **20.000**
Continuous Index: **F01**
Within 8" of Joint: **NO**
Remarks:

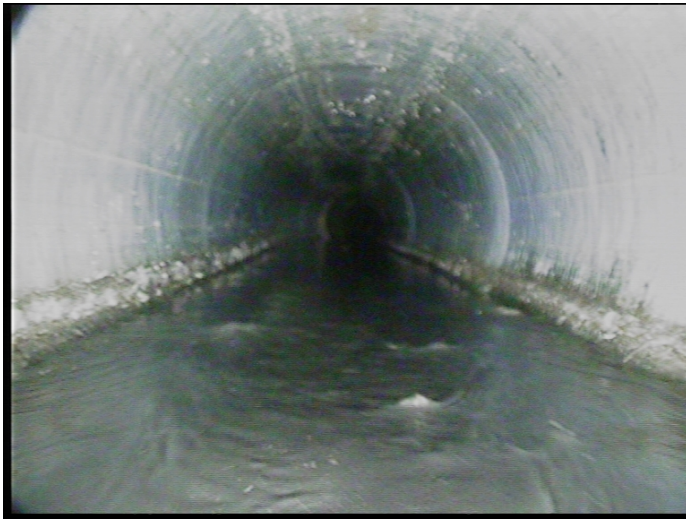
Code:	MSA
Description:	Abandoned Survey
Distance (ft):	123.9
Structural Grade:	0
O&M Grade:	0
Clock Start/From:	
Clock To:	
1st Value:	
2nd Value:	
Value Percent:	
Continuous Index:	
Within 8" of Joint:	NO
Remarks:	sediment
