## Profile/Photo Observation Report

Date:	<b>05/02/2018</b>	Weather:		Coding:	<b>PACP 6.0</b>
Pipe Length (ft):		Owner:	<b>City of Hobart</b>	Pre Clean:	<b>No Pre-Cleaning</b>
P.O.#:	<b>163</b>	Surveyor:	<b>M. Pielacha</b>	PSR:	<b>P-705-036-037</b>
Customer:	<b>City of Hobart</b>	Clean Date:		Shape:	<b>C</b>

Street:	<b>Center Street</b>	Flow Control:	<b>Not Controlled</b>
City:	<b>Hobart, IN</b>	Year Renewed:	
Location:	<b>Light Highway</b>	Tape/Media #:	<b>DEP 163</b>
Purpose:	<b>Routine Assessment</b>	Dia/Height:	<b>20"</b>
Use:	<b>Sanitary</b>	Material:	<b>PVC</b>
Drain Area:		Lining:	
Category:	<b>NA</b>		
Comment:	<b>5-21-2018</b>		
Location Details:		Direction of Survey:	<b>Downstream</b>
US MH:	<b>M-705-037</b>	DS MH:	<b>M-705-036</b>
		Total Length Surveyed (ft):	<b>309.0</b>

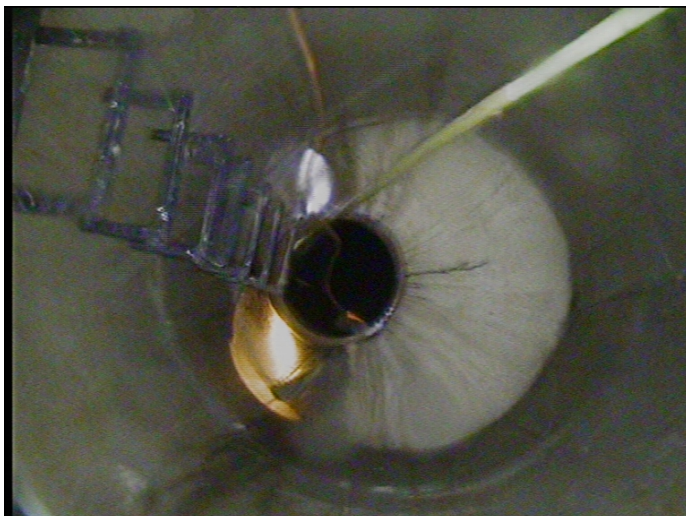
Code: **AMH**  
 Description: **Manhole**

Distance (ft): **.0**  
 Structural Grade: **0**  
 O&M Grade: **0**  
 Clock Start/From:  
 Clock To:  
 1st Value:  
 2nd Value:  
 Value Percent:  
 Continuous Index:  
 Within 8" of Joint: **NO**  
 Remarks: **M-705-036**

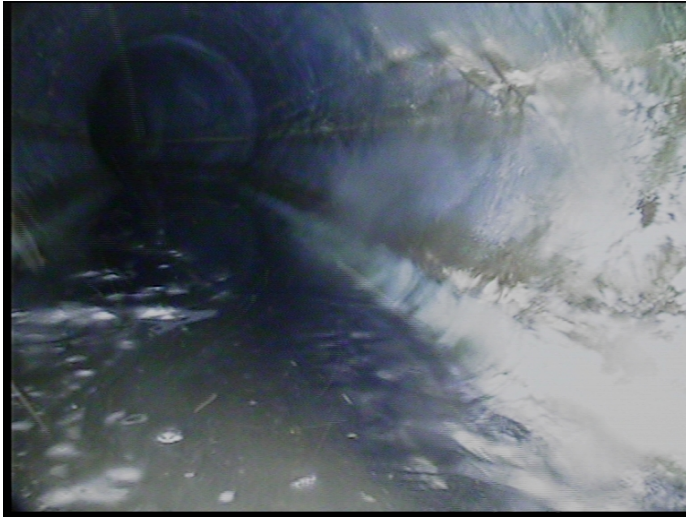
Code: **MWL**  
Description: **Water Level**

Distance (ft): **.0**  
Structural Grade: **0**  
O&M Grade: **0**  
Clock Start/From:  
Clock To:  
1st Value:  
2nd Value:  
Value Percent: **10.000**  
Continuous Index:  
Within 8" of Joint: **NO**  
Remarks:

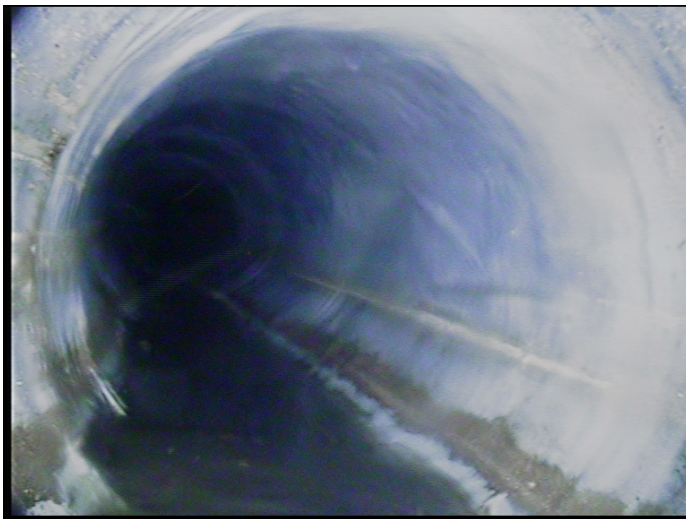
Code: **LL**  
Description: **Alignment Left**

Distance (ft): **4.6**  
Structural Grade: **0**  
O&M Grade: **1**  
Clock Start/From:  
Clock To:  
1st Value:  
2nd Value:  
Value Percent: **5.000**  
Continuous Index:  
Within 8" of Joint: **NO**  
Remarks:

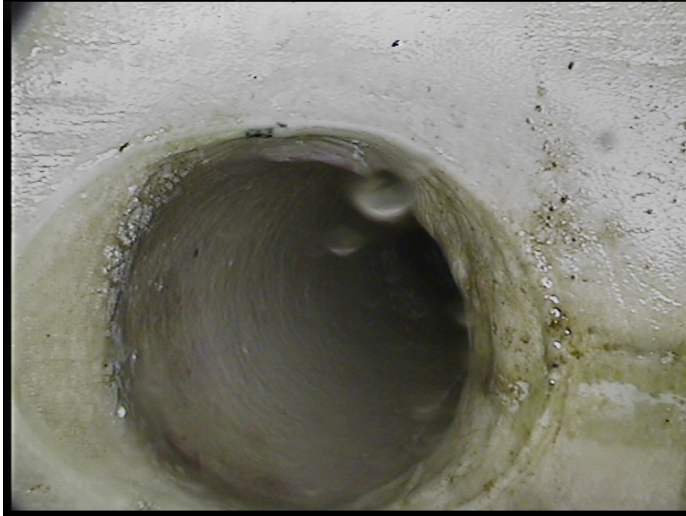
Code: **TF**  
Description: **Tap Factory**

Distance (ft): **94.7**  
Structural Grade: **0**  
O&M Grade: **0**  
Clock Start/From: **2**  
Clock To:  
1st Value: **4.000**  
2nd Value:  
Value Percent:  
Continuous Index:  
Within 8" of Joint: **NO**  
Remarks:

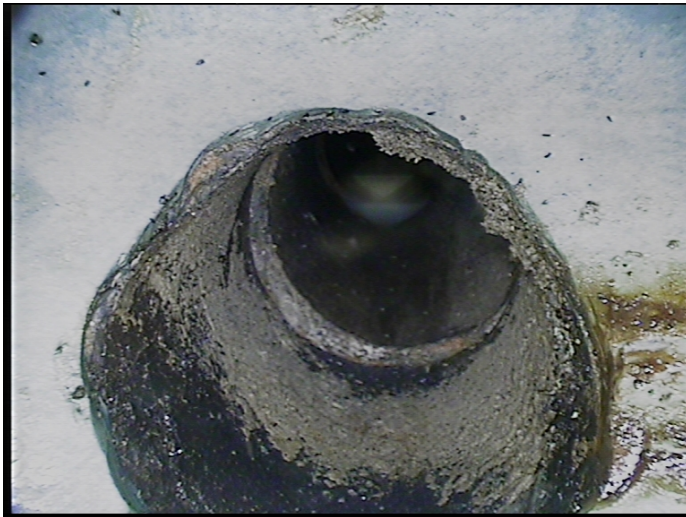
Code: **TF**  
Description: **Tap Factory**

Distance (ft): **128.2**  
Structural Grade: **0**  
O&M Grade: **0**  
Clock Start/From: **2**  
Clock To:  
1st Value: **4.000**  
2nd Value:  
Value Percent:  
Continuous Index:  
Within 8" of Joint: **NO**  
Remarks:

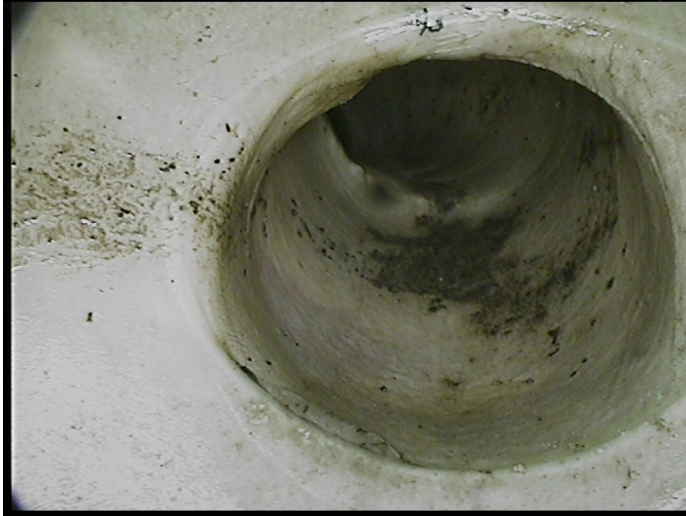
Code: **TF**  
Description: **Tap Factory**

Distance (ft): **158.8**  
Structural Grade: **0**  
O&M Grade: **0**  
Clock Start/From: **10**  
Clock To:  
1st Value: **4.000**  
2nd Value:  
Value Percent:  
Continuous Index:  
Within 8" of Joint: **NO**  
Remarks:

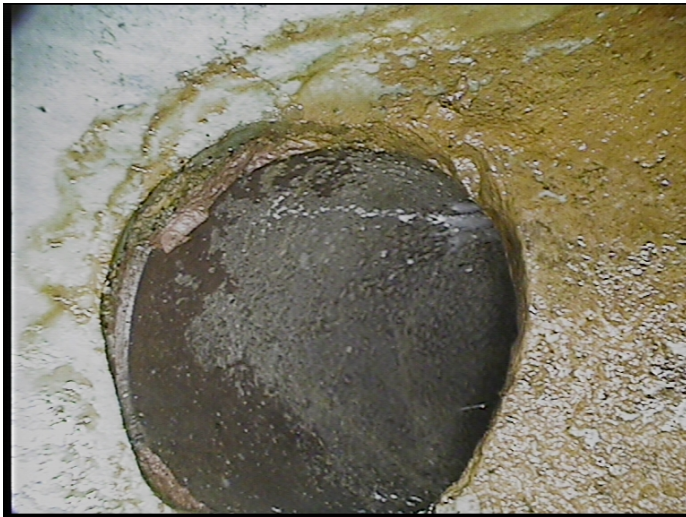
Code: **TF**  
Description: **Tap Factory**

Distance (ft): **191.8**  
Structural Grade: **0**  
O&M Grade: **0**  
Clock Start/From: **2**  
Clock To:  
1st Value: **4.000**  
2nd Value:  
Value Percent:  
Continuous Index:  
Within 8" of Joint: **NO**  
Remarks:

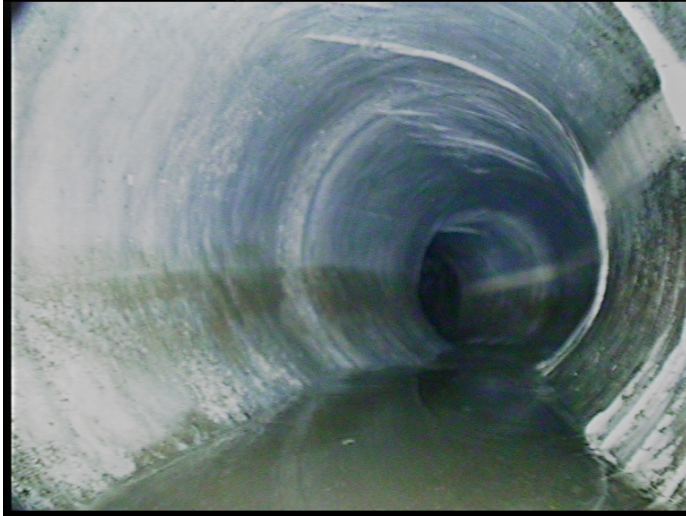
Code:	<b>LR</b>
Description:	<b>Alignment Right</b>
Distance (ft):	<b>297.1</b>
Structural Grade:	<b>0</b>
O&M Grade:	<b>1</b>
Clock Start/From:	
Clock To:	
1st Value:	
2nd Value:	
Value Percent:	<b>5.000</b>
Continuous Index:	
Within 8" of Joint:	<b>NO</b>
Remarks:

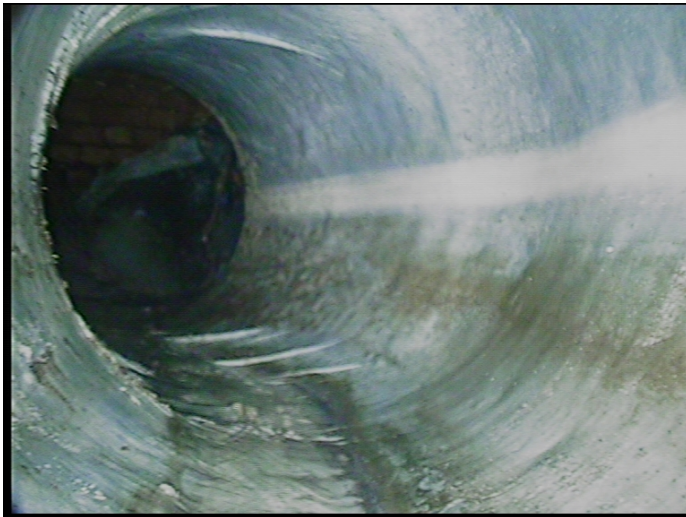
Code:	<b>LL</b>
Description:	<b>Alignment Left</b>
Distance (ft):	<b>303.6</b>
Structural Grade:	<b>0</b>
O&M Grade:	<b>1</b>
Clock Start/From:	
Clock To:	
1st Value:	
2nd Value:	
Value Percent:	<b>5.000</b>
Continuous Index:	
Within 8" of Joint:	<b>NO</b>
Remarks:

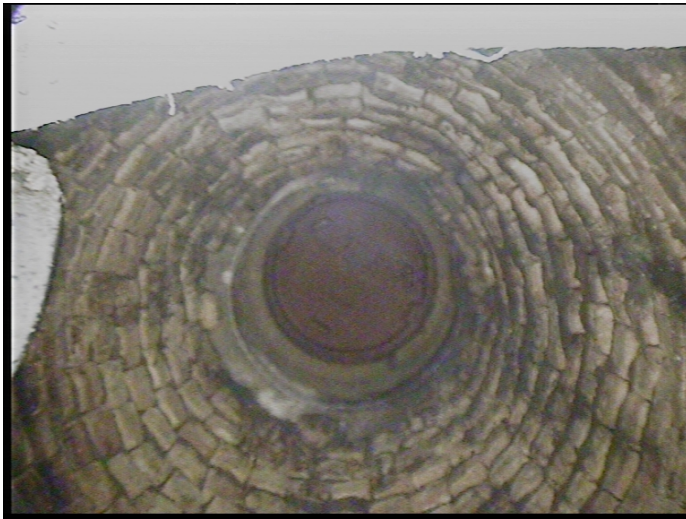
Code:	<b>AMH</b>
Description:	<b>Manhole</b>
Distance (ft):	<b>309.0</b>
Structural Grade:	<b>0</b>
O&M Grade:	<b>0</b>
Clock Start/From:	
Clock To:	
1st Value:	
2nd Value:	
Value Percent:	
Continuous Index:	
Within 8" of Joint:	<b>NO</b>
Remarks:	<b>M-705-037</b>
