Profile/Photo Observation Report

Street:	Center Street	Flow Control:	Not Controlled
City:	Hobart, IN	Year Renewed:	
Location:	Light Highway	Tape/Media #:	DEP 150
Purpose:	Routine Assessment	Dia/Height:	18"
Use:	Sanitary	Material:	CP
Drain Area:		Lining:	
Category:	NA		
Comment:	5-21-2018		
Location Details:		Direction of Survey:	Upstream
US MH:	M-705-037	DS MH:	M-705-061
		Total Length Surveyed (ft):	48.4

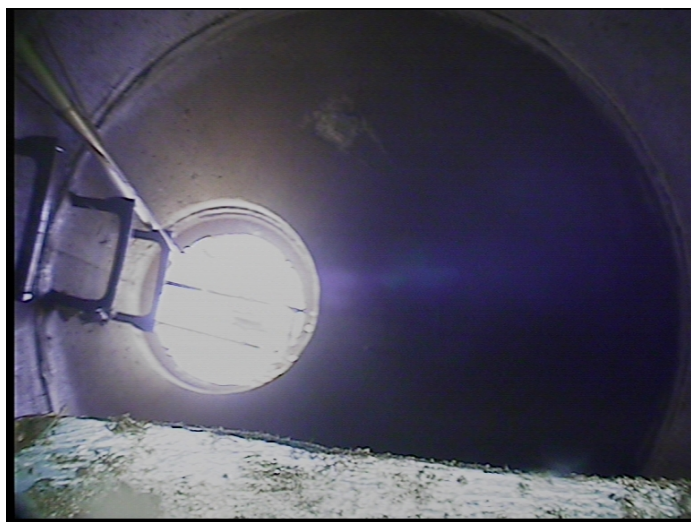
Code: **AMH**
Description: **Manhole**

Distance (ft): **.0**
Structural Grade: **0**
O&M Grade: **0**
Clock Start/From:
Clock To:
1st Value:
2nd Value:
Value Percent:
Continuous Index:
Within 8" of Joint: **NO**
Remarks: **M-705-061**

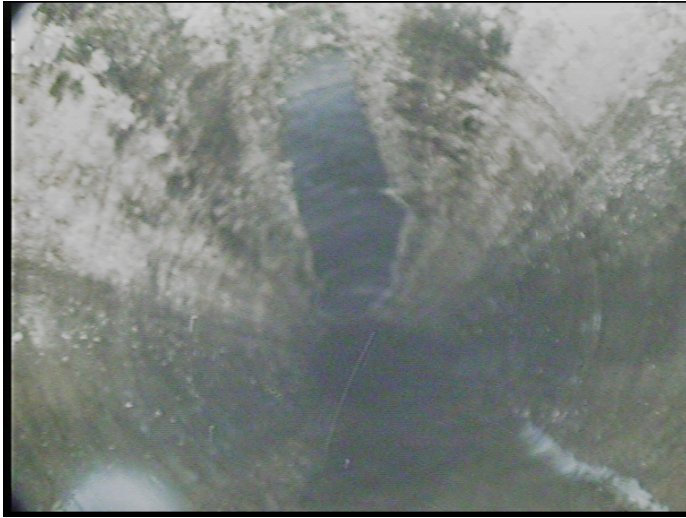
Code:	MWL
Description:	Water Level
Distance (ft):	.0
Structural Grade:	0
O&M Grade:	0
Clock Start/From:	
Clock To:	
1st Value:	
2nd Value:	
Value Percent:	10.000
Continuous Index:	
Within 8" of Joint:	NO
Remarks:

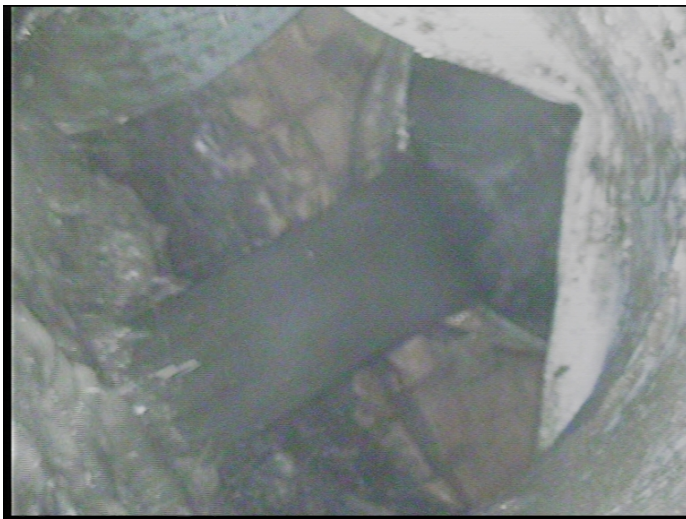
Code:	AMH
Description:	Manhole
Distance (ft):	48.4
Structural Grade:	0
O&M Grade:	0
Clock Start/From:	
Clock To:	
1st Value:	
2nd Value:	
Value Percent:	
Continuous Index:	
Within 8" of Joint:	NO
Remarks:	M-705-037
