## Profile/Photo Observation Report

Street:	East 4th Street	Flow Control:	Not Controlled
City:	Hobart, IN	Year Renewed:	
Location:	Local rural streets with light traffic, t	Tape/Media #:	
Purpose:	Routine Assessment	Dia/Height:	8"
Use:	Sanitary Sewage Pipe	Material:	CP
Drain Area:		Lining:	None
Category:	NA		
Comment:	No U/S access found.		
Location Details:		Direction of Survey:	Upstream
US MH:	M-705-045	DS MH:	M-705-045
		Total Length Surveyed (ft):	1.3

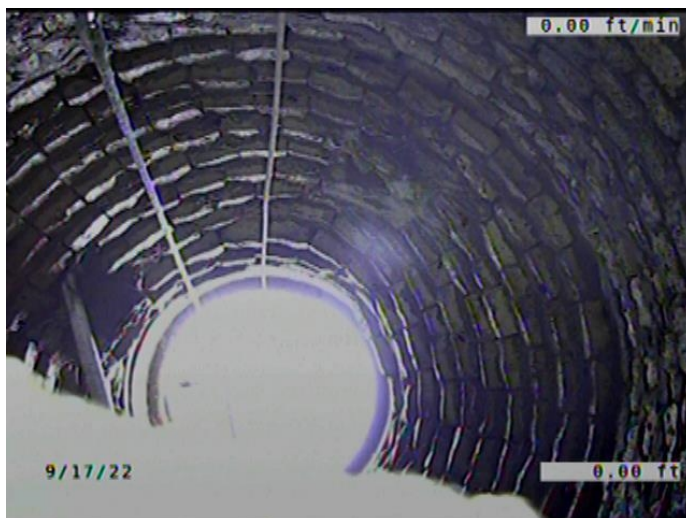
Code: **AMH**  
Description: **Manhole**

Distance (ft): **.0**  
Structural Grade: **0**  
O&M Grade: **0**  
Clock Start/From:  
Clock To:  
1st Value:  
2nd Value:  
Value Percent:  
Continuous Index:  
Within 8" of Joint: **NO**  
Remarks: **M-705-045**

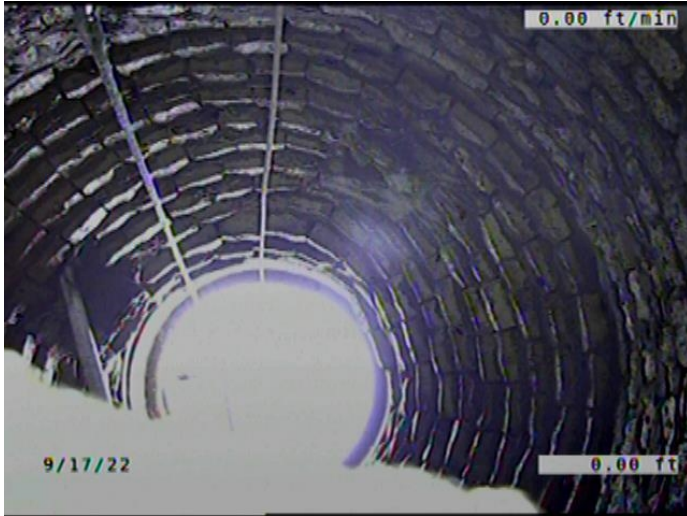
Code:	<b>MWL</b>
Description:	<b>Miscellaneous Water Level</b>
Distance (ft):	<b>.0</b>
Structural Grade:	<b>0</b>
O&M Grade:	<b>0</b>
Clock Start/From:	
Clock To:	
1st Value:	
2nd Value:	
Value Percent:	<b>65.000</b>
Continuous Index:	
Within 8" of Joint:	<b>NO</b>
Remarks:

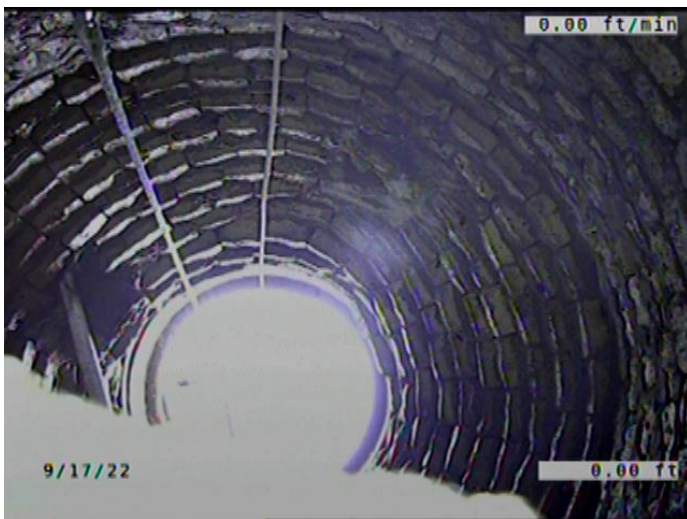
Code:	<b>DSF</b>
Description:	<b>Deposits Settled Fine</b>
Distance (ft):	<b>.0</b>
Structural Grade:	<b>0</b>
O&M Grade:	<b>5</b>
Clock Start/From:	<b>2</b>
Clock To:	<b>10</b>
1st Value:	
2nd Value:	
Value Percent:	<b>65.000</b>
Continuous Index:	
Within 8" of Joint:	<b>YES</b>
Remarks:

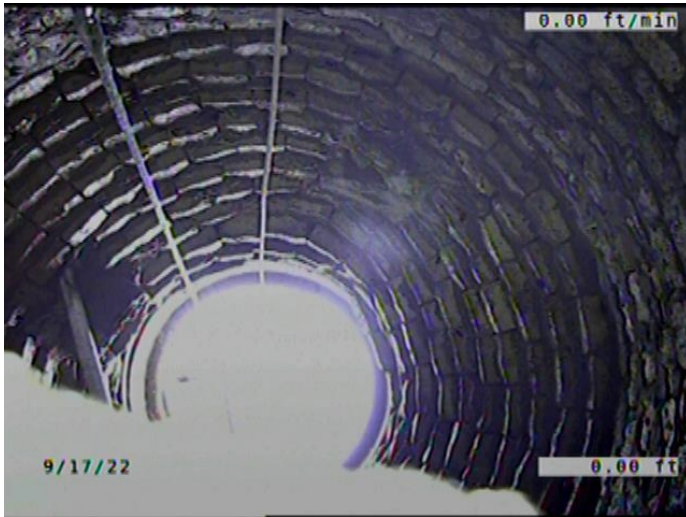
Code: **VC**  
 Description: **Vermin Cockroach**

Distance (ft): **.3**  
 Structural Grade: **0**  
 O&M Grade: **1**  
 Clock Start/From:  
 Clock To:  
 1st Value:  
 2nd Value:  
 Value Percent:  
 Continuous Index:  
 Within 8" of Joint: **YES**  
 Remarks:

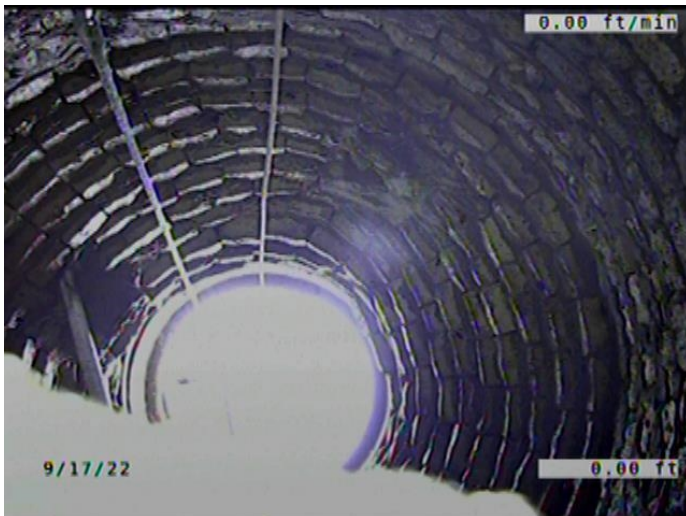
Code: **MSA**  
 Description: **Miscellaneous Survey Abandoned**

Distance (ft): **1.3**  
 Structural Grade: **0**  
 O&M Grade: **0**  
 Clock Start/From:  
 Clock To:  
 1st Value:  
 2nd Value:  
 Value Percent:  
 Continuous Index:  
 Within 8" of Joint: **NO**  
 Remarks: **CAMERA CANT MAKE IT PAST DEBRIS.**
