## Profile/Photo Observation Report

Date:	<b>05/02/2018</b>	Weather:		Coding:	<b>PACP 6.0</b>
Pipe Length (ft):		Owner:	<b>City of Hobart</b>	Pre Clean:	<b>No Pre-Cleaning</b>
P.O.#:	<b>165</b>	Surveyor:	<b>M. Pielacha</b>	PSR:	<b>P-705-050-046</b>
Customer:	<b>City of Hobart</b>	Clean Date:		Shape:	<b>C</b>

Street:	<b>3rd Street</b>	Flow Control:	<b>Not Controlled</b>
City:	<b>Hobart, IN</b>	Year Renewed:	
Location:	<b>Light Highway</b>	Tape/Media #:	<b>DEP 165</b>
Purpose:	<b>Routine Assessment</b>	Dia/Height:	<b>18"</b>
Use:	<b>Sanitary</b>	Material:	<b>VCP</b>
Drain Area:		Lining:	
Category:	<b>NA</b>		
Comment:	<b>5-21-2018</b>		
Location Details:		Direction of Survey:	<b>Upstream</b>
US MH:	<b>M-705-046</b>	DS MH:	<b>M-705-050</b>
		Total Length Surveyed (ft):	<b>183.5</b>

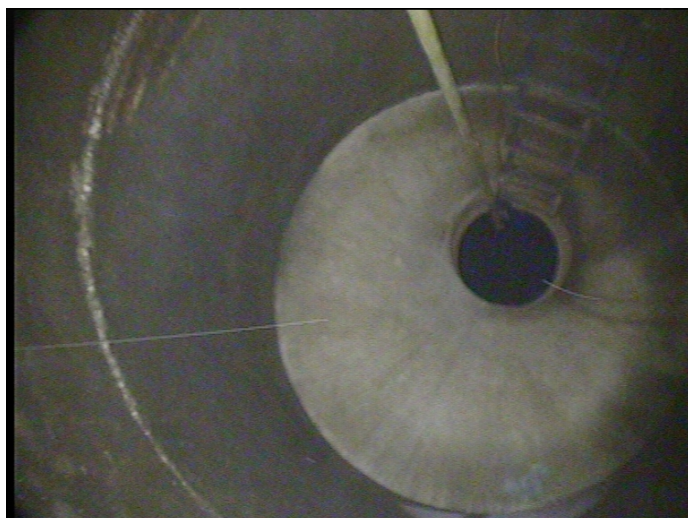
Code: **AMH**  
 Description: **Manhole**

Distance (ft): **.0**  
 Structural Grade: **0**  
 O&M Grade: **0**  
 Clock Start/From:  
 Clock To:  
 1st Value:  
 2nd Value:  
 Value Percent:  
 Continuous Index:  
 Within 8" of Joint: **NO**  
 Remarks: **M-705-046**

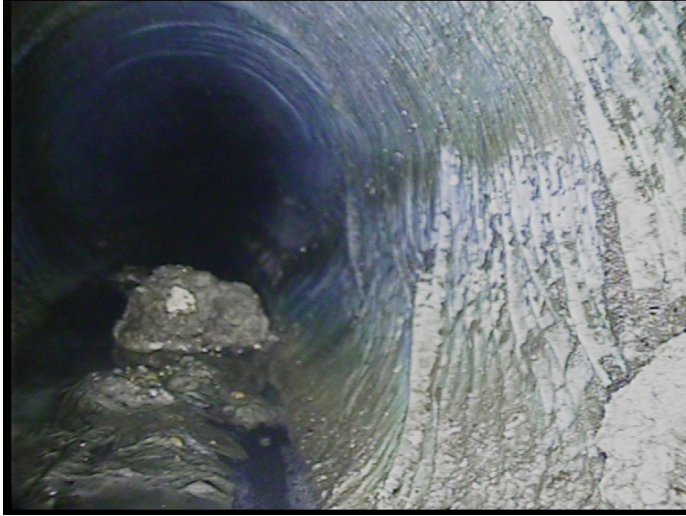
Code:	<b>MWL</b>
Description:	<b>Water Level</b>
Distance (ft):	<b>.0</b>
Structural Grade:	<b>0</b>
O&M Grade:	<b>0</b>
Clock Start/From:	
Clock To:	
1st Value:	
2nd Value:	
Value Percent:	<b>5.000</b>
Continuous Index:	
Within 8" of Joint:	<b>NO</b>
Remarks:

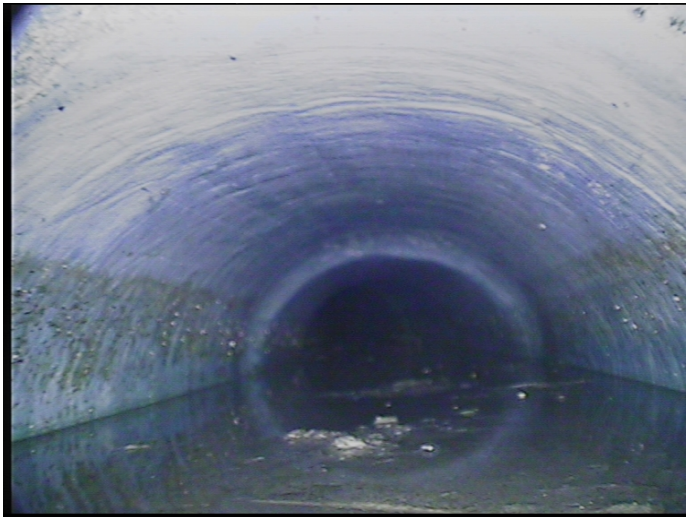
Code:	<b>MWL</b>
Description:	<b>Water Level</b>
Distance (ft):	<b>45.1</b>
Structural Grade:	<b>0</b>
O&M Grade:	<b>0</b>
Clock Start/From:	
Clock To:	
1st Value:	
2nd Value:	
Value Percent:	<b>45.000</b>
Continuous Index:	
Within 8" of Joint:	<b>NO</b>
Remarks:

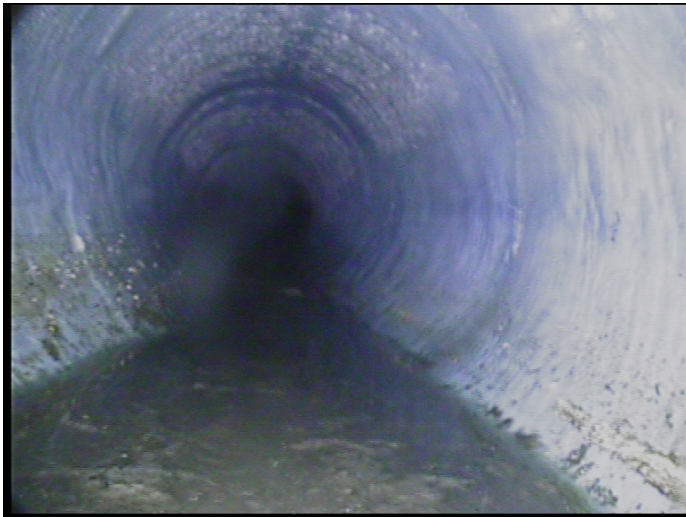
Code:	<b>MWL</b>
Description:	<b>Water Level</b>
Distance (ft):	<b>59.4</b>
Structural Grade:	<b>0</b>
O&M Grade:	<b>0</b>
Clock Start/From:	
Clock To:	
1st Value:	
2nd Value:	
Value Percent:	<b>10.000</b>
Continuous Index:	
Within 8" of Joint:	<b>NO</b>
Remarks:

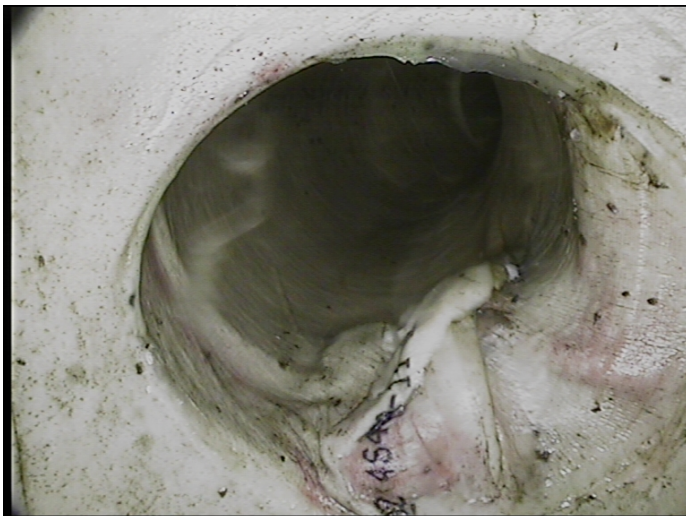
Code:	<b>TF</b>
Description:	<b>Tap Factory</b>
Distance (ft):	<b>81.7</b>
Structural Grade:	<b>0</b>
O&M Grade:	<b>0</b>
Clock Start/From:	<b>2</b>
Clock To:	
1st Value:	<b>4.000</b>
2nd Value:	
Value Percent:	
Continuous Index:	
Within 8" of Joint:	<b>NO</b>
Remarks:

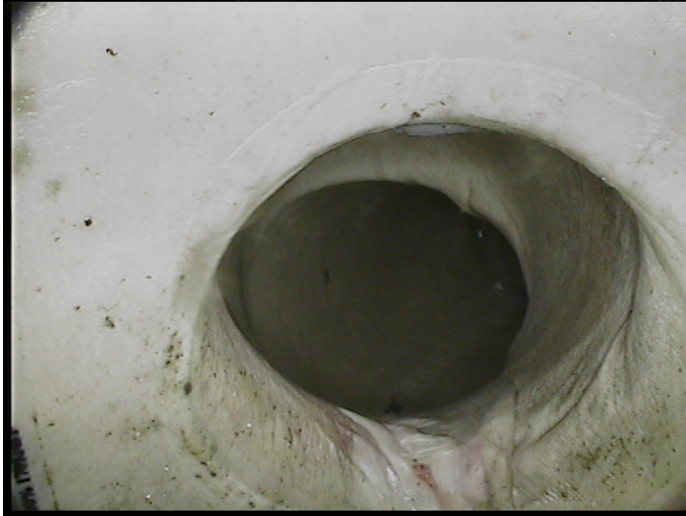
Code: **TF**  
Description: **Tap Factory**

Distance (ft): **90.8**  
Structural Grade: **0**  
O&M Grade: **0**  
Clock Start/From: **2**  
Clock To:  
1st Value: **4.000**  
2nd Value:  
Value Percent:  
Continuous Index:  
Within 8" of Joint: **NO**  
Remarks:

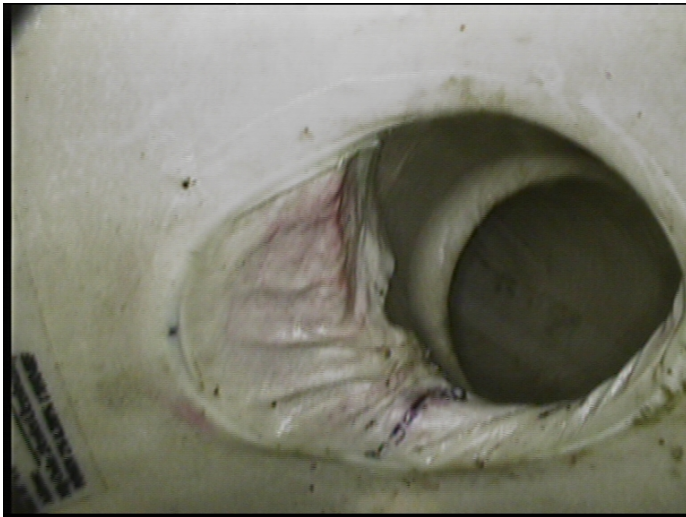
Code: **TF**  
Description: **Tap Factory**

Distance (ft): **96.7**  
Structural Grade: **0**  
O&M Grade: **0**  
Clock Start/From: **10**  
Clock To:  
1st Value: **4.000**  
2nd Value:  
Value Percent:  
Continuous Index:  
Within 8" of Joint: **NO**  
Remarks:

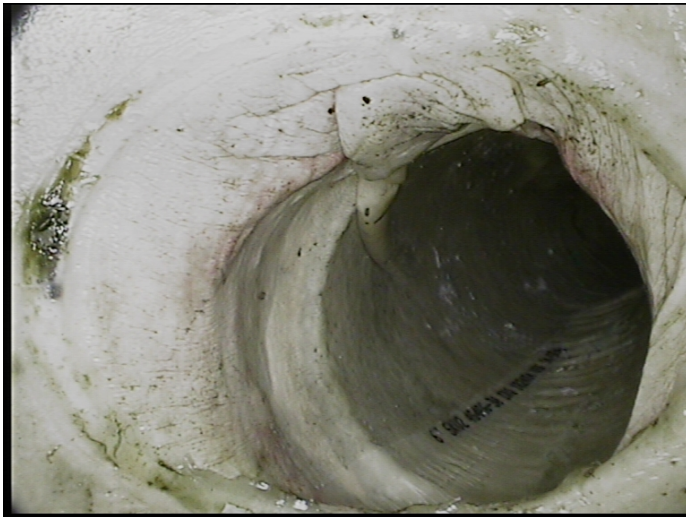
Code: **TF**  
Description: **Tap Factory**

Distance (ft): **118.2**  
Structural Grade: **0**  
O&M Grade: **0**  
Clock Start/From: **2**  
Clock To:  
1st Value: **4.000**  
2nd Value:  
Value Percent:  
Continuous Index:  
Within 8" of Joint: **NO**  
Remarks:

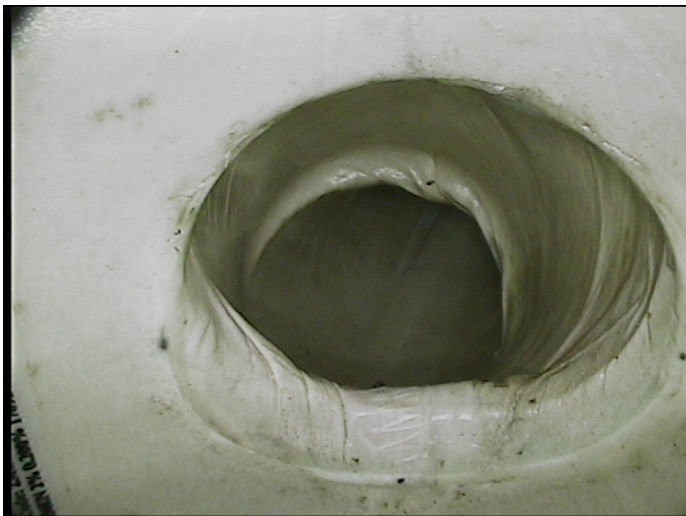
Code: **TF**  
Description: **Tap Factory**

Distance (ft): **142.0**  
Structural Grade: **0**  
O&M Grade: **0**  
Clock Start/From: **2**  
Clock To:  
1st Value: **4.000**  
2nd Value:  
Value Percent:  
Continuous Index:  
Within 8" of Joint: **NO**  
Remarks:

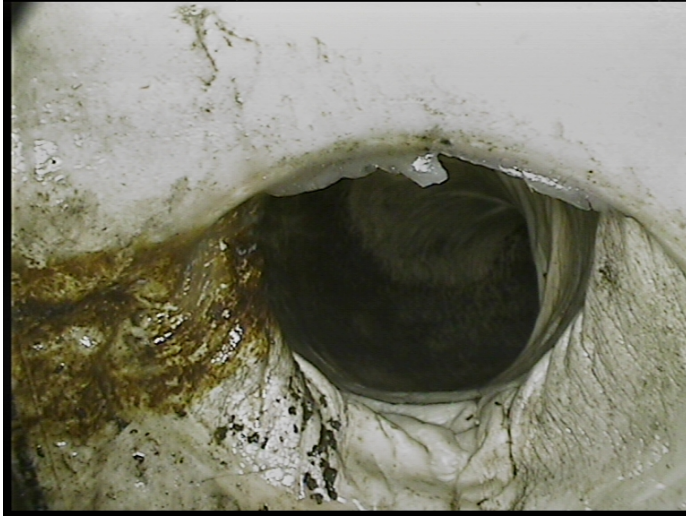
Code:	<b>TF</b>
Description:	<b>Tap Factory</b>
Distance (ft):	<b>151.7</b>
Structural Grade:	<b>0</b>
O&M Grade:	<b>0</b>
Clock Start/From:	<b>10</b>
Clock To:	
1st Value:	<b>4.000</b>
2nd Value:	
Value Percent:	
Continuous Index:	
Within 8" of Joint:	<b>NO</b>
Remarks:

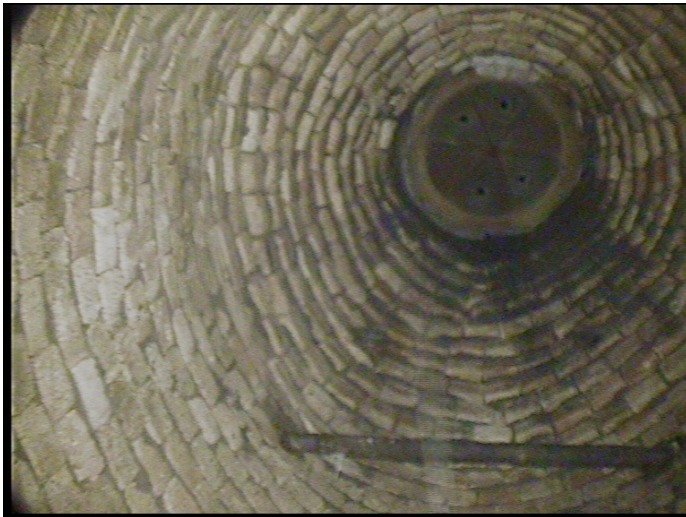
Code:	<b>AMH</b>
Description:	<b>Manhole</b>
Distance (ft):	<b>183.4</b>
Structural Grade:	<b>0</b>
O&M Grade:	<b>0</b>
Clock Start/From:	
Clock To:	
1st Value:	
2nd Value:	
Value Percent:	
Continuous Index:	
Within 8" of Joint:	<b>NO</b>
Remarks:	<b>M-705-050</b>
