Profile/Photo Observation Report

Date:	05/02/2018	Weather:		Coding:	PACP 6.0
Pipe Length (ft):		Owner:	City of Hobart	Pre Clean:	No Pre-Cleaning
P.O.#:	165	Surveyor:	M. Pielacha	PSR:	P-705-052-050
Customer:	City of Hobart	Clean Date:		Shape:	C

Street:	3rd Street	Flow Control:	Not Controlled
City:	Hobart, IN	Year Renewed:	
Location:	Light Highway	Tape/Media #:	DEP 165
Purpose:	Routine Assessment	Dia/Height:	18"
Use:	Sanitary	Material:	VCP
Drain Area:		Lining:	
Category:	NA		
Comment:	5-21-2018		
Location Details:		Direction of Survey:	Upstream
US MH:	M-705-050	DS MH:	M-705-052
		Total Length Surveyed (ft):	211.9

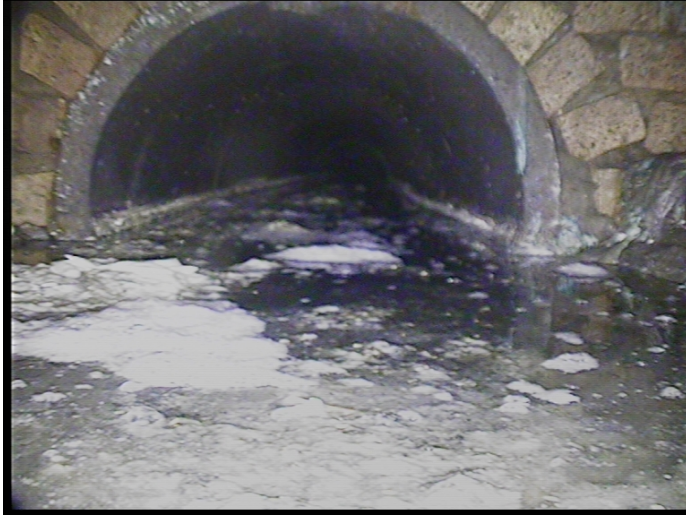
Code: **MWL**
Description: **Water Level**

Distance (ft): **.0**
Structural Grade: **0**
O&M Grade: **0**
Clock Start/From:
Clock To:
1st Value:
2nd Value:
Value Percent: **25.000**
Continuous Index:
Within 8" of Joint: **NO**
Remarks:

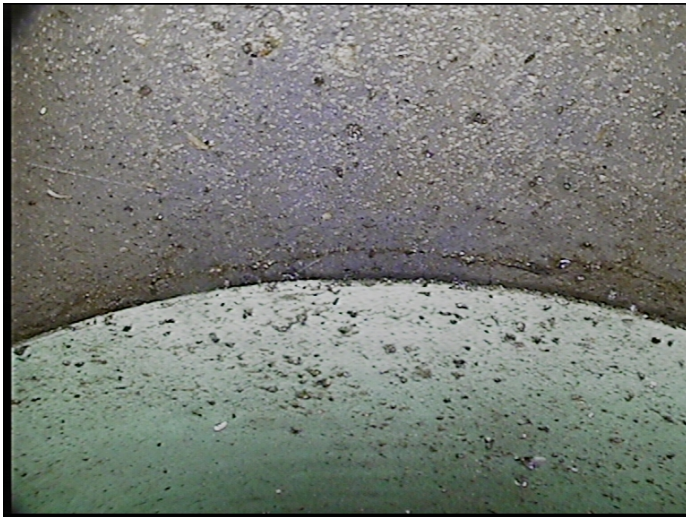
Code: **MMC**
Description: **Material Change**

Distance (ft): **13.9**
Structural Grade: **0**
O&M Grade: **0**
Clock Start/From:
Clock To:
1st Value:
2nd Value:
Value Percent:
Continuous Index:
Within 8" of Joint: **NO**
Remarks: **pvc**

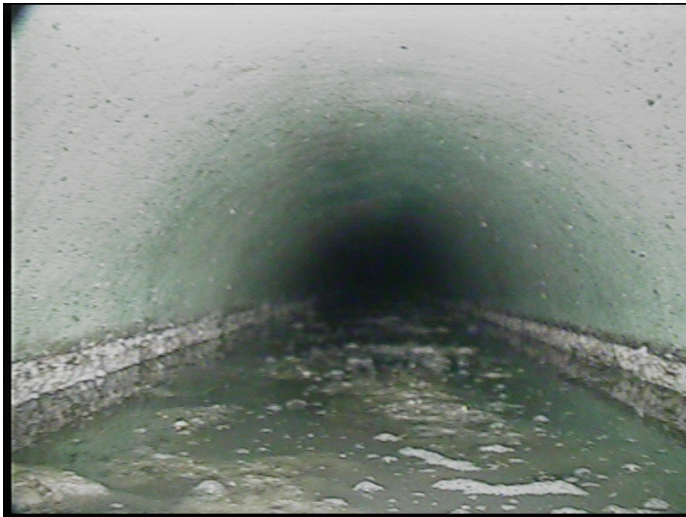
Code: **DSF**
Description: **Deposits Settled Fine**

Distance (ft): **18.1**
Structural Grade: **0**
O&M Grade: **3**
Clock Start/From: **4**
Clock To: **8**
1st Value:
2nd Value:
Value Percent: **15.000**
Continuous Index: **S01**
Within 8" of Joint: **YES**
Remarks:

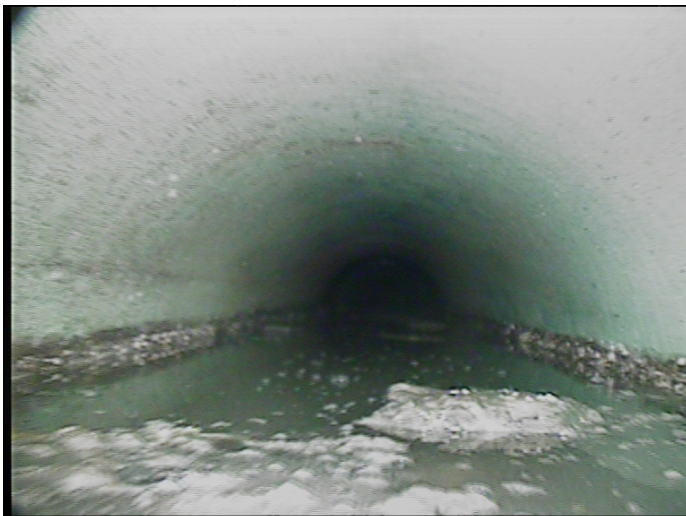
Code: **DSF**
Description: **Deposits Settled Fine**

Distance (ft): **40.2**
Structural Grade: **0**
O&M Grade: **3**
Clock Start/From: **4**
Clock To: **8**
1st Value:
2nd Value:
Value Percent: **15.000**
Continuous Index: **F01**
Within 8" of Joint: **NO**
Remarks:

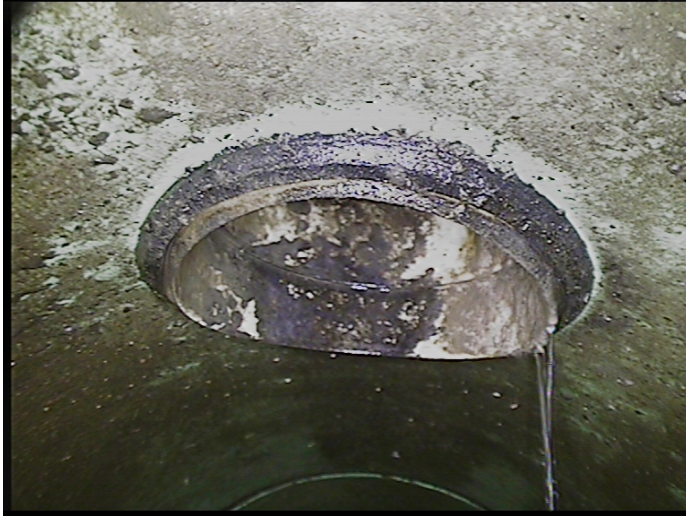
Code: **TBA**
Description: **Tap Break-in Active**

Distance (ft): **50.5**
Structural Grade: **0**
O&M Grade: **0**
Clock Start/From: **12**
Clock To:
1st Value: **4.000**
2nd Value:
Value Percent:
Continuous Index:
Within 8" of Joint: **NO**
Remarks:

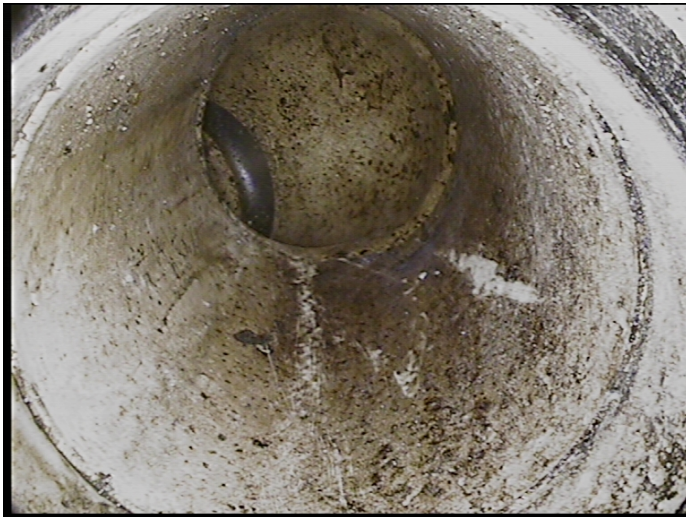
Code: **TB**
Description: **Tap Break-in**

Distance (ft): **72.1**
Structural Grade: **0**
O&M Grade: **0**
Clock Start/From: **11**
Clock To:
1st Value: **4.000**
2nd Value:
Value Percent:
Continuous Index:
Within 8" of Joint: **NO**
Remarks:

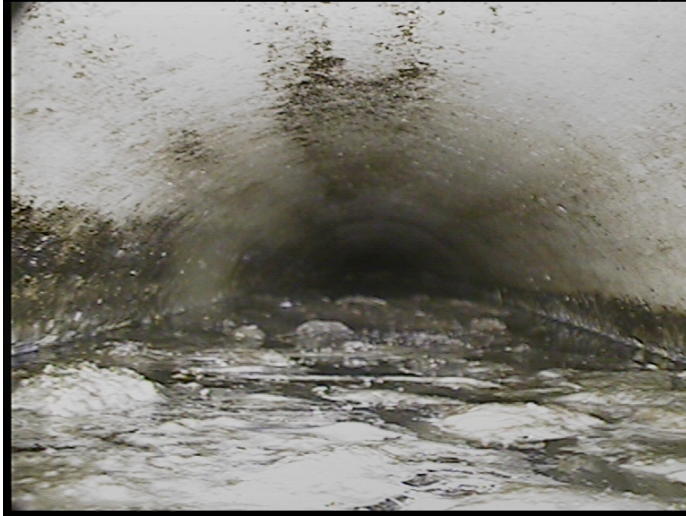
Code:	MWL
Description:	Water Level
Distance (ft):	81.3
Structural Grade:	0
O&M Grade:	0
Clock Start/From:	
Clock To:	
1st Value:	
2nd Value:	
Value Percent:	50.000
Continuous Index:	
Within 8" of Joint:	NO
Remarks:

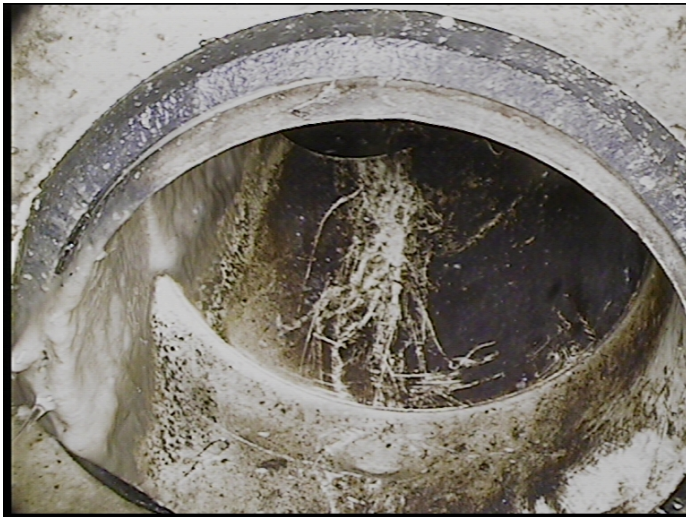
Code:	TBA
Description:	Tap Break-in Active
Distance (ft):	108.3
Structural Grade:	0
O&M Grade:	0
Clock Start/From:	12
Clock To:	
1st Value:	4.000
2nd Value:	
Value Percent:	
Continuous Index:	
Within 8" of Joint:	NO
Remarks:

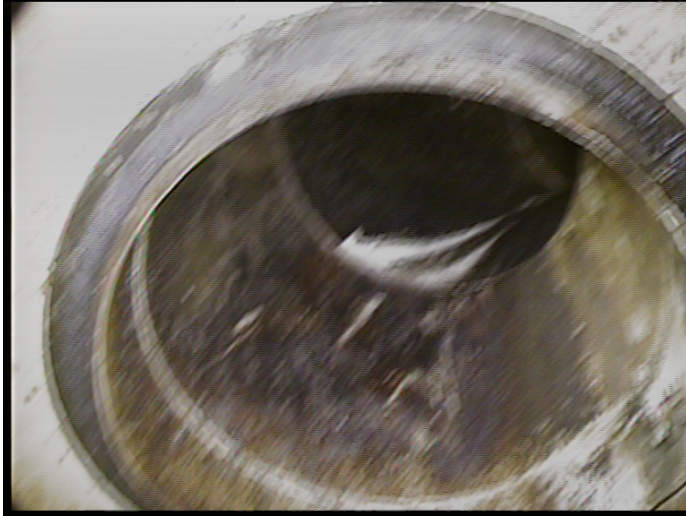
Code: **TF**
Description: **Tap Factory**

Distance (ft): **113.5**
Structural Grade: **0**
O&M Grade: **0**
Clock Start/From: **2**
Clock To:
1st Value: **4.000**
2nd Value:
Value Percent:
Continuous Index:
Within 8" of Joint: **NO**
Remarks:

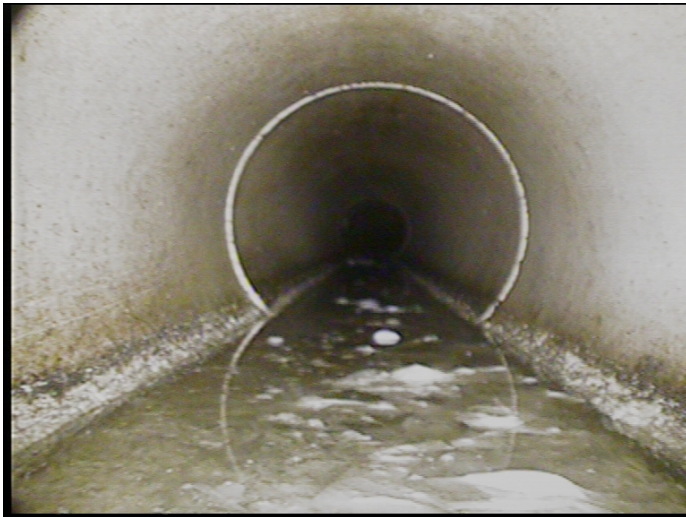
Code: **MWL**
Description: **Water Level**

Distance (ft): **114.0**
Structural Grade: **0**
O&M Grade: **0**
Clock Start/From:
Clock To:
1st Value:
2nd Value:
Value Percent: **15.000**
Continuous Index:
Within 8" of Joint: **NO**
Remarks:

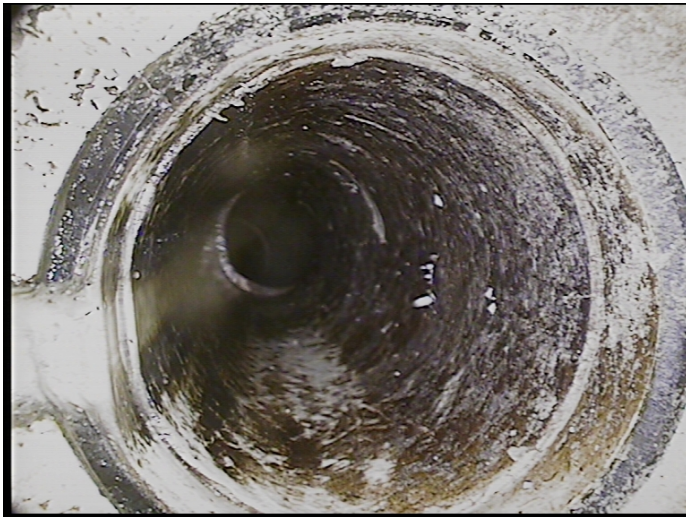
Code: **TB**
Description: **Tap Break-in**

Distance (ft): **132.6**
Structural Grade: **0**
O&M Grade: **0**
Clock Start/From: **10**
Clock To:
1st Value: **4.000**
2nd Value:
Value Percent:
Continuous Index:
Within 8" of Joint: **NO**
Remarks:

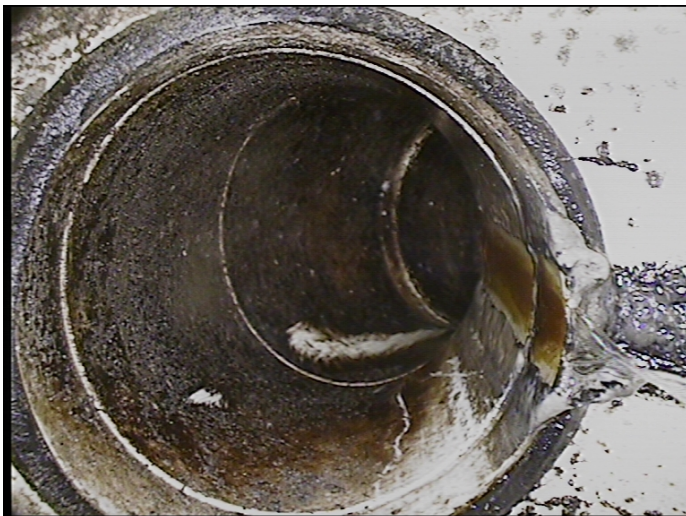
Code: **TBA**
Description: **Tap Break-in Active**

Distance (ft): **137.4**
Structural Grade: **0**
O&M Grade: **0**
Clock Start/From: **2**
Clock To:
1st Value: **4.000**
2nd Value:
Value Percent:
Continuous Index:
Within 8" of Joint: **NO**
Remarks:

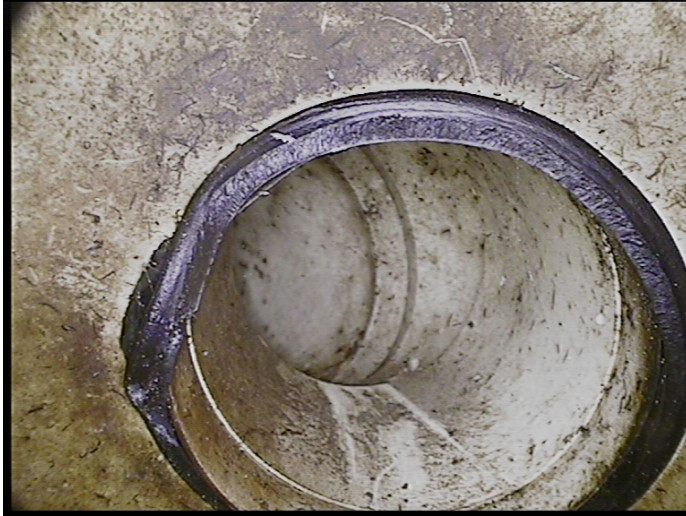
Code: **TB**
Description: **Tap Break-in**

Distance (ft): **168.2**
Structural Grade: **0**
O&M Grade: **0**
Clock Start/From: **10**
Clock To:
1st Value: **4.000**
2nd Value:
Value Percent:
Continuous Index:
Within 8" of Joint: **NO**
Remarks:

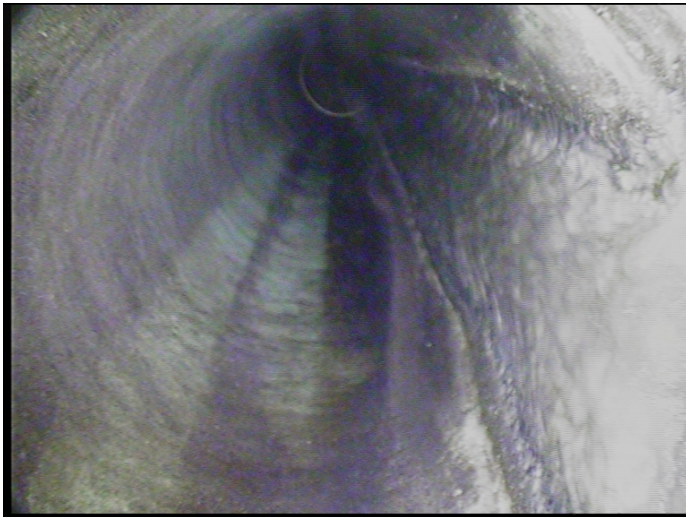
Code: **ATC**
Description: **Tee Connection**

Distance (ft): **211.9**
Structural Grade: **0**
O&M Grade: **0**
Clock Start/From: **3**
Clock To:
1st Value: **18.000**
2nd Value:
Value Percent:
Continuous Index:
Within 8" of Joint: **NO**
Remarks: **M-705-050**
