## Profile/Photo Observation Report

Date:	<b>05/02/2018</b>	Weather:		Coding:	<b>PACP 6.0</b>
Pipe Length (ft):		Owner:	<b>City of Hobart</b>	Pre Clean:	<b>No Pre-Cleaning</b>
P.O.#:	<b>167</b>	Surveyor:	<b>M. Pielacha</b>	PSR:	<b>P-805-053-052.1</b>
Customer:	<b>City of Hobart</b>	Clean Date:		Shape:	<b>C</b>

Street:	<b>3rd Street</b>	Flow Control:	<b>Not Controlled</b>
City:	<b>Hobart, IN</b>	Year Renewed:	
Location:	<b>Light Highway</b>	Tape/Media #:	<b>DEP 167</b>
Purpose:	<b>Routine Assessment</b>	Dia/Height:	<b>18"</b>
Use:	<b>Sanitary</b>	Material:	<b>VCP</b>
Drain Area:		Lining:	
Category:	<b>NA</b>		
Comment:	<b>5-21-2018</b>		
Location Details:		Direction of Survey:	<b>Downstream</b>
US MH:	<b>M-705-052.1</b>	DS MH:	<b>M-805-053</b>
		Total Length Surveyed (ft):	<b>8.2</b>

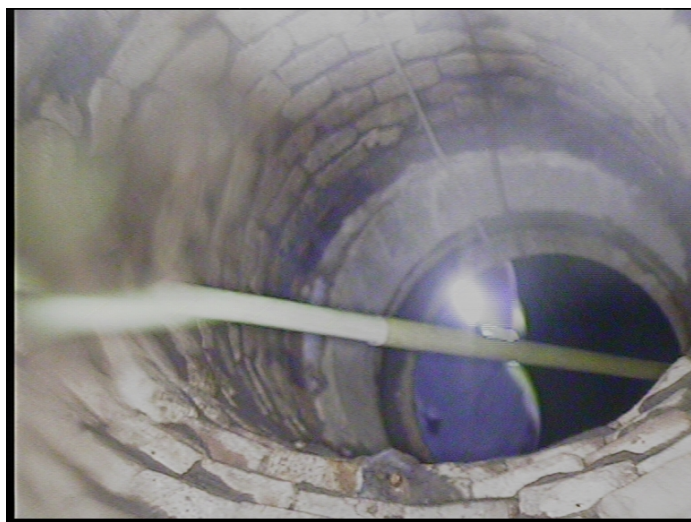
Code: **AMH**  
Description: **Manhole**

Distance (ft): **.0**  
Structural Grade: **0**  
O&M Grade: **0**  
Clock Start/From:  
Clock To:  
1st Value:  
2nd Value:  
Value Percent:  
Continuous Index:  
Within 8" of Joint: **NO**  
Remarks: **M-705-053**

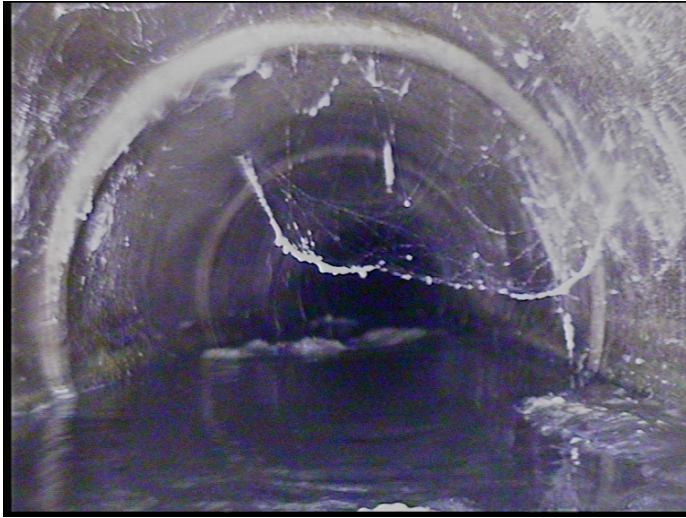
Code: **MWL**  
Description: **Water Level**

Distance (ft): **.0**  
Structural Grade: **0**  
O&M Grade: **0**  
Clock Start/From:  
Clock To:  
1st Value:  
2nd Value:  
Value Percent: **15.000**  
Continuous Index:  
Within 8" of Joint: **NO**  
Remarks:

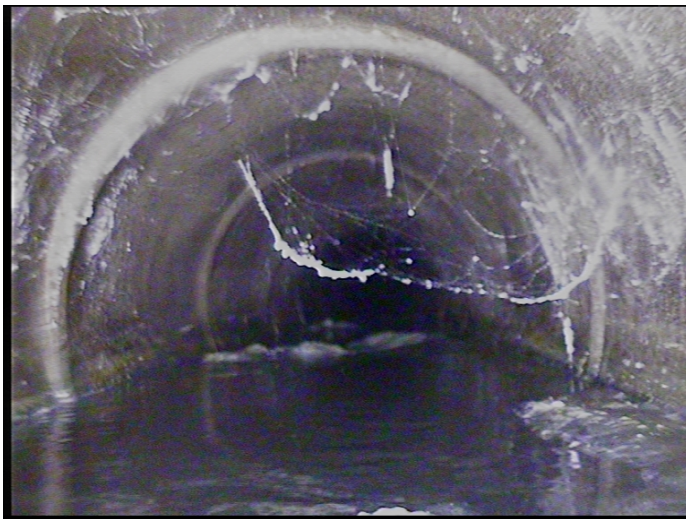
Code: **DSF**  
Description: **Deposits Settled Fine**

Distance (ft): **.0**  
Structural Grade: **0**  
O&M Grade: **3**  
Clock Start/From: **4**  
Clock To: **8**  
1st Value:  
2nd Value:  
Value Percent: **20.000**  
Continuous Index: **S01**  
Within 8" of Joint: **YES**  
Remarks:

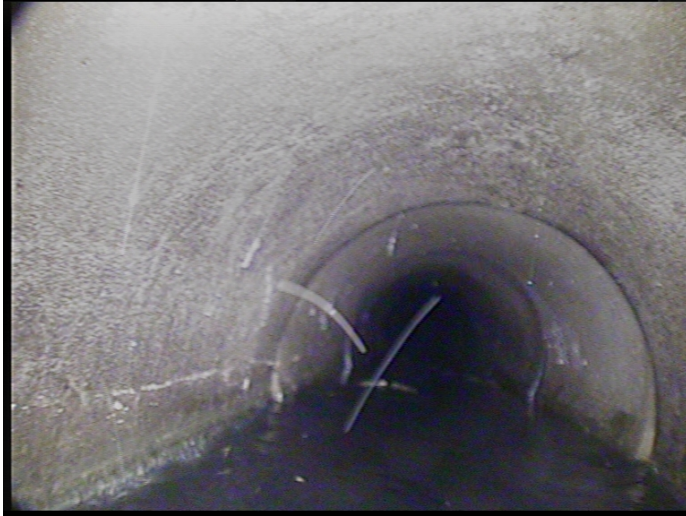
Code: **DSF**  
Description: **Deposits Settled Fine**

Distance (ft): **5.6**  
Structural Grade: **0**  
O&M Grade: **3**  
Clock Start/From: **4**  
Clock To: **8**  
1st Value:  
2nd Value:  
Value Percent: **20.000**  
Continuous Index: **F01**  
Within 8" of Joint: **NO**  
Remarks:

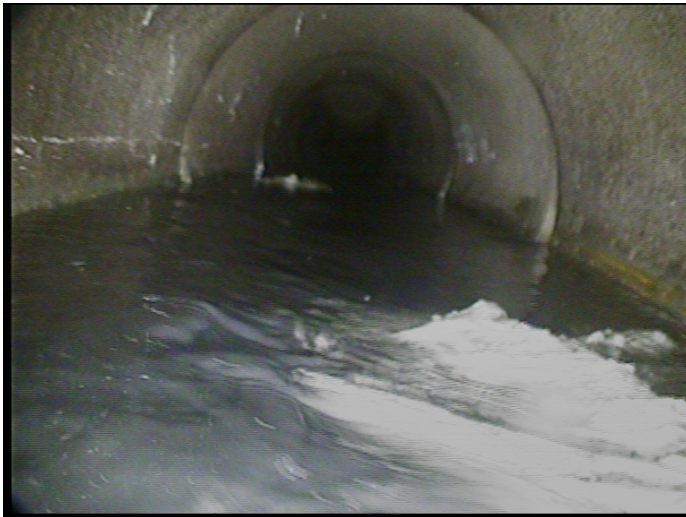
Code: **MSA**  
Description: **Abandoned Survey**

Distance (ft): **7.7**  
Structural Grade: **0**  
O&M Grade: **0**  
Clock Start/From:  
Clock To:  
1st Value:  
2nd Value:  
Value Percent:  
Continuous Index:  
Within 8" of Joint: **NO**  
Remarks: **sediment/debris**
