## Profile/Photo Observation Report

Street:	<b>East 3rd Street</b>	Flow Control:	<b>Not Controlled</b>
City:	<b>Hobart, IN</b>	Year Renewed:	
Location:	<b>Local rural streets with light traffic, t</b>	Tape/Media #:	
Purpose:	<b>Routine Assessment</b>	Dia/Height:	<b>12"</b>
Use:	<b>Sanitary Sewage Pipe</b>	Material:	<b>PVC</b>
Drain Area:		Lining:	<b>None</b>
Category:	<b>NA</b>		
Comment:			
Location Details:		Direction of Survey:	<b>Downstream</b>
US MH:	<b>M-705-054</b>	DS MH:	<b>M-705-053</b>
		Total Length Surveyed (ft):	<b>171.5</b>

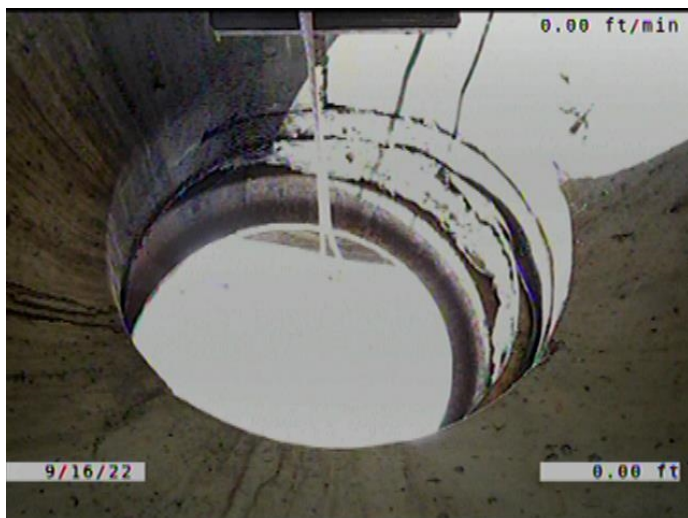
Code: **AMH**  
Description: **Manhole**

Distance (ft): **.0**  
Structural Grade: **0**  
O&M Grade: **0**  
Clock Start/From:  
Clock To:  
1st Value:  
2nd Value:  
Value Percent:  
Continuous Index:  
Within 8" of Joint: **NO**  
Remarks: **M-705-054**

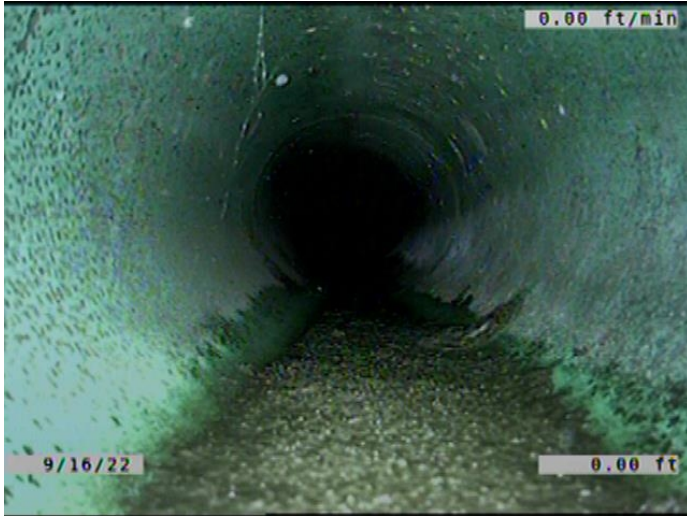
Code:	<b>MWL</b>
Description:	<b>Miscellaneous Water Level</b>
Distance (ft):	<b>.0</b>
Structural Grade:	<b>0</b>
O&M Grade:	<b>0</b>
Clock Start/From:	
Clock To:	
1st Value:	
2nd Value:	
Value Percent:	<b>5.000</b>
Continuous Index:	
Within 8" of Joint:	<b>NO</b>
Remarks:

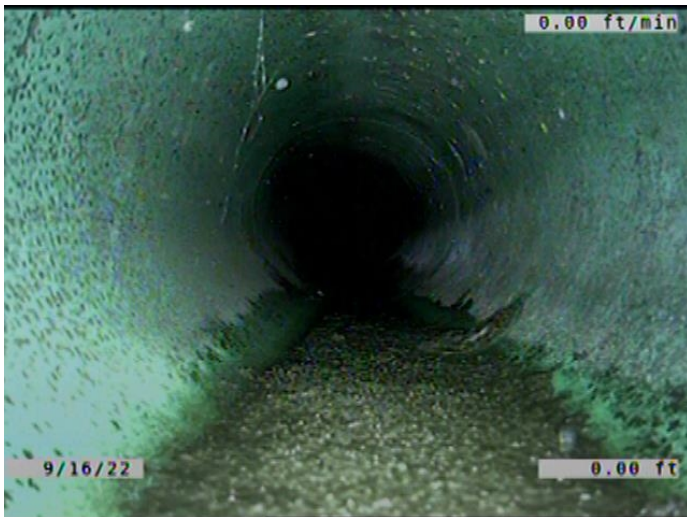
Code:	<b>DSF</b>
Description:	<b>Deposits Settled Fine</b>
Distance (ft):	<b>.0</b>
Structural Grade:	<b>0</b>
O&M Grade:	<b>2</b>
Clock Start/From:	<b>5</b>
Clock To:	<b>7</b>
1st Value:	
2nd Value:	
Value Percent:	<b>5.000</b>
Continuous Index:	<b>S01</b>
Within 8" of Joint:	<b>YES</b>
Remarks:

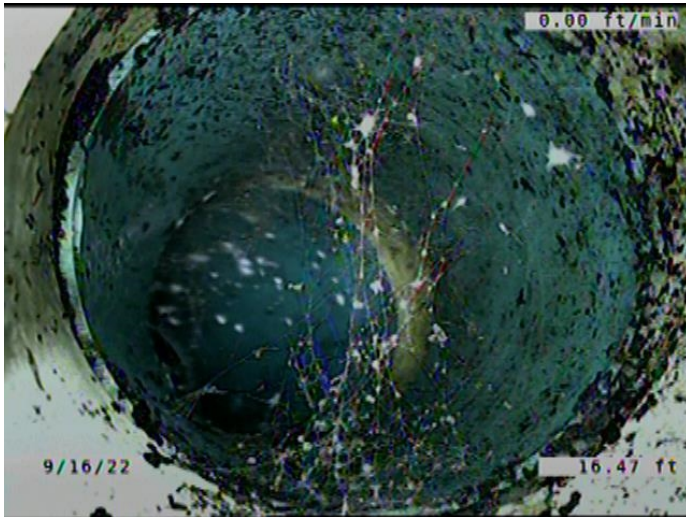
Code: **TF**  
 Description: **Tap Factory**

Distance (ft): **16.5**  
 Structural Grade: **0**  
 O&M Grade: **0**  
 Clock Start/From: **10**  
 Clock To:  
 1st Value: **6.000**  
 2nd Value:  
 Value Percent:  
 Continuous Index:  
 Within 8" of Joint: **YES**  
 Remarks:

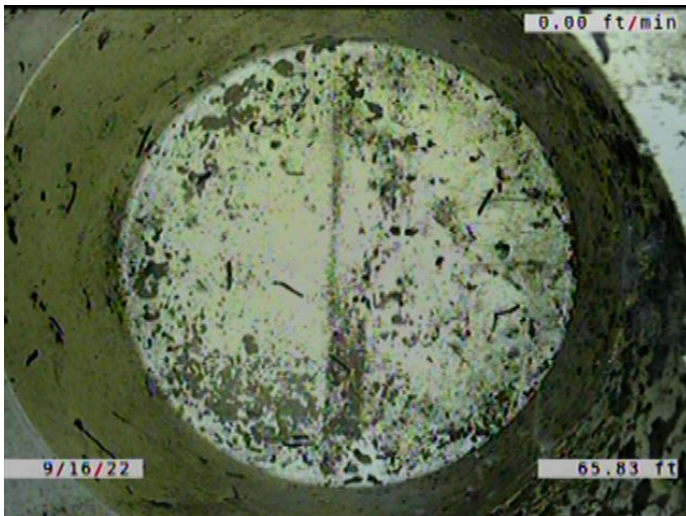
Code: **TFC**  
 Description: **Tap Factory Capped**

Distance (ft): **65.8**  
 Structural Grade: **0**  
 O&M Grade: **0**  
 Clock Start/From: **2**  
 Clock To:  
 1st Value: **6.000**  
 2nd Value:  
 Value Percent:  
 Continuous Index:  
 Within 8" of Joint: **YES**  
 Remarks:

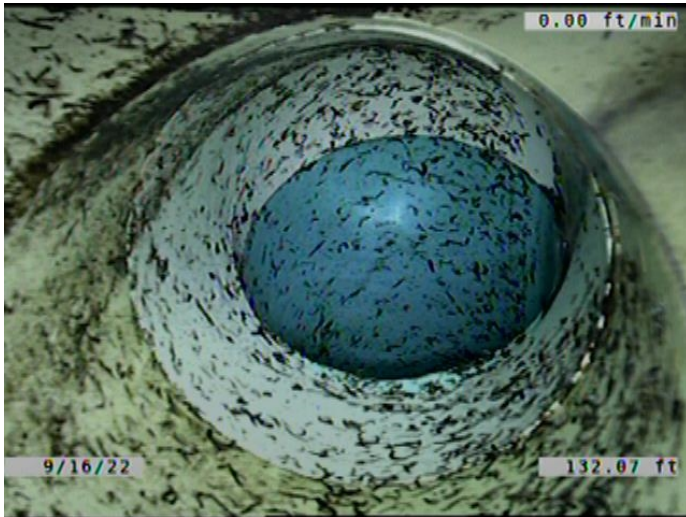
Code: **TF**  
Description: **Tap Factory**

Distance (ft): **132.1**  
Structural Grade: **0**  
O&M Grade: **0**  
Clock Start/From: **1**  
Clock To:  
1st Value: **6.000**  
2nd Value:  
Value Percent:  
Continuous Index:  
Within 8" of Joint: **YES**  
Remarks:

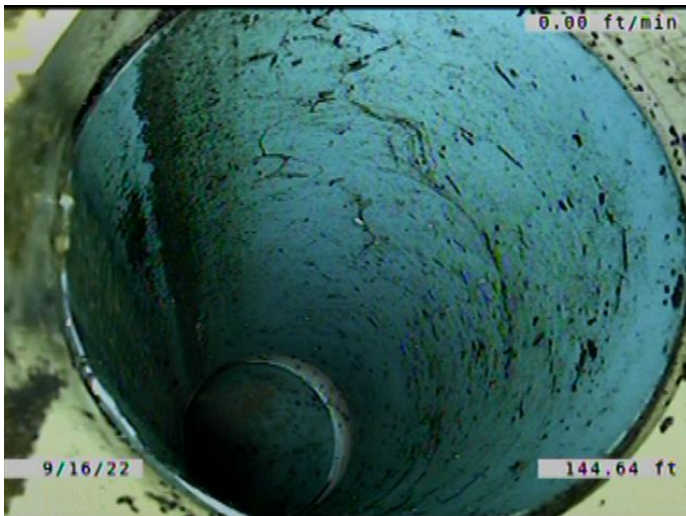
Code: **TF**  
Description: **Tap Factory**

Distance (ft): **144.6**  
Structural Grade: **0**  
O&M Grade: **0**  
Clock Start/From: **10**  
Clock To:  
1st Value: **6.000**  
2nd Value:  
Value Percent:  
Continuous Index:  
Within 8" of Joint: **YES**  
Remarks:

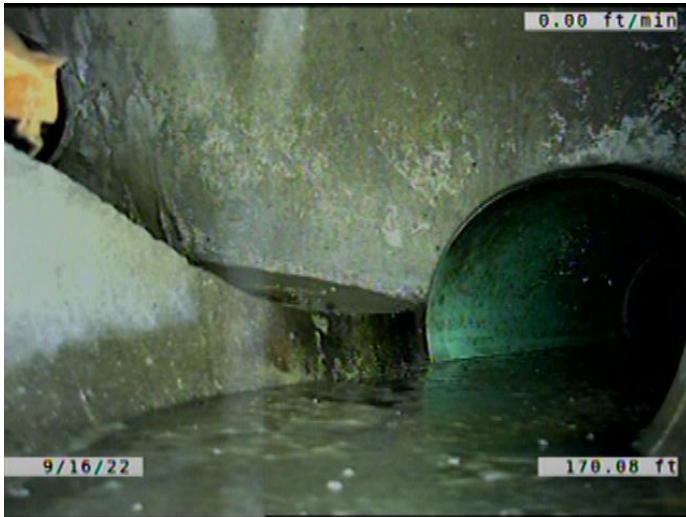
Code: **DSF**  
 Description: **Deposits Settled Fine**

Distance (ft): **170.1**  
 Structural Grade: **0**  
 O&M Grade: **2**  
 Clock Start/From: **5**  
 Clock To: **7**  
 1st Value:  
 2nd Value:  
 Value Percent: **5.000**  
 Continuous Index: **F01**  
 Within 8" of Joint: **YES**  
 Remarks:

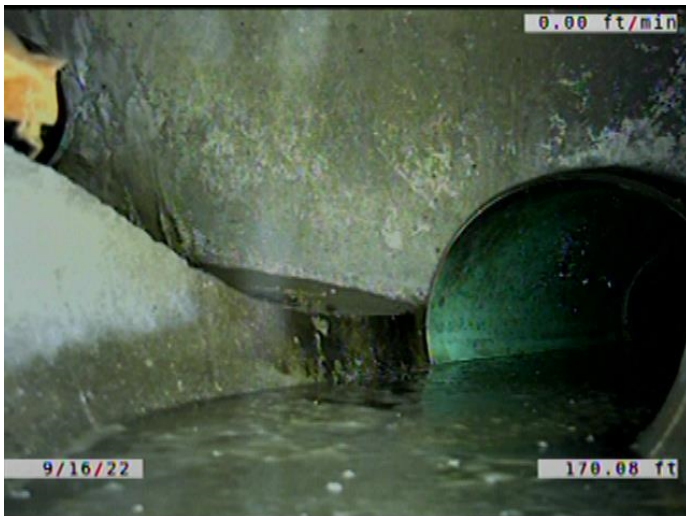
Code: **DSF**  
 Description: **Deposits Settled Fine**

Distance (ft): **170.1**  
 Structural Grade: **0**  
 O&M Grade: **3**  
 Clock Start/From: **4**  
 Clock To: **8**  
 1st Value:  
 2nd Value:  
 Value Percent: **20.000**  
 Continuous Index:  
 Within 8" of Joint: **YES**  
 Remarks:

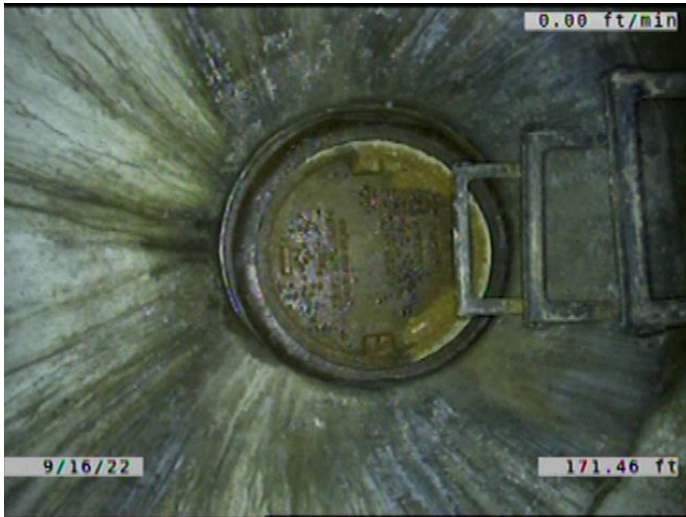
Code:	<b>AMH</b>
Description:	<b>Manhole</b>
Distance (ft):	<b>171.5</b>
Structural Grade:	<b>0</b>
O&M Grade:	<b>0</b>
Clock Start/From:	
Clock To:	
1st Value:	
2nd Value:	
Value Percent:	
Continuous Index:	
Within 8" of Joint:	<b>NO</b>
Remarks:	<b>M-705-053</b>
