## Profile/Photo Observation Report

Street:	<b>3rd Street</b>	Flow Control:	
City:	<b>Hobart, IN</b>	Year Renewed:	
Location:	<b>Light Highway</b>	Tape/Media #:	<b>935</b>
Purpose:	<b>Routine Assessment</b>	Dia/Height:	<b>12"</b>
Use:	<b>Sanitary</b>	Material:	<b>PVC</b>
Drain Area:		Lining:

US MH: **M-705-54** DS MH: **M-705-53** Total Length Surveyed (ft): **170.2**

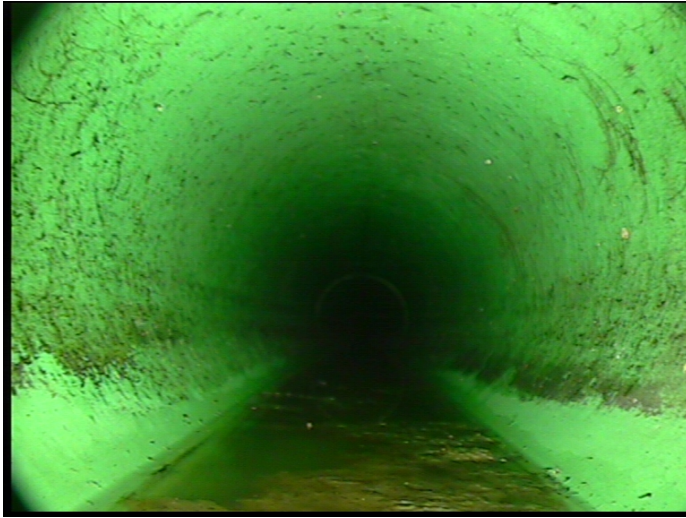
Code:	AMH
Description:	Manhole
Distance (ft):	.0
Structural Grade:	0
O&M Grade:	0
Clock Start/From:	
Clock To:	
1st Value:	
2nd Value:	
Value Percent:	
Continuous Index:	
Within 8" of Joint:	NO
Remarks:	M-705-53

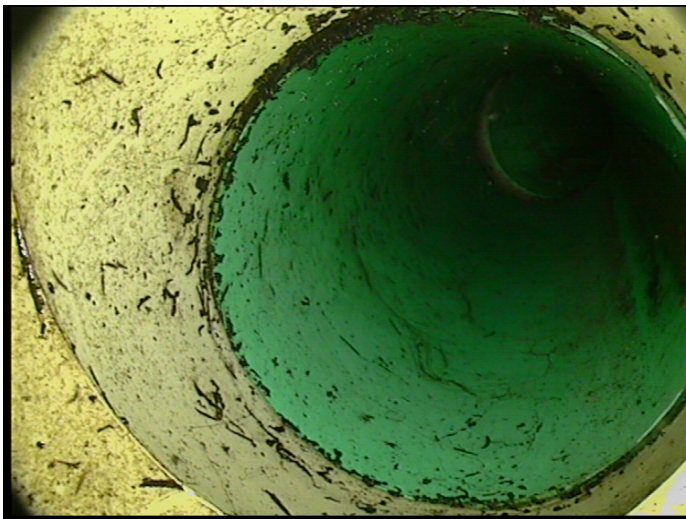
Code:	<b>MWL</b>
Description:	<b>Water Level</b>
Distance (ft):	<b>.0</b>
Structural Grade:	<b>0</b>
O&M Grade:	<b>0</b>
Clock Start/From:	
Clock To:	
1st Value:	
2nd Value:	
Value Percent:	<b>5.000</b>
Continuous Index:	
Within 8" of Joint:	<b>NO</b>
Remarks:

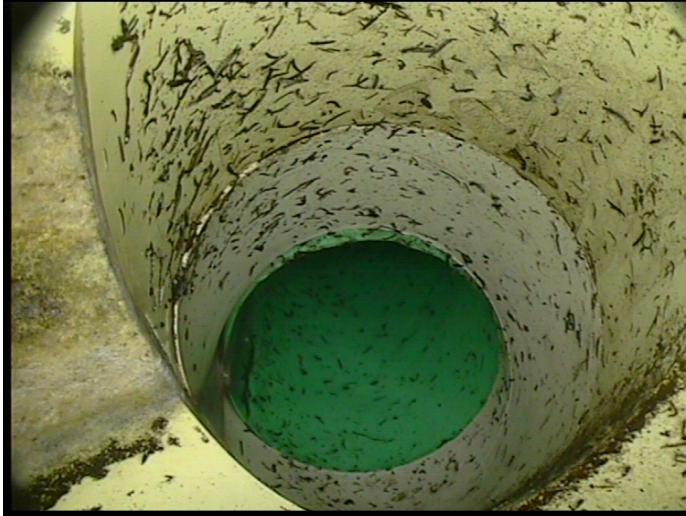
Code:	<b>TF</b>
Description:	<b>Tap Factory</b>
Distance (ft):	<b>26.7</b>
Structural Grade:	<b>0</b>
O&M Grade:	<b>0</b>
Clock Start/From:	<b>3</b>
Clock To:	
1st Value:	<b>4.000</b>
2nd Value:	
Value Percent:	
Continuous Index:	
Within 8" of Joint:	<b>NO</b>
Remarks:

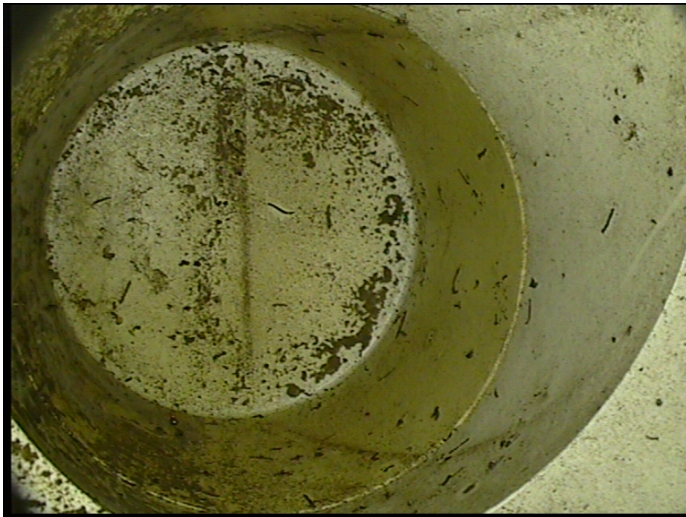
Code: **TF**  
Description: **Tap Factory**

Distance (ft): **39.3**  
Structural Grade: **0**  
O&M Grade: **0**  
Clock Start/From: **10**  
Clock To:  
1st Value: **4.000**  
2nd Value:  
Value Percent:  
Continuous Index:  
Within 8" of Joint: **NO**  
Remarks:

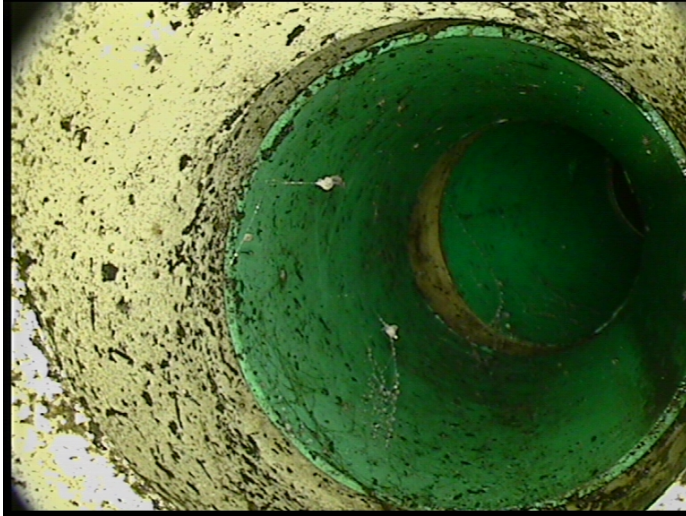
Code: **TFC**  
Description: **Tap Factory Capped**

Distance (ft): **105.7**  
Structural Grade: **0**  
O&M Grade: **0**  
Clock Start/From: **10**  
Clock To:  
1st Value: **4.000**  
2nd Value:  
Value Percent:  
Continuous Index:  
Within 8" of Joint: **NO**  
Remarks:

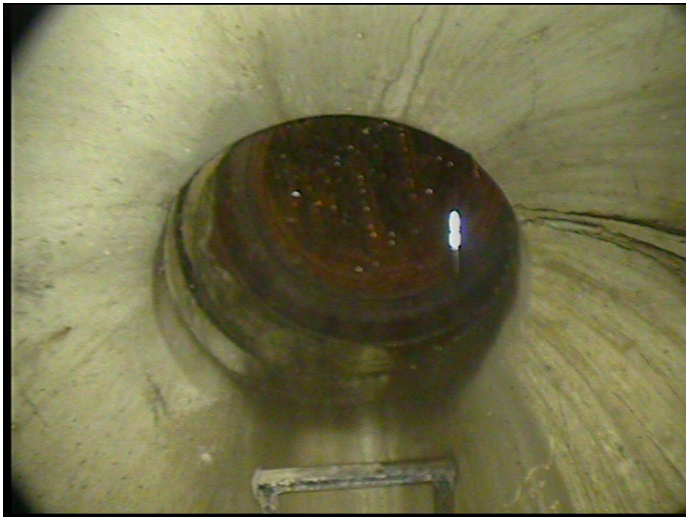
Code: **TF**  
Description: **Tap Factory**

Distance (ft): **154.5**  
Structural Grade: **0**  
O&M Grade: **0**  
Clock Start/From: **3**  
Clock To:  
1st Value: **4.000**  
2nd Value:  
Value Percent:  
Continuous Index:  
Within 8" of Joint: **NO**  
Remarks:
