Profile/Photo Observation Report

Street:	Off Old Ridge Road	Flow Control:	
City:	Hobart, IN	Year Renewed:	
Location:	Easement/Right of Way	Tape/Media #:	846
Purpose:	Routine Assessment	Dia/Height:	36"
Use:	Sanitary	Material:	RCP
Drain Area:		Lining:	
Category:	NA		
Comment:

Location Details:		Direction of Survey:	Downstream
US MH:	M-705-63.3	DS MH:	M-705-74
		Total Length Surveyed (ft):	7.5

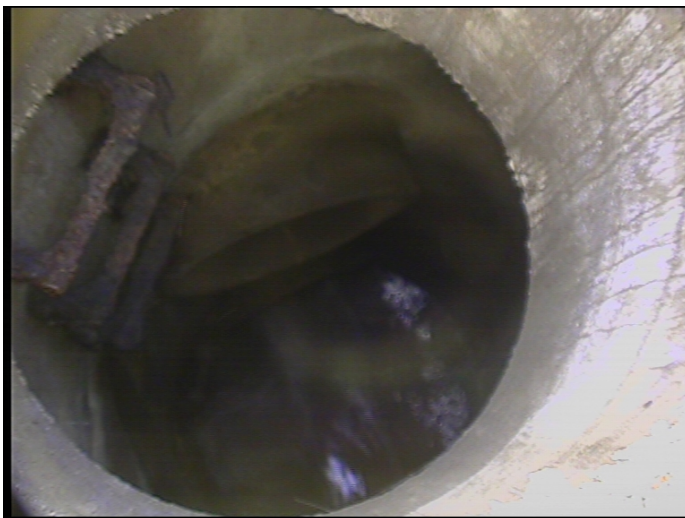
Code:	AMH
Description:	Manhole
Distance (ft):	.0
Structural Grade:	0
O&M Grade:	0
Clock Start/From:	
Clock To:	
1st Value:	
2nd Value:	
Value Percent:	
Continuous Index:	
Within 8" of Joint:	NO
Remarks:	M-705-63.3

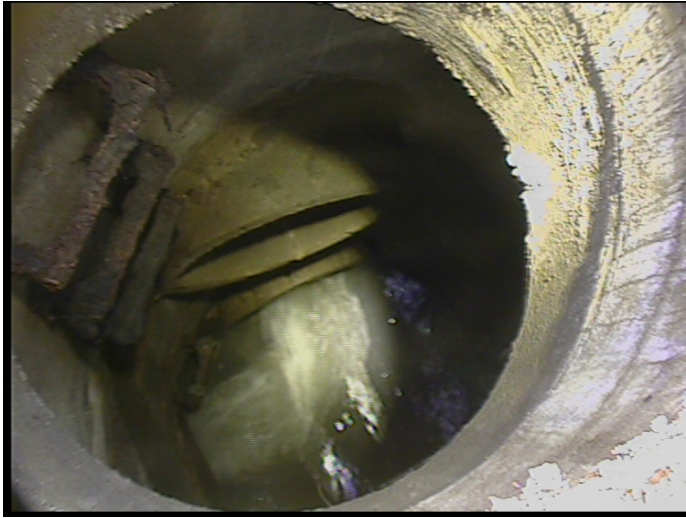
Code:	MWL
Description:	Water Level
Distance (ft):	.0
Structural Grade:	0
O&M Grade:	0
Clock Start/From:	
Clock To:	
1st Value:	
2nd Value:	
Value Percent:	10.000
Continuous Index:	
Within 8" of Joint:	NO
Remarks:

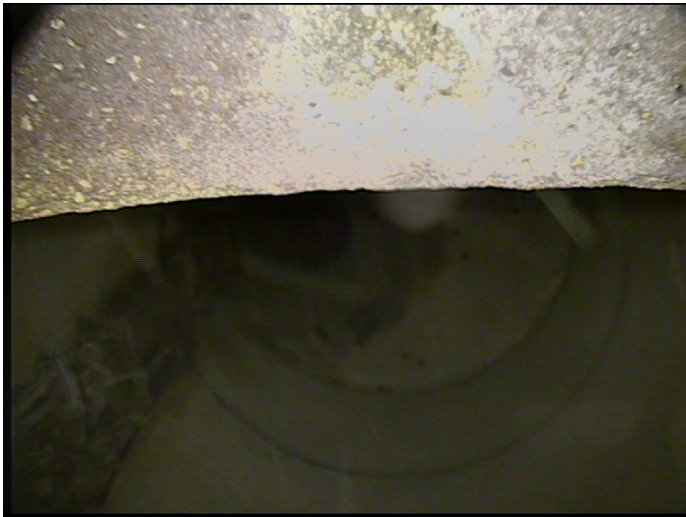
Code:	AMH
Description:	Manhole
Distance (ft):	7.5
Structural Grade:	0
O&M Grade:	0
Clock Start/From:	
Clock To:	
1st Value:	
2nd Value:	
Value Percent:	
Continuous Index:	
Within 8" of Joint:	NO
Remarks:	M-705-74
