## Profile/Photo Observation Report

Street:	<b>Off Center Street</b>	Flow Control:	<b>Not Controlled</b>
City:	<b>Hobart, IN</b>	Year Renewed:	
Location:	<b>Light Highway</b>	Tape/Media #:	<b>DEP 149</b>
Purpose:	<b>Routine Assessment</b>	Dia/Height:	<b>18"</b>
Use:	<b>Sanitary</b>	Material:	<b>CP</b>
Drain Area:		Lining:	
Category:	<b>NA</b>		
Comment:	<b>5-21-2018</b>		
Location Details:		Direction of Survey:	<b>Downstream</b>
US MH:	<b>M-705-069</b>	DS MH:	<b>M-705-070</b>
		Total Length Surveyed (ft):	<b>75.9</b>

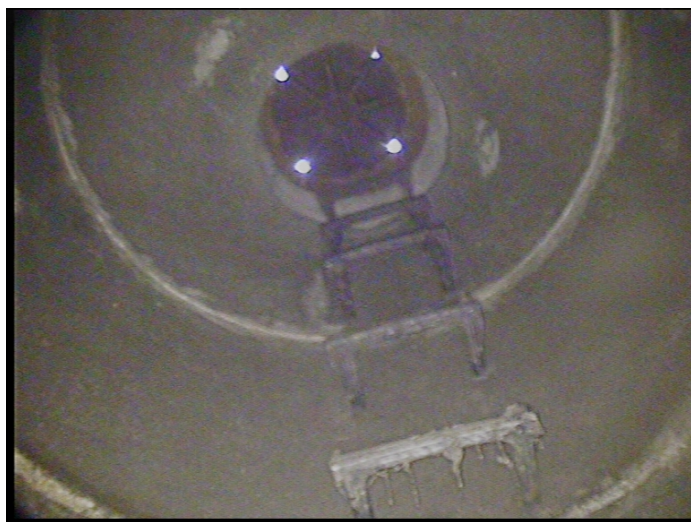
Code: **AMH**  
Description: **Manhole**

Distance (ft): **.0**  
Structural Grade: **0**  
O&M Grade: **0**  
Clock Start/From:  
Clock To:  
1st Value:  
2nd Value:  
Value Percent:  
Continuous Index:  
Within 8" of Joint: **NO**  
Remarks: **M-705-069**

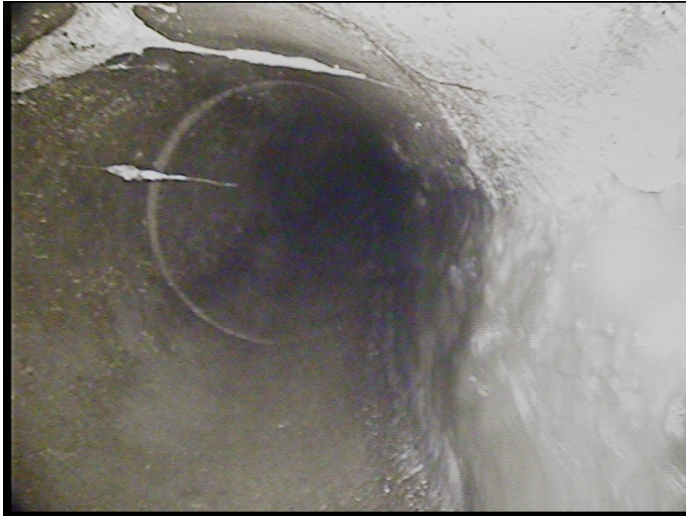
Code:	<b>MWL</b>
Description:	<b>Water Level</b>
Distance (ft):	<b>.0</b>
Structural Grade:	<b>0</b>
O&M Grade:	<b>0</b>
Clock Start/From:	
Clock To:	
1st Value:	
2nd Value:	
Value Percent:	<b>10.000</b>
Continuous Index:	
Within 8" of Joint:	<b>NO</b>
Remarks:

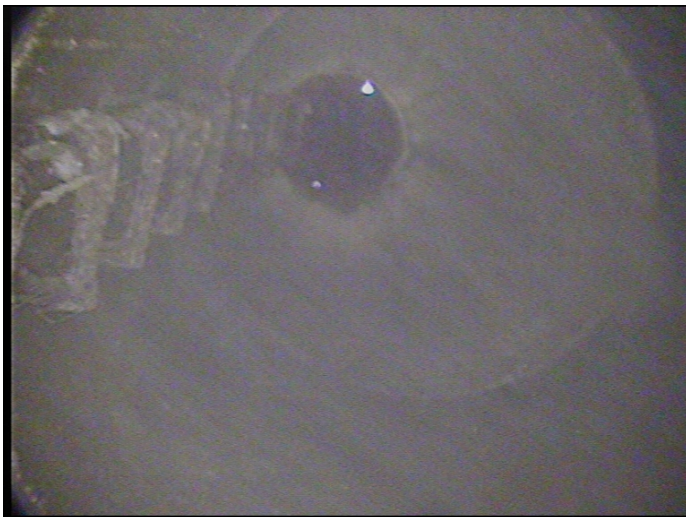
Code:	<b>AMH</b>
Description:	<b>Manhole</b>
Distance (ft):	<b>75.9</b>
Structural Grade:	<b>0</b>
O&M Grade:	<b>0</b>
Clock Start/From:	
Clock To:	
1st Value:	
2nd Value:	
Value Percent:	
Continuous Index:	
Within 8" of Joint:	<b>NO</b>
Remarks:	<b>M-705-070</b>
