## Profile/Photo Observation Report

| Street: | <b>Capitol</b> | Flow Control: | <b>Not Controlled</b> |
| City: | <b>Hobart, IN</b> | Year Renewed: | |

| US MH: | <b>M-705-079</b> | DS MH: | <b>M-705-045</b> |

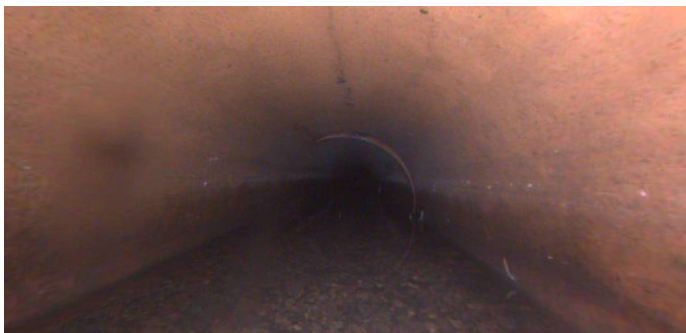
Code: **AMH**  
Description: **Manhole**

Distance (ft): **.0**  
Structural Grade: **0**  
O&M Grade: **0**  
Clock Start/From:  
Clock To:  
1st Value:  
2nd Value:  
Value Percent:  
Continuous Index:  
Within 8" of Joint: **NO**  
Remarks: **M-705-045**

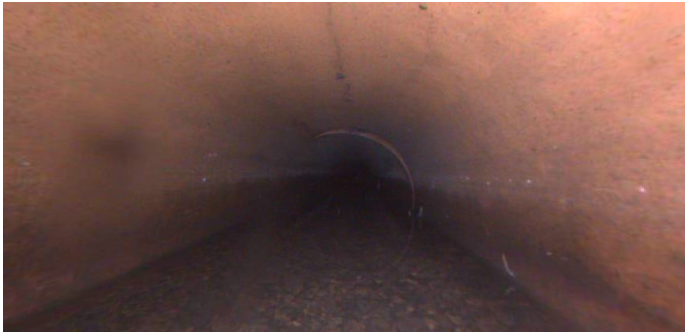
| Code: | <b>MWL</b> |

| Description: | <b>Water Level</b> |

| Value Percent: | <b>30.000</b> |

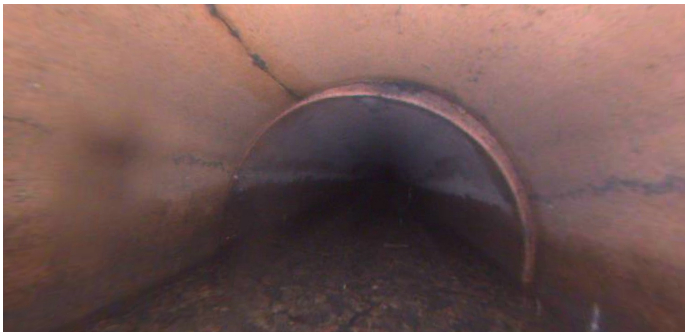
| Code: | <b>FL</b> |

| Description: | <b>Fracture Longitudinal</b> |

| Distance (ft): | <b>2.2</b> |
| Structural Grade: | <b>3</b> |
| Clock Start/From: | <b>11</b> |
| Within 8" of Joint: | <b>YES</b> |

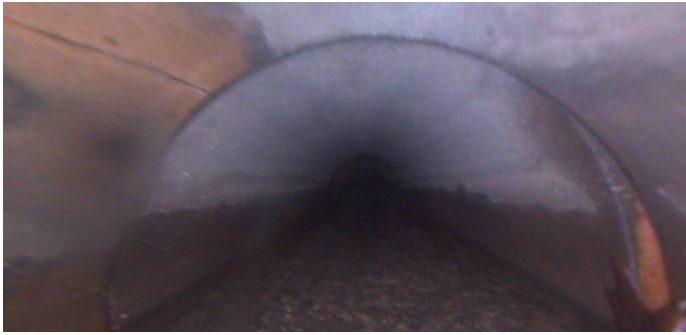
Code: **FL**  
Description: **Fracture Longitudinal**

Distance (ft): **6.5**  
Structural Grade: **3**  
O&M Grade: **0**  
Clock Start/From: **11**  
Clock To:  
1st Value:  
2nd Value:  
Value Percent:  
Continuous Index:  
Within 8" of Joint: **YES**  
Remarks:

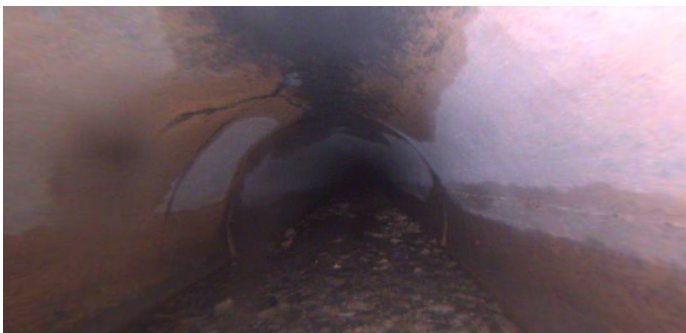
Code: **FM**  
Description: **Fracture Multiple**

Distance (ft): **9.7**  
Structural Grade: **4**  
O&M Grade: **0**  
Clock Start/From: **8**  
Clock To: **12**  
1st Value:  
2nd Value:  
Value Percent:  
Continuous Index:  
Within 8" of Joint: **YES**  
Remarks:

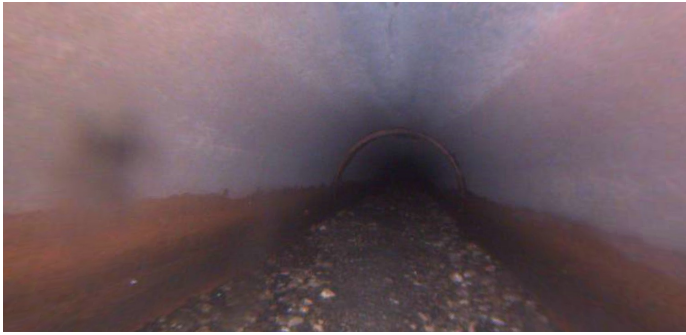
Code: **DSGV**  
Description: **Deposits Settled Gravel**

Distance (ft): **12.8**  
Structural Grade: **0**  
O&M Grade: **5**  
Clock Start/From: **3**  
Clock To: **9**  
1st Value:  
2nd Value:  
Value Percent: **40.000**  
Continuous Index: **S01**  
Within 8" of Joint: **NO**  
Remarks:

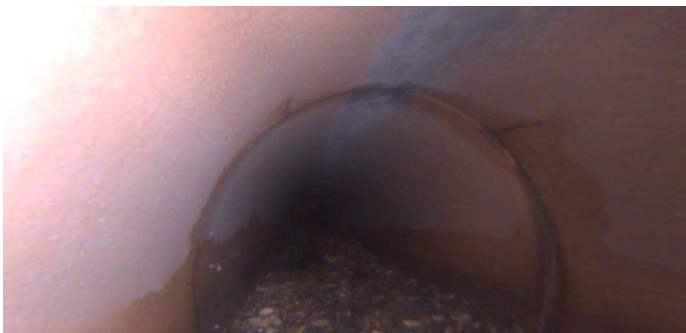
Code: **FM**  
Description: **Fracture Multiple**

Distance (ft): **18.3**  
Structural Grade: **4**  
O&M Grade: **0**  
Clock Start/From: **10**  
Clock To: **2**  
1st Value:  
2nd Value:  
Value Percent:  
Continuous Index:  
Within 8" of Joint: **YES**  
Remarks:

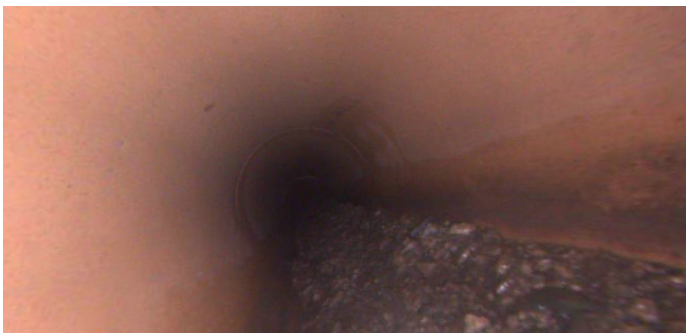
Code: **MSA**  
Description: **Abandoned Survey**

Distance (ft): **25.0**  
Structural Grade: **0**  
O&M Grade: **0**  
Clock Start/From:  
Clock To:  
1st Value:  
2nd Value:  
Value Percent:  
Continuous Index:  
Within 8" of Joint: **NO**  
Remarks: **overturned**
