Profile/Photo Observation Report

Street:	E 4TH ST & EAST ST	Flow Control:	Not Controlled
City:	Hobart, IN	Year Renewed:	
Location:	Light Highway	Tape/Media #:	
Purpose:	Maintenance Related	Dia/Height:	8"
Use:	Sanitary	Material:	VCP
Drain Area:	NA	Lining:	Cured in Place
Category:	NA		
Comment:	Reverse setup. mh confirmed at 179'.		
Location Details:		Direction of Survey:	Downstream
US MH:	M-705-079	DS MH:	M-705-045
		Total Length Surveyed (ft):	180.1

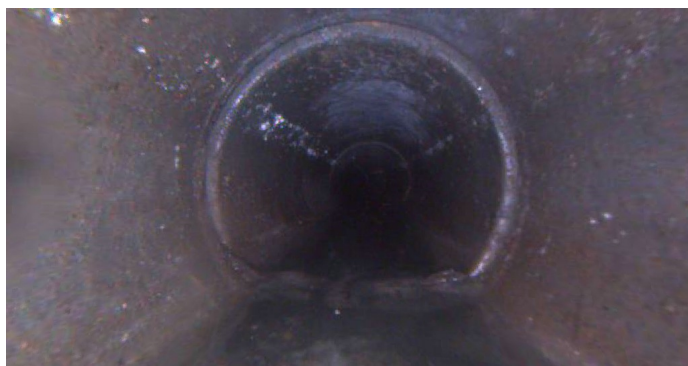
Code: **AMH**
 Description: **Manhole**

Distance (ft): **.0**
 Structural Grade: **0**
 O&M Grade: **0**
 Clock Start/From:
 Clock To:
 1st Value:
 2nd Value:
 Value Percent:
 Continuous Index:
 Within 8" of Joint: **NO**
 Remarks: **M-705-079**

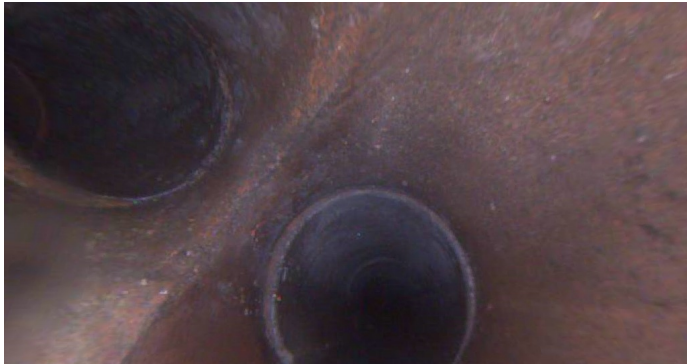
Code: **TF**
Description: **Tap Factory**

Distance (ft): **10.8**
Structural Grade: **0**
O&M Grade: **0**
Clock Start/From: **10**
Clock To:
1st Value: **4.000**
2nd Value:
Value Percent:
Continuous Index:
Within 8" of Joint:
Remarks:

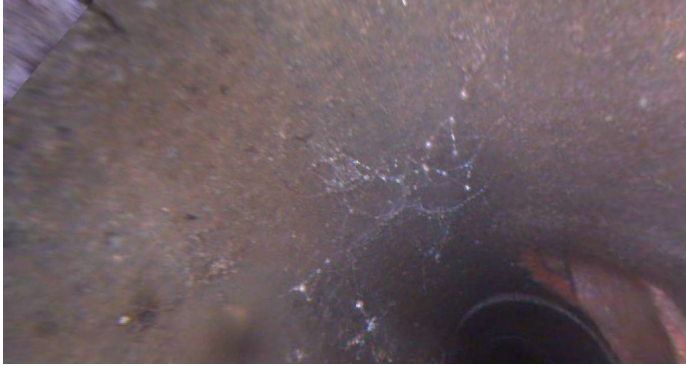
Code: **FL**
Description: **Fracture Longitudinal**

Distance (ft): **35.0**
Structural Grade: **3**
O&M Grade: **0**
Clock Start/From: **10**
Clock To:
1st Value:
2nd Value:
Value Percent:
Continuous Index:
Within 8" of Joint: **YES**
Remarks:

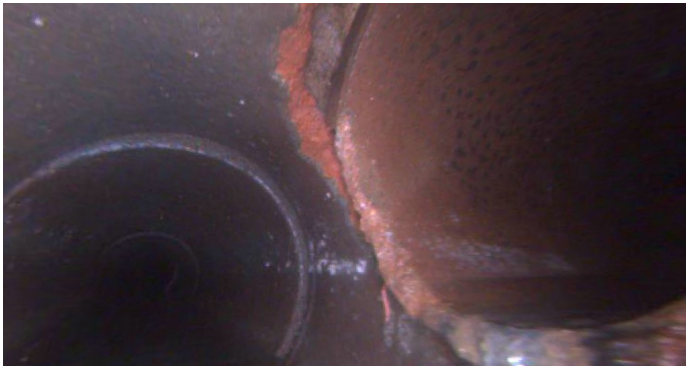
Code: **TB**
Description: **Tap Break-in**

Distance (ft): **36.0**
Structural Grade: **0**
O&M Grade: **0**
Clock Start/From: **4**
Clock To:
1st Value: **4.000**
2nd Value:
Value Percent:
Continuous Index:
Within 8" of Joint:
Remarks:

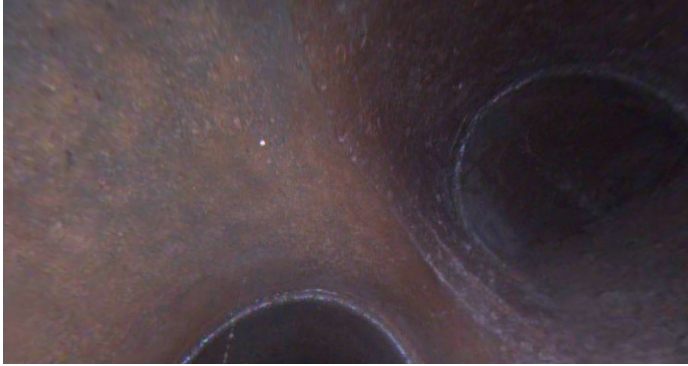
Code: **TF**
Description: **Tap Factory**

Distance (ft): **46.2**
Structural Grade: **0**
O&M Grade: **0**
Clock Start/From: **2**
Clock To:
1st Value: **4.000**
2nd Value:
Value Percent:
Continuous Index:
Within 8" of Joint:
Remarks:

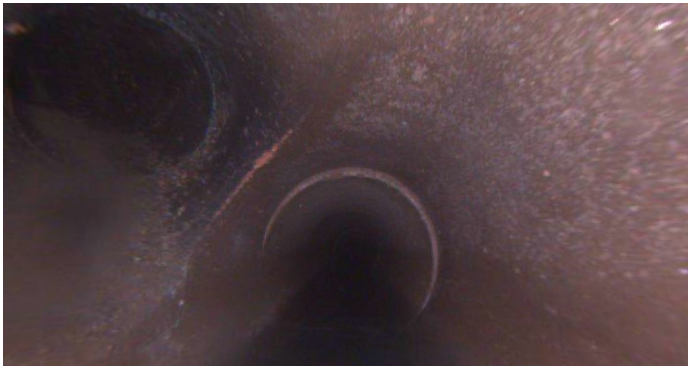
Code: **TF**
Description: **Tap Factory**

Distance (ft): **54.1**
Structural Grade: **0**
O&M Grade: **0**
Clock Start/From: **10**
Clock To:
1st Value: **4.000**
2nd Value:
Value Percent:
Continuous Index:
Within 8" of Joint:
Remarks:

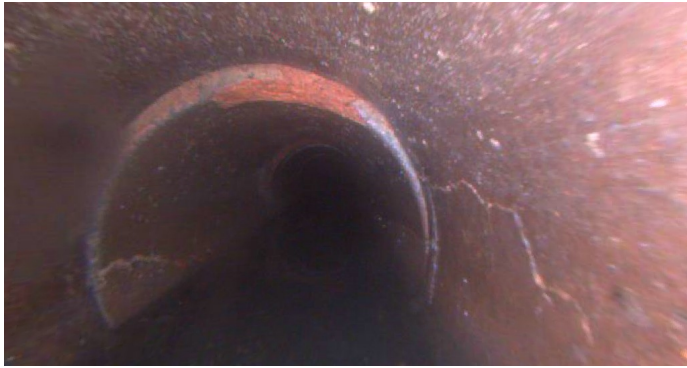
Code: **CM**
Description: **Crack Multiple**

Distance (ft): **69.2**
Structural Grade: **3**
O&M Grade: **0**
Clock Start/From: **8**
Clock To: **5**
1st Value:
2nd Value:
Value Percent:
Continuous Index:
Within 8" of Joint: **YES**
Remarks:

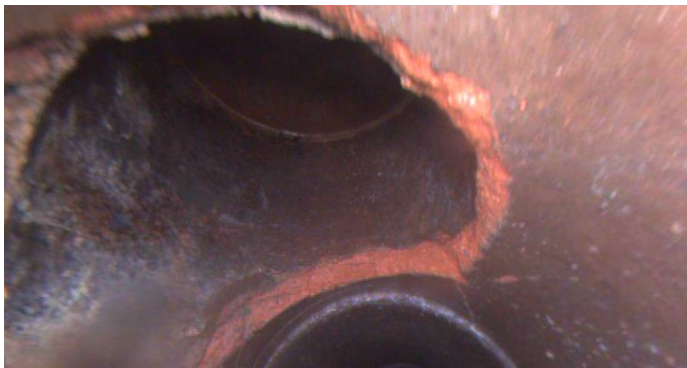
Code: **TB**
Description: **Tap Break-in**

Distance (ft): **71.0**
Structural Grade: **0**
O&M Grade: **0**
Clock Start/From: **11**
Clock To:
1st Value: **4.000**
2nd Value:
Value Percent:
Continuous Index:
Within 8" of Joint:
Remarks:

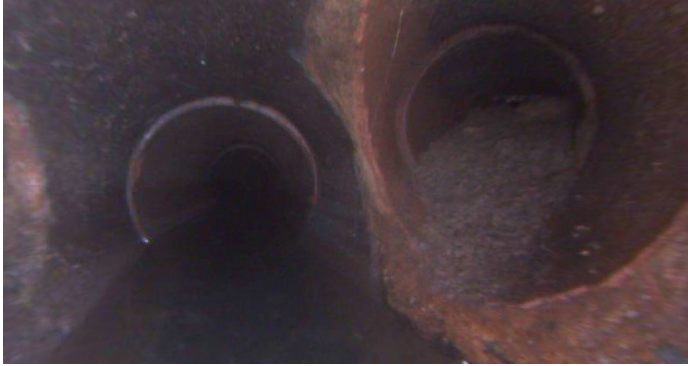
Code: **TB**
Description: **Tap Break-in**

Distance (ft): **76.8**
Structural Grade: **0**
O&M Grade: **0**
Clock Start/From: **3**
Clock To:
1st Value: **4.000**
2nd Value:
Value Percent:
Continuous Index:
Within 8" of Joint:
Remarks:

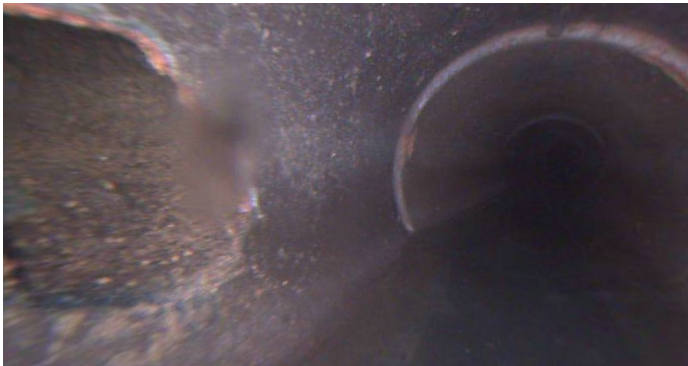
Code: **H**
Description: **Hole**

Distance (ft): **77.3**
Structural Grade: **3**
O&M Grade: **0**
Clock Start/From: **8**
Clock To:
1st Value:
2nd Value:
Value Percent:
Continuous Index:
Within 8" of Joint:
Remarks:

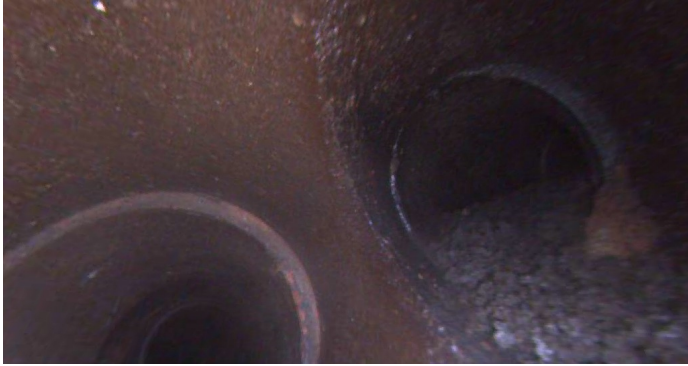
Code: **TF**
Description: **Tap Factory**

Distance (ft): **81.4**
Structural Grade: **0**
O&M Grade: **0**
Clock Start/From: **2**
Clock To:
1st Value: **4.000**
2nd Value:
Value Percent:
Continuous Index:
Within 8" of Joint:
Remarks:

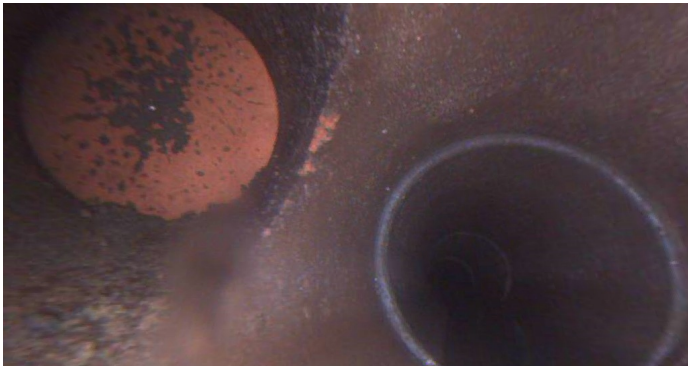
Code: **TFC**
Description: **Tap Factory Capped**

Distance (ft): **83.3**
Structural Grade: **0**
O&M Grade: **0**
Clock Start/From: **10**
Clock To:
1st Value: **4.000**
2nd Value:
Value Percent:
Continuous Index:
Within 8" of Joint:
Remarks:

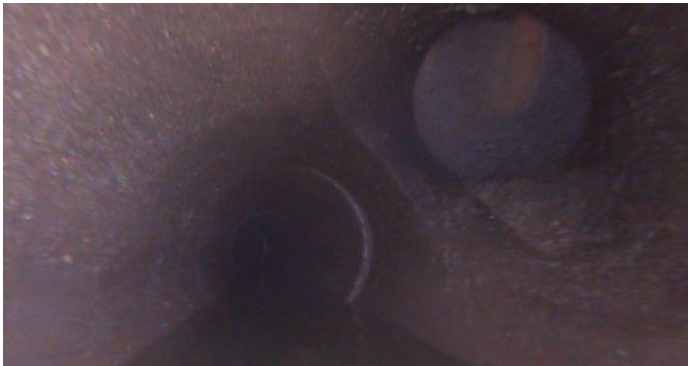
Code: **TFC**
Description: **Tap Factory Capped**

Distance (ft): **133.9**
Structural Grade: **0**
O&M Grade: **0**
Clock Start/From: **2**
Clock To:
1st Value: **4.000**
2nd Value:
Value Percent:
Continuous Index:
Within 8" of Joint:
Remarks:

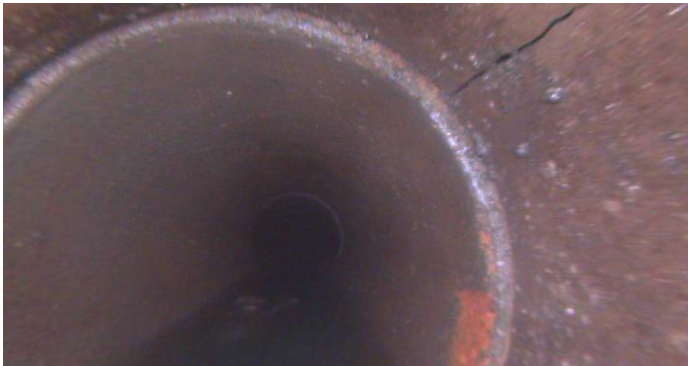
Code: **FL**
Description: **Fracture Longitudinal**

Distance (ft): **153.3**
Structural Grade: **3**
O&M Grade: **0**
Clock Start/From: **2**
Clock To:
1st Value:
2nd Value:
Value Percent:
Continuous Index:
Within 8" of Joint: **YES**
Remarks:

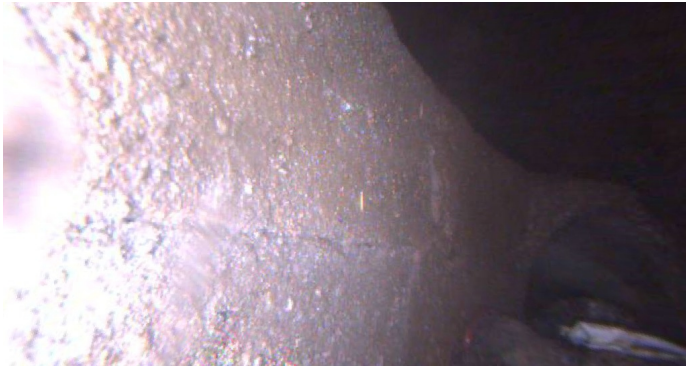
Code:	AMH
Description:	Manhole
Distance (ft):	180.1
Structural Grade:	0
O&M Grade:	0
Clock Start/From:	
Clock To:	
1st Value:	
2nd Value:	
Value Percent:	
Continuous Index:	
Within 8" of Joint:	NO
Remarks:	M-705-045
