## Profile/Photo Observation Report

Street:	<b>Capitol</b>	Flow Control:	<b>Not Controlled</b>
City:	<b>Hobart, IN</b>	Year Renewed:	
Location:	<b>Light Highway</b>	Tape/Media #:	
Purpose:	<b>Maintenance Related</b>	Dia/Height:	<b>8"</b>
Use:	<b>Sanitary</b>	Material:	<b>VCP</b>
Drain Area:	<b>NA</b>	Lining:	<b>Cured in Place</b>
Category:	<b>NA</b>		
Comment:	<b>mh</b>

Location Details:		Direction of Survey:	<b>Downstream</b>
US MH:	<b>M-705-085</b>	DS MH:	<b>M-705-049</b>
		Total Length Surveyed (ft):	<b>162.7</b>

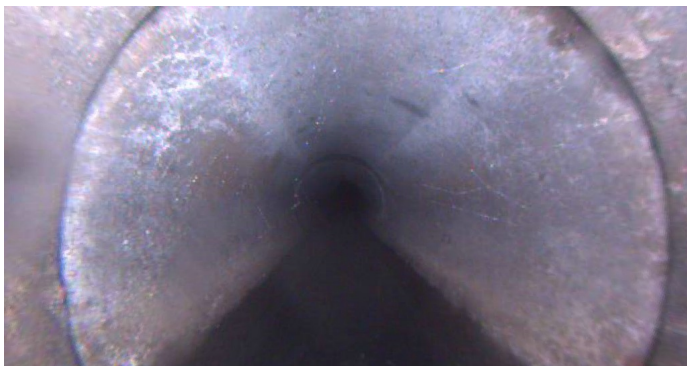
Code: **AMH**  
 Description: **Manhole**

Distance (ft): **.0**  
 Structural Grade: **0**  
 O&M Grade: **0**  
 Clock Start/From:  
 Clock To:  
 1st Value:  
 2nd Value:  
 Value Percent:  
 Continuous Index:  
 Within 8" of Joint: **NO**  
 Remarks: **M-705-085**

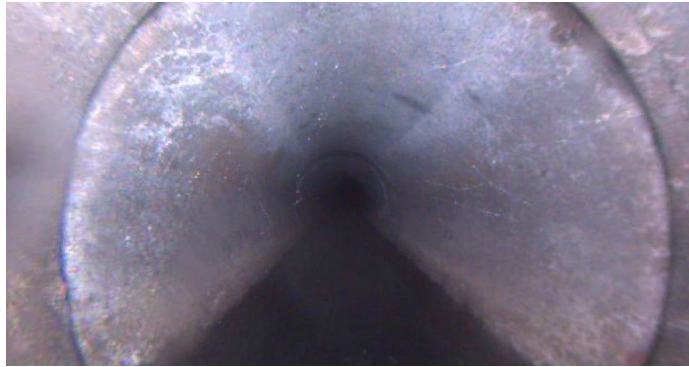
Code: **MWL**  
Description: **Water Level**

Distance (ft): **.0**  
Structural Grade: **0**  
O&M Grade: **0**  
Clock Start/From:  
Clock To:  
1st Value:  
2nd Value:  
Value Percent: **10.000**  
Continuous Index:  
Within 8" of Joint: **NO**  
Remarks:

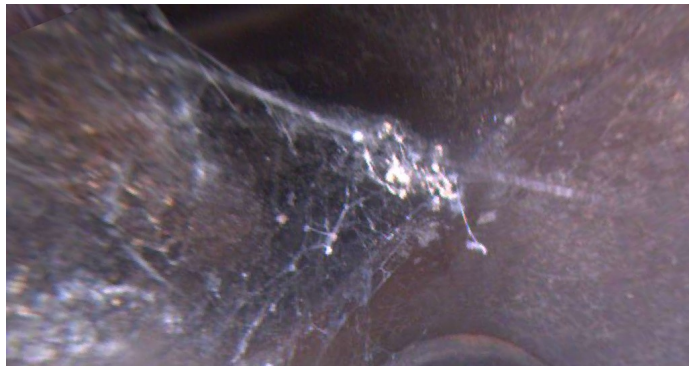
Code: **TFD**  
Description: **Tap Factory Defective**

Distance (ft): **18.8**  
Structural Grade: **0**  
O&M Grade: **2**  
Clock Start/From: **10**  
Clock To:  
1st Value: **4.000**  
2nd Value:  
Value Percent:  
Continuous Index:  
Within 8" of Joint:  
Remarks: **Debris**

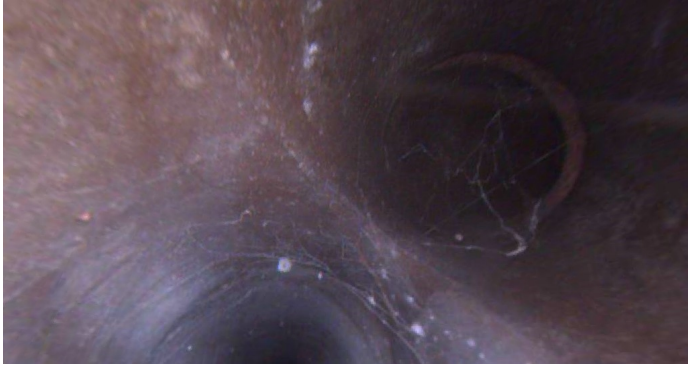
Code: **TF**  
Description: **Tap Factory**

Distance (ft): **20.8**  
Structural Grade: **0**  
O&M Grade: **0**  
Clock Start/From: **2**  
Clock To:  
1st Value: **4.000**  
2nd Value:  
Value Percent:  
Continuous Index:  
Within 8" of Joint:  
Remarks:

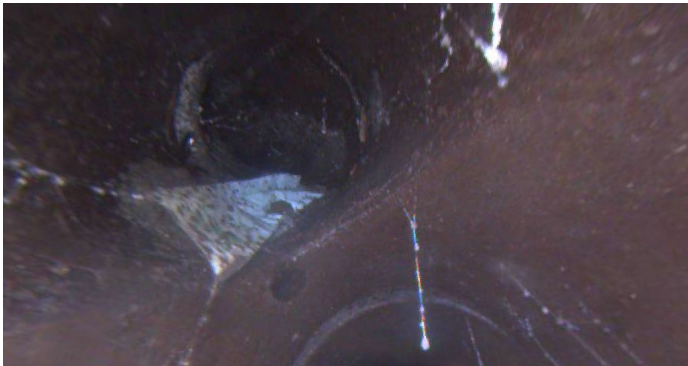
Code: **TF**  
Description: **Tap Factory**

Distance (ft): **47.7**  
Structural Grade: **0**  
O&M Grade: **0**  
Clock Start/From: **10**  
Clock To:  
1st Value: **4.000**  
2nd Value:  
Value Percent:  
Continuous Index:  
Within 8" of Joint:  
Remarks:

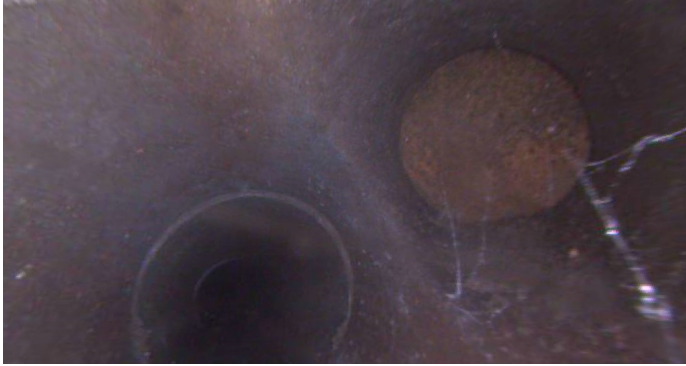
Code: **TFC**  
Description: **Tap Factory Capped**

Distance (ft): **49.6**  
Structural Grade: **0**  
O&M Grade: **0**  
Clock Start/From: **2**  
Clock To:  
1st Value: **4.000**  
2nd Value:  
Value Percent:  
Continuous Index:  
Within 8" of Joint:  
Remarks:

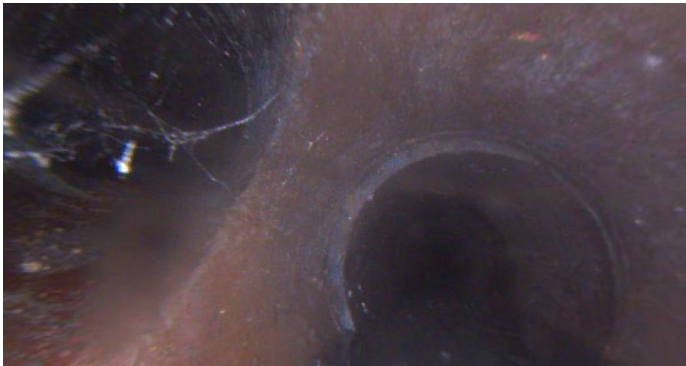
Code: **TF**  
Description: **Tap Factory**

Distance (ft): **83.0**  
Structural Grade: **0**  
O&M Grade: **0**  
Clock Start/From: **10**  
Clock To:  
1st Value: **4.000**  
2nd Value:  
Value Percent:  
Continuous Index:  
Within 8" of Joint:  
Remarks:

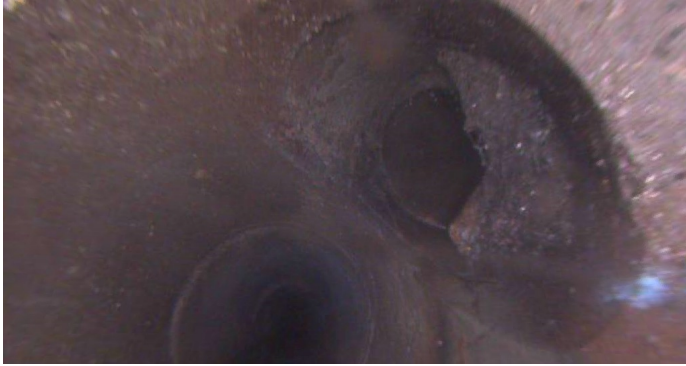
Code: **TF**  
Description: **Tap Factory**

Distance (ft): **84.7**  
Structural Grade: **0**  
O&M Grade: **0**  
Clock Start/From: **2**  
Clock To:  
1st Value: **4.000**  
2nd Value:  
Value Percent:  
Continuous Index:  
Within 8" of Joint:  
Remarks:

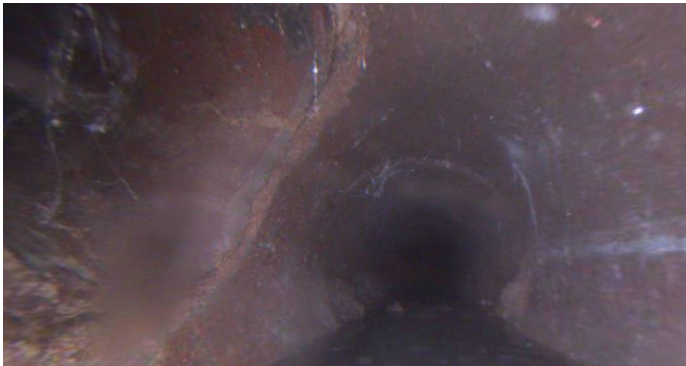
Code: **TF**  
Description: **Tap Factory**

Distance (ft): **88.9**  
Structural Grade: **0**  
O&M Grade: **0**  
Clock Start/From: **10**  
Clock To:  
1st Value: **4.000**  
2nd Value:  
Value Percent:  
Continuous Index:  
Within 8" of Joint:  
Remarks:

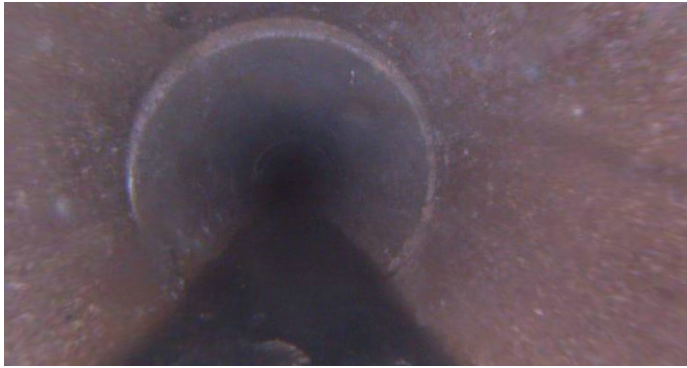
Code:	<b>DAE</b>
Description:	<b>Deposits Attached Encrustation</b>
Distance (ft):	<b>93.5</b>
Structural Grade:	<b>0</b>
O&M Grade:	<b>2</b>
Clock Start/From:	<b>7</b>
Clock To:	<b>5</b>
1st Value:	
2nd Value:	
Value Percent:	<b>5.000</b>
Continuous Index:	<b>S01</b>
Within 8" of Joint:	<b>YES</b>
Remarks:

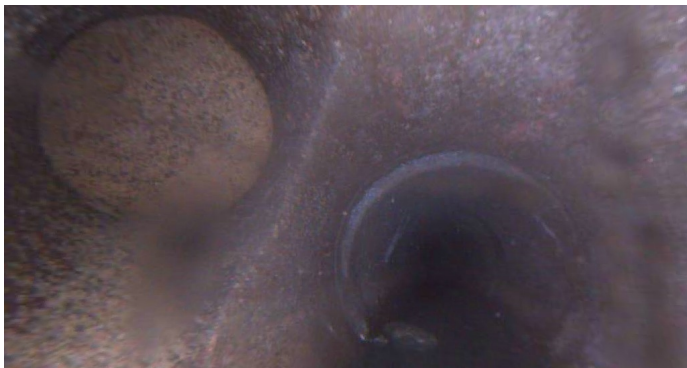
Code:	<b>TFC</b>
Description:	<b>Tap Factory Capped</b>
Distance (ft):	<b>109.6</b>
Structural Grade:	<b>0</b>
O&M Grade:	<b>0</b>
Clock Start/From:	<b>10</b>
Clock To:	
1st Value:	<b>4.000</b>
2nd Value:	
Value Percent:	
Continuous Index:	
Within 8" of Joint:	
Remarks:

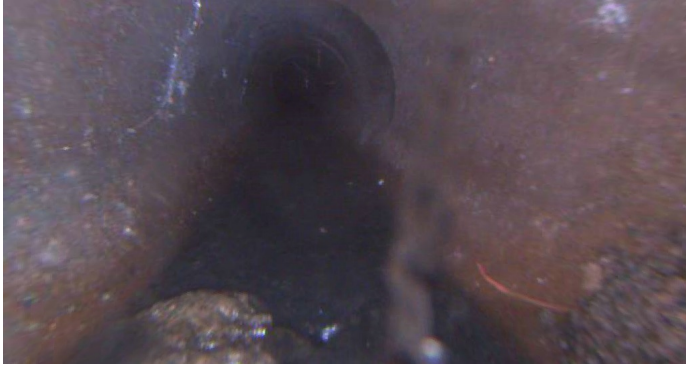
Code: **DAE**  
Description: **Deposits Attached Encrustation**

Distance (ft): **110.4**  
Structural Grade: **0**  
O&M Grade: **2**  
Clock Start/From: **7**  
Clock To: **5**  
1st Value:  
2nd Value:  
Value Percent: **5.000**  
Continuous Index: **F01**  
Within 8" of Joint: **YES**  
Remarks:

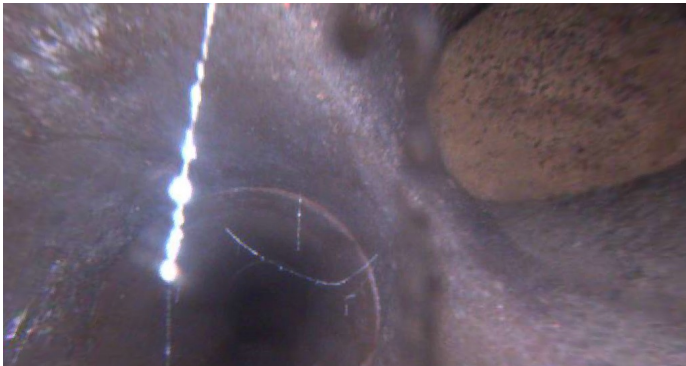
Code: **TFC**  
Description: **Tap Factory Capped**

Distance (ft): **111.7**  
Structural Grade: **0**  
O&M Grade: **0**  
Clock Start/From: **2**  
Clock To:  
1st Value: **4.000**  
2nd Value:  
Value Percent:  
Continuous Index:  
Within 8" of Joint:  
Remarks:

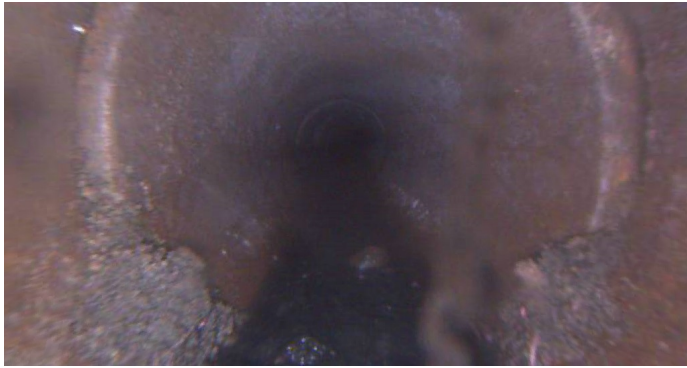
Code: **DAZ**  
Description: **Deposits Attached Other**

Distance (ft): **118.6**  
Structural Grade: **0**  
O&M Grade: **2**  
Clock Start/From: **7**  
Clock To: **5**  
1st Value:  
2nd Value:  
Value Percent: **5.000**  
Continuous Index: **S02**  
Within 8" of Joint: **YES**  
Remarks:

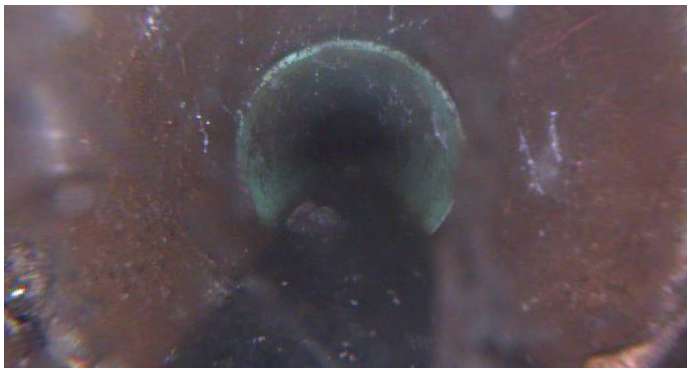
Code: **DAZ**  
Description: **Deposits Attached Other**

Distance (ft): **158.7**  
Structural Grade: **0**  
O&M Grade: **2**  
Clock Start/From: **7**  
Clock To: **5**  
1st Value:  
2nd Value:  
Value Percent: **5.000**  
Continuous Index: **F02**  
Within 8" of Joint: **YES**  
Remarks:

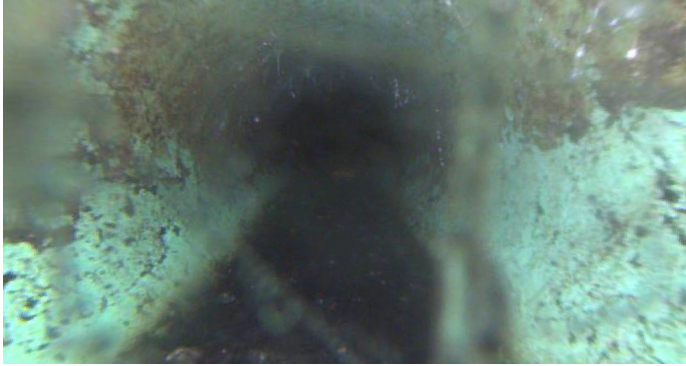
Code: **MMC**  
Description: **Material Change**

Distance (ft): **159.8**  
Structural Grade: **0**  
O&M Grade: **0**  
Clock Start/From:  
Clock To:  
1st Value:  
2nd Value:  
Value Percent:  
Continuous Index:  
Within 8" of Joint: **NO**  
Remarks: **PVC**

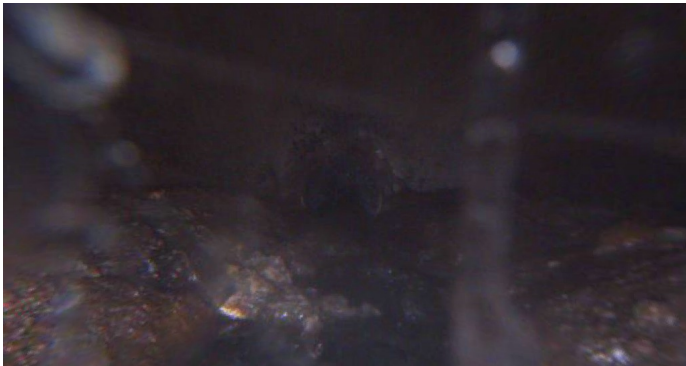
Code: **AMH**  
Description: **Manhole**

Distance (ft): **162.7**  
Structural Grade: **0**  
O&M Grade: **0**  
Clock Start/From:  
Clock To:  
1st Value:  
2nd Value:  
Value Percent:  
Continuous Index:  
Within 8" of Joint: **NO**  
Remarks: **M-705-049**
