Profile/Photo Observation Report

Date:	04/29/2018	Weather:		Coding:	PACP 6.0
Pipe Length (ft):		Owner:	City of Hobart	Pre Clean:	Not Known
P.O.#:	261	Surveyor:	B. Helbling	PSR:	P-706-002-001
Customer:	City of Hobart	Clean Date:		Shape:	C

Street:	East 10th Street	Flow Control:	Not Controlled
City:	Hobart, IN	Year Renewed:	
Location:	Light Highway	Tape/Media #:	DEP261
Purpose:	Routine Assessment	Dia/Height:	18"
Use:	Sanitary	Material:	VCP
Drain Area:		Lining:	
Category:	NA		
Comment:	5-21-2018		
Location Details:		Direction of Survey:	Downstream
US MH:	M-706-001	DS MH:	M-706-002
		Total Length Surveyed (ft):	3.5

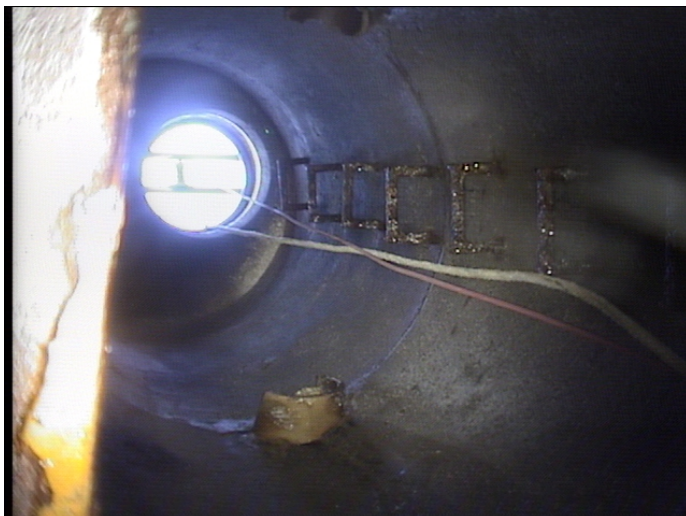
Code: **AMH**
Description: **Manhole**

Distance (ft): **.0**
Structural Grade: **0**
O&M Grade: **0**
Clock Start/From:
Clock To:
1st Value:
2nd Value:
Value Percent:
Continuous Index:
Within 8" of Joint: **NO**
Remarks: **M-706-002**

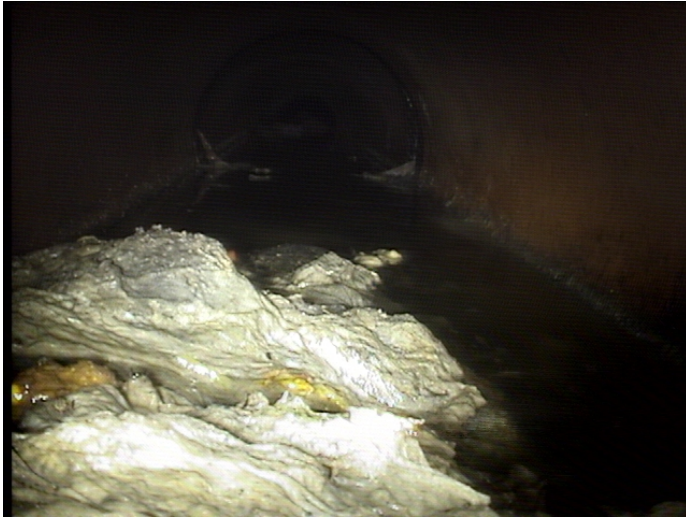
Code: **MWL**
Description: **Water Level**

Distance (ft): **.0**
Structural Grade: **0**
O&M Grade: **0**
Clock Start/From:
Clock To:
1st Value:
2nd Value:
Value Percent: **10.000**
Continuous Index:
Within 8" of Joint: **NO**
Remarks:

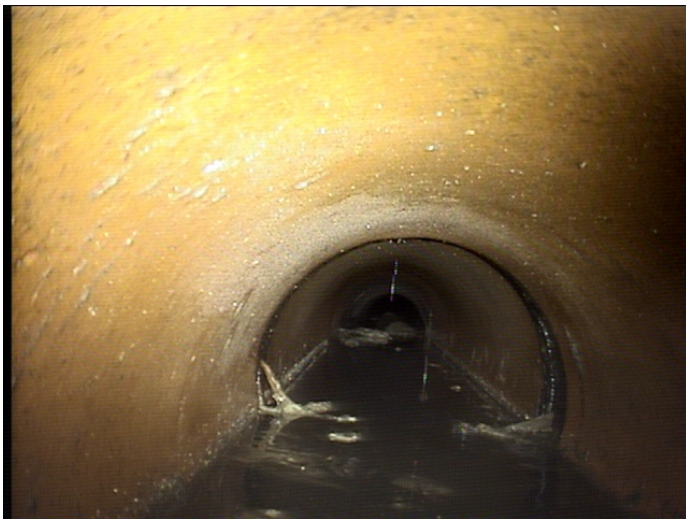
Code: **DSF**
Description: **Deposits Settled Fine**

Distance (ft): **.2**
Structural Grade: **0**
O&M Grade: **2**
Clock Start/From: **5**
Clock To: **8**
1st Value:
2nd Value:
Value Percent: **10.000**
Continuous Index:
Within 8" of Joint: **NO**
Remarks:

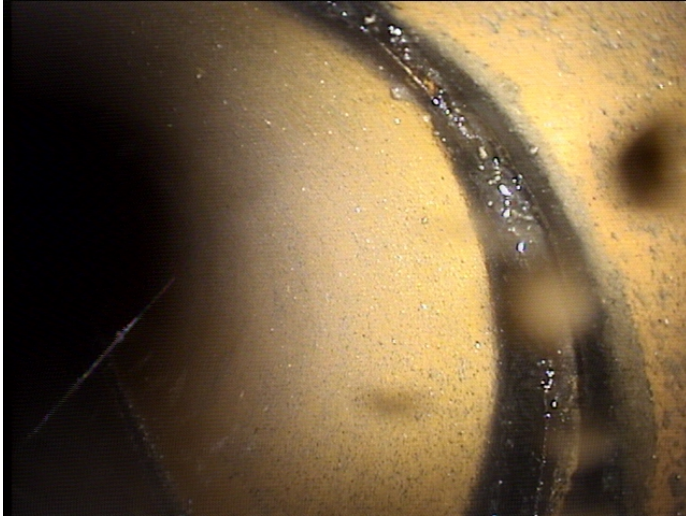
Code: **ID**
Description: **Infil Dripper**

Distance (ft): **1.1**
Structural Grade: **0**
O&M Grade: **3**
Clock Start/From: **11**
Clock To: **1**
1st Value:
2nd Value:
Value Percent:
Continuous Index:
Within 8" of Joint: **YES**
Remarks:

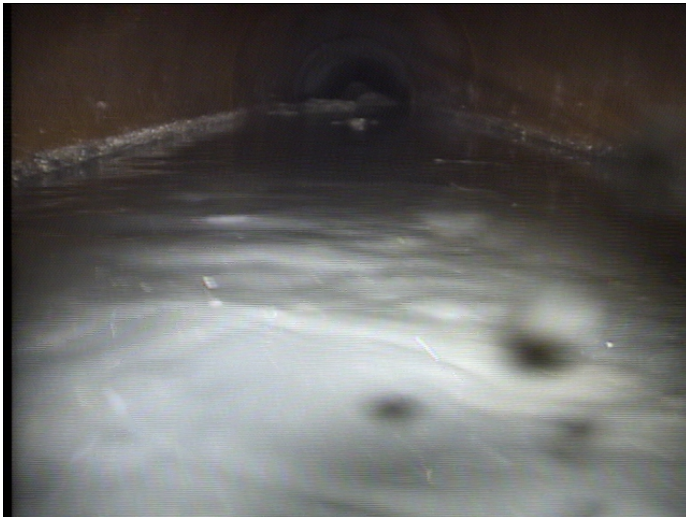
Code: **MSA**
Description: **Abandoned Survey**

Distance (ft): **3.5**
Structural Grade: **0**
O&M Grade: **0**
Clock Start/From:
Clock To:
1st Value:
2nd Value:
Value Percent:
Continuous Index:
Within 8" of Joint: **NO**
Remarks: **Sediment/debris**
