Profile/Photo Observation Report

Date:	04/14/2018	Weather:		Coding:	PACP 6.0
Pipe Length (ft):		Owner:	City of Hobart	Pre Clean:	Not Known
P.O.#:	252	Surveyor:	B. Helbling	PSR:	P-707-016-002
Customer:	City of Hobart	Clean Date:		Shape:	C

Street:	Garfield Street	Flow Control:	Not Controlled
City:	Hobart, IN	Year Renewed:	
Location:	Light Highway	Tape/Media #:	DEP252
Purpose:	Routine Assessment	Dia/Height:	12"
Use:	Sanitary	Material:	VCP
Drain Area:		Lining:	
Category:	NA		
Comment:	YES501824 Submittal 2		
Location Details:		Direction of Survey:	Downstream
US MH:	M-706-002	DS MH:	M-707-016
		Total Length Surveyed (ft):	218.5

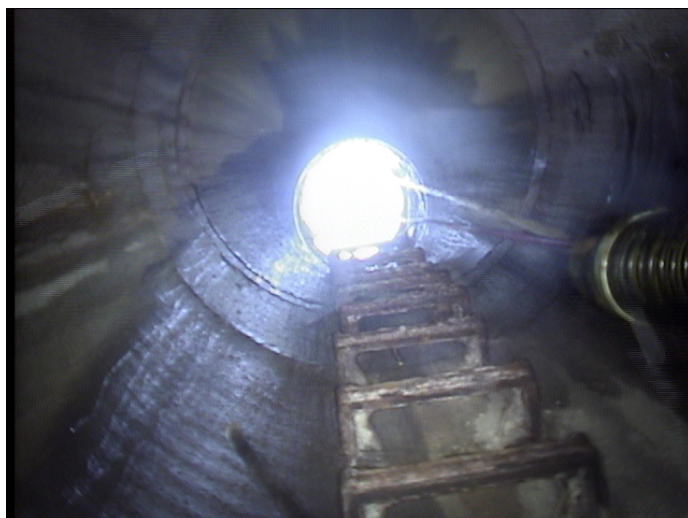
Code: **AMH**
Description: **Manhole**

Distance (ft): **.0**
Structural Grade: **0**
O&M Grade: **0**
Clock Start/From:
Clock To:
1st Value:
2nd Value:
Value Percent:
Continuous Index:
Within 8" of Joint: **NO**
Remarks: **M-707-016**

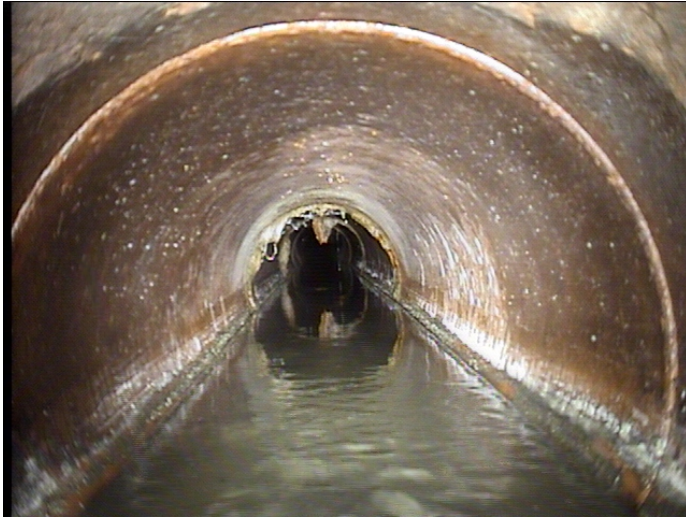
Code: **MWL**
Description: **Water Level**

Distance (ft): **.0**
Structural Grade: **0**
O&M Grade: **0**
Clock Start/From:
Clock To:
1st Value:
2nd Value:
Value Percent: **15.000**
Continuous Index:
Within 8" of Joint: **NO**
Remarks:

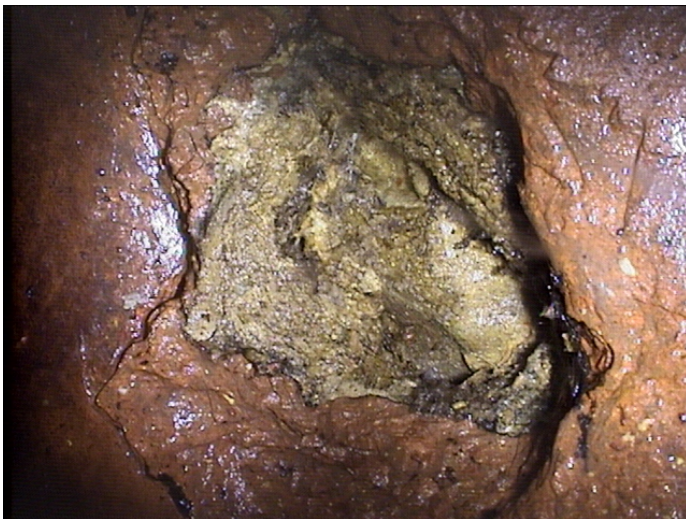
Code: **H**
Description: **Hole**

Distance (ft): **7.9**
Structural Grade: **3**
O&M Grade: **0**
Clock Start/From: **12**
Clock To:
1st Value:
2nd Value:
Value Percent:
Continuous Index:
Within 8" of Joint: **NO**
Remarks:

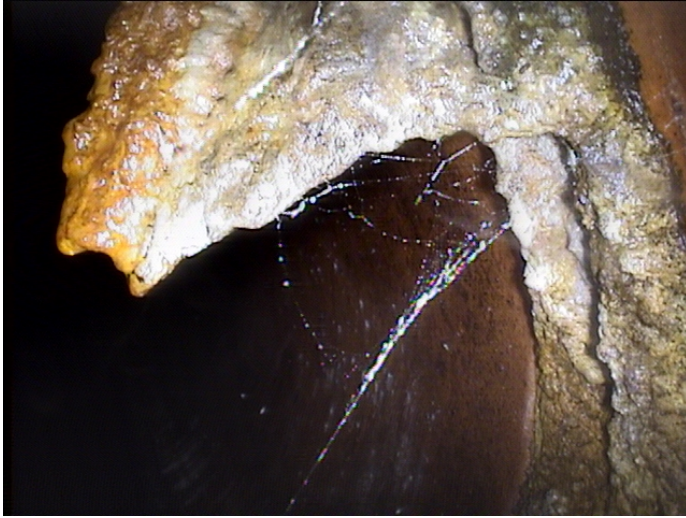
Code:	DAE
Description:	Deposits Attached Encrustation
Distance (ft):	10.4
Structural Grade:	0
O&M Grade:	2
Clock Start/From:	8
Clock To:	4
1st Value:	
2nd Value:	
Value Percent:	5.000
Continuous Index:	
Within 8" of Joint:	YES
Remarks:

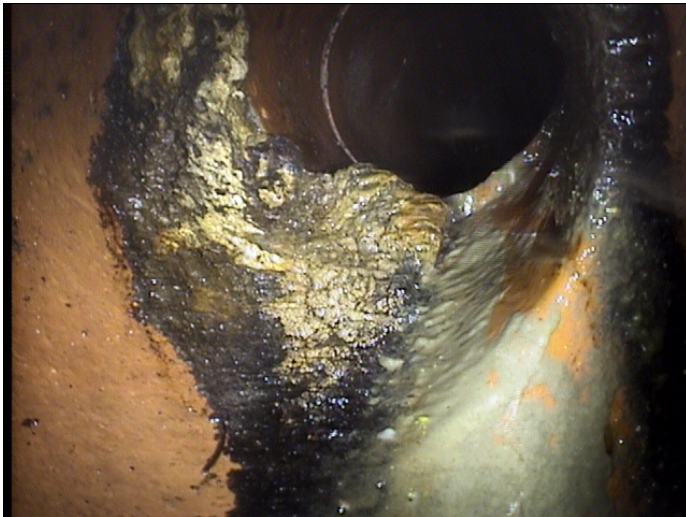
Code:	TFA
Description:	Tap Factory Active
Distance (ft):	17.2
Structural Grade:	0
O&M Grade:	0
Clock Start/From:	2
Clock To:	
1st Value:	4.000
2nd Value:	
Value Percent:	
Continuous Index:	
Within 8" of Joint:	NO
Remarks:

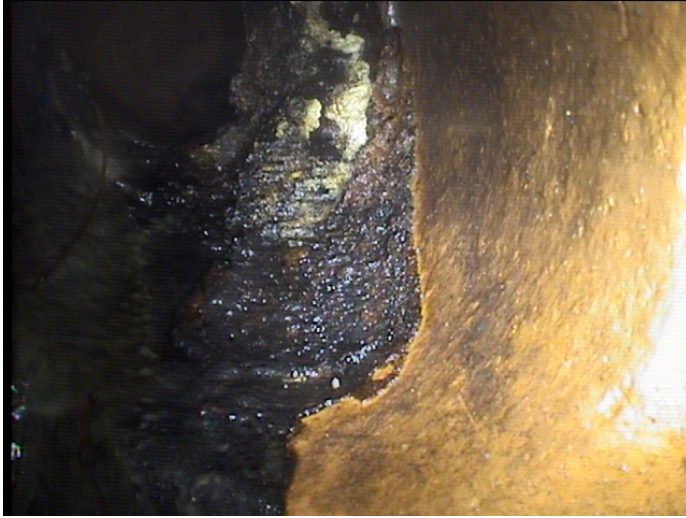
Code: **TFA**
Description: **Tap Factory Active**

Distance (ft): **35.6**
Structural Grade: **0**
O&M Grade: **0**
Clock Start/From: **10**
Clock To:
1st Value: **4.000**
2nd Value:
Value Percent:
Continuous Index:
Within 8" of Joint: **NO**
Remarks:

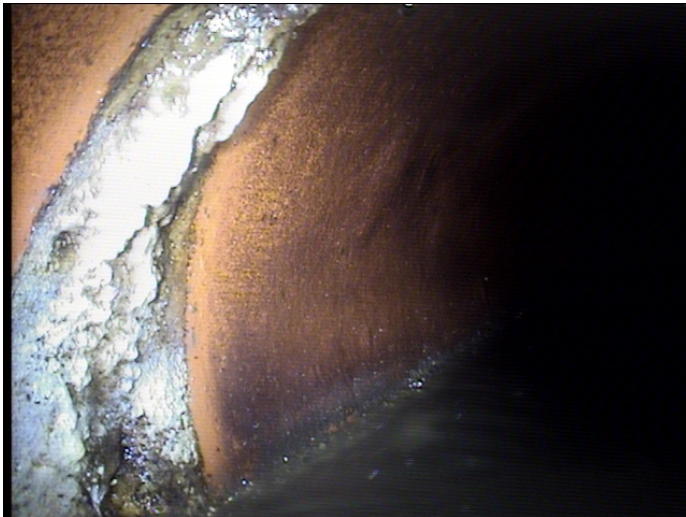
Code: **DAE**
Description: **Deposits Attached Encrustation**

Distance (ft): **51.8**
Structural Grade: **0**
O&M Grade: **2**
Clock Start/From: **8**
Clock To: **4**
1st Value:
2nd Value:
Value Percent: **5.000**
Continuous Index:
Within 8" of Joint: **YES**
Remarks:

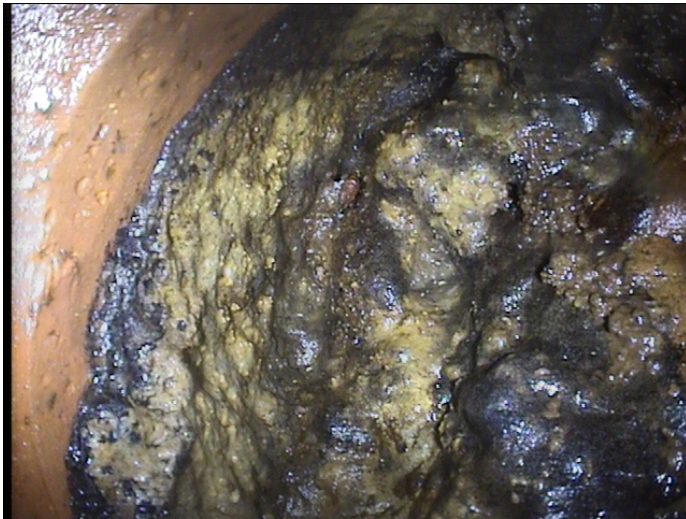
Code: **TFD**
Description: **Tap Factory Defective**

Distance (ft): **99.4**
Structural Grade: **0**
O&M Grade: **2**
Clock Start/From: **2**
Clock To:
1st Value: **4.000**
2nd Value:
Value Percent:
Continuous Index:
Within 8" of Joint: **NO**
Remarks: **Defective**

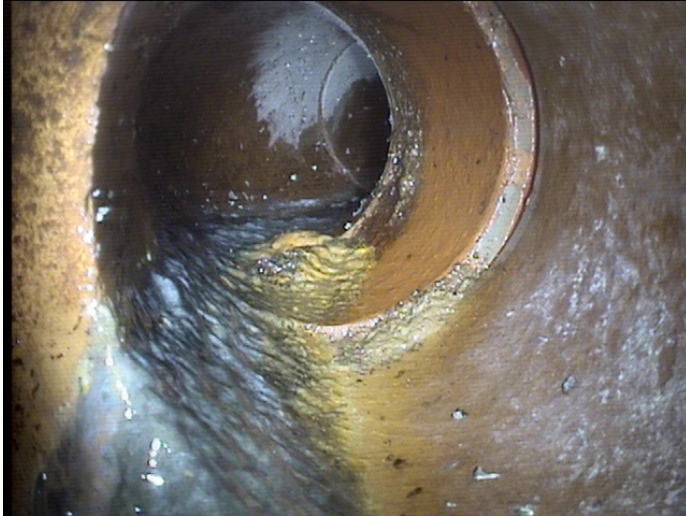
Code: **TF**
Description: **Tap Factory**

Distance (ft): **153.1**
Structural Grade: **0**
O&M Grade: **0**
Clock Start/From: **10**
Clock To:
1st Value: **4.000**
2nd Value:
Value Percent:
Continuous Index:
Within 8" of Joint: **NO**
Remarks:

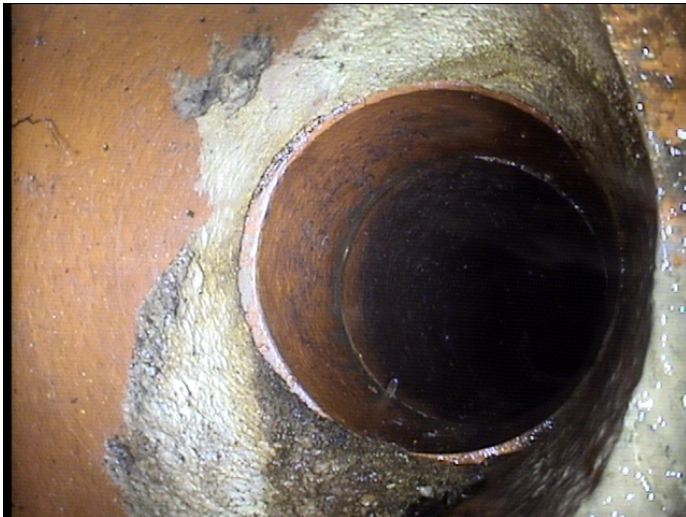
Code: **TF**
Description: **Tap Factory**

Distance (ft): **196.3**
Structural Grade: **0**
O&M Grade: **0**
Clock Start/From: **2**
Clock To:
1st Value: **4.000**
2nd Value:
Value Percent:
Continuous Index:
Within 8" of Joint: **NO**
Remarks:
