Profile/Photo Observation Report

Date:	02/22/2022	Weather:		Coding:	PACP 7.0
Pipe Length (ft):	286.0	Owner:	City of Hobart	Pre Clean:	Heavy Cleaning
P.O.#:	YES502259	Surveyor:	S. Bucklin	PSR:	P-706-069-003
Customer:	City of Hobart, IN (Red	Clean Date:	02/19/2022	Shape:	C

Street:	South Linda Street	Flow Control:	Not Controlled
City:	Hobart, IN	Year Renewed:	
Location:	Easement/Right of Way	Tape/Media #:	
Purpose:	Routine Assessment	Dia/Height:	8"
Use:	Sanitary Sewage Pipe	Material:	PVC
Drain Area:		Lining:	None
Category:	NA		
Comment:			
Location Details:		Direction of Survey:	Downstream
US MH:	M-706-003	DS MH:	M-706-069
		Total Length Surveyed (ft):	284.3

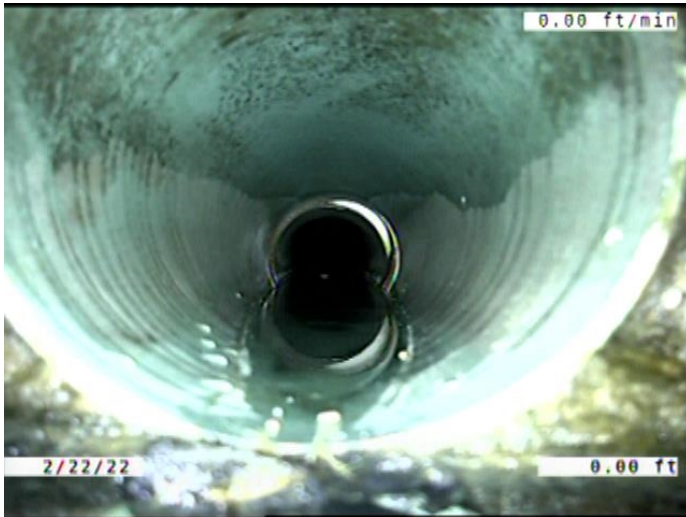
Code: **MWL**
Description: **Miscellaneous Water Level**

Distance (ft): **.0**
Structural Grade: **0**
O&M Grade: **0**
Clock Start/From:
Clock To:
1st Value:
2nd Value:
Value Percent: **5.000**
Continuous Index:
Within 8" of Joint: **NO**
Remarks:

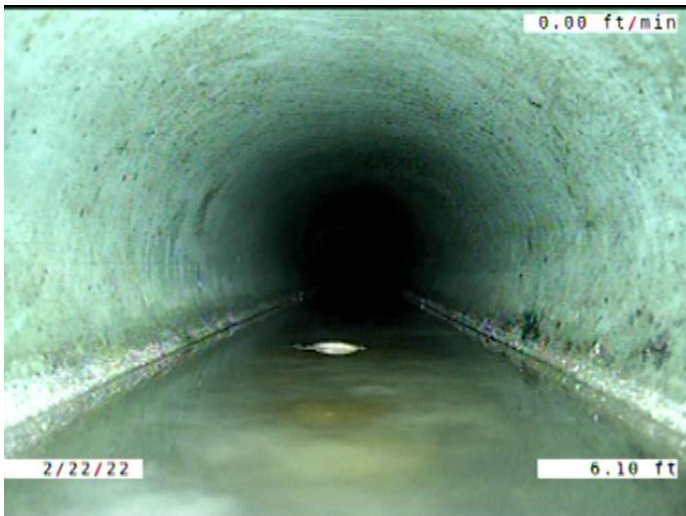
Code: **DSF**
Description: **Deposits Settled Fine**

Distance (ft): **6.1**
Structural Grade: **0**
O&M Grade: **2**
Clock Start/From: **5**
Clock To: **7**
1st Value:
2nd Value:
Value Percent: **5.000**
Continuous Index: **S02**
Within 8" of Joint: **YES**
Remarks:

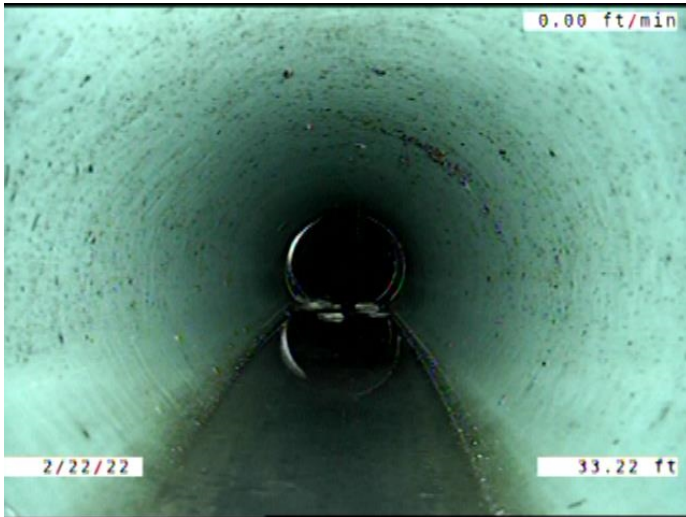
Code: **MWLS**
Description: **Miscellaneous Water Level Sag**

Distance (ft): **33.2**
Structural Grade: **2**
O&M Grade: **0**
Clock Start/From:
Clock To:
1st Value:
2nd Value:
Value Percent: **5.000**
Continuous Index: **S03**
Within 8" of Joint: **NO**
Remarks:

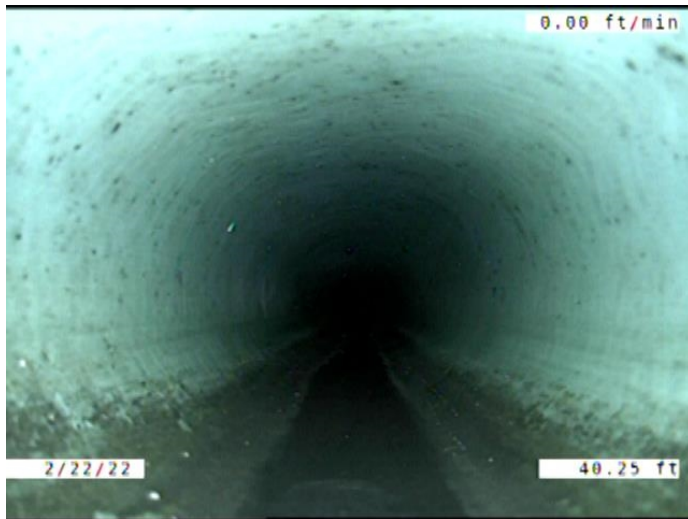
Code: **MWLS**
Description: **Miscellaneous Water Level Sag**

Distance (ft): **40.2**
Structural Grade: **2**
O&M Grade: **0**
Clock Start/From:
Clock To:
1st Value:
2nd Value:
Value Percent: **5.000**
Continuous Index: **F03**
Within 8" of Joint: **NO**
Remarks:

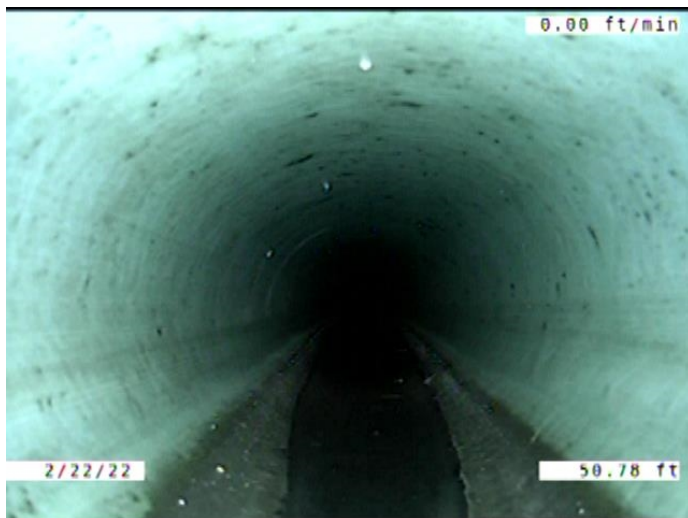
Code: **MWLS**
Description: **Miscellaneous Water Level Sag**

Distance (ft): **50.8**
Structural Grade: **2**
O&M Grade: **0**
Clock Start/From:
Clock To:
1st Value:
2nd Value:
Value Percent: **5.000**
Continuous Index: **S04**
Within 8" of Joint: **NO**
Remarks:

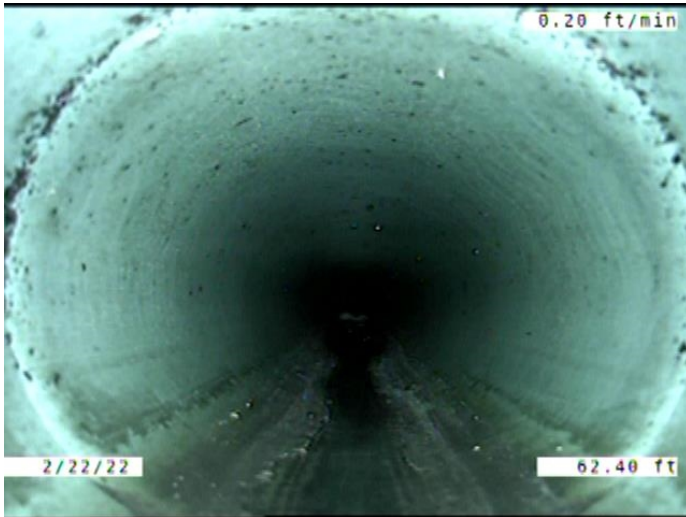
Code: **MWLS**
Description: **Miscellaneous Water Level Sag**

Distance (ft): **62.4**
Structural Grade: **2**
O&M Grade: **0**
Clock Start/From:
Clock To:
1st Value:
2nd Value:
Value Percent: **5.000**
Continuous Index: **F04**
Within 8" of Joint: **NO**
Remarks:

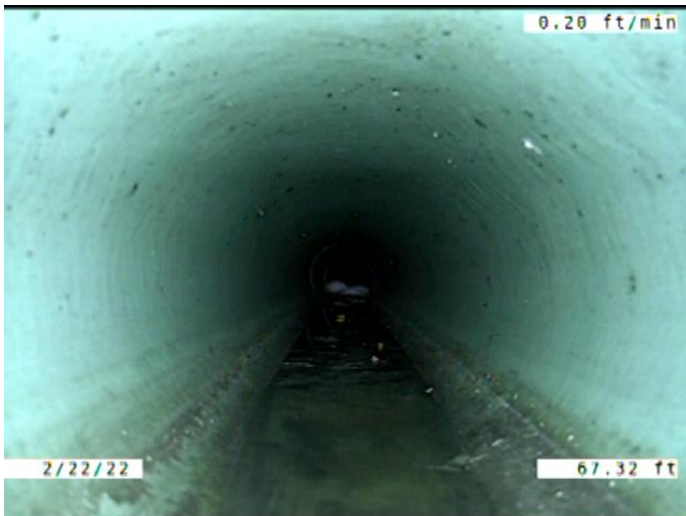
Code: **MWLS**
Description: **Miscellaneous Water Level Sag**

Distance (ft): **67.3**
Structural Grade: **2**
O&M Grade: **0**
Clock Start/From:
Clock To:
1st Value:
2nd Value:
Value Percent: **5.000**
Continuous Index: **S05**
Within 8" of Joint: **NO**
Remarks:

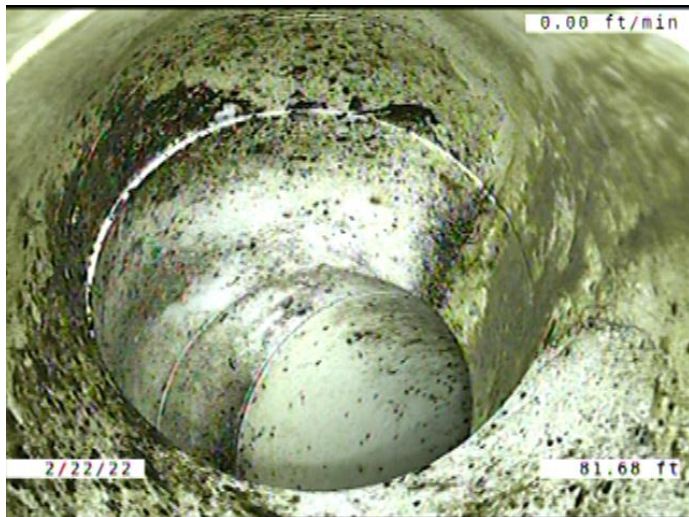
Code: **TF**
 Description: **Tap Factory**

Distance (ft): **81.7**
 Structural Grade: **0**
 O&M Grade: **0**
 Clock Start/From: **1**
 Clock To:
 1st Value: **4.000**
 2nd Value:
 Value Percent:
 Continuous Index:
 Within 8" of Joint: **YES**
 Remarks:

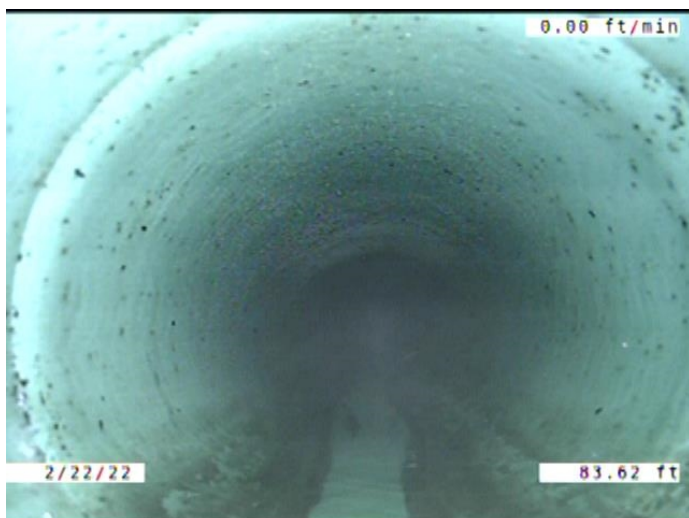
Code: **MWLS**
 Description: **Miscellaneous Water Level Sag**

Distance (ft): **83.6**
 Structural Grade: **2**
 O&M Grade: **0**
 Clock Start/From:
 Clock To:
 1st Value:
 2nd Value:
 Value Percent: **5.000**
 Continuous Index: **F05**
 Within 8" of Joint: **NO**
 Remarks:

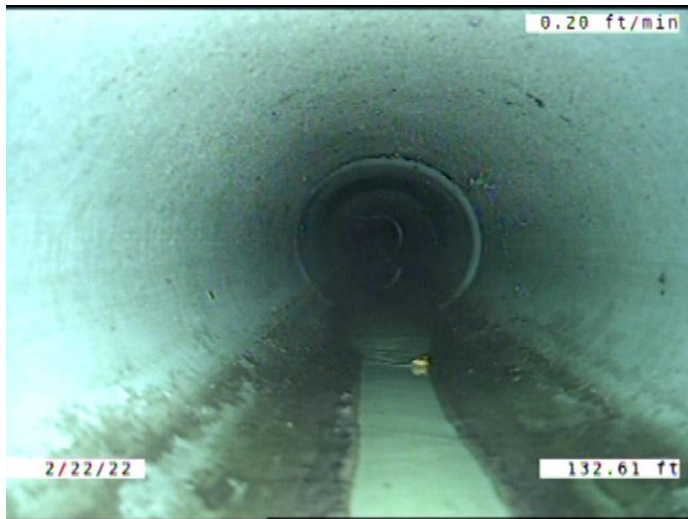
Code: **MWLS**
Description: **Miscellaneous Water Level Sag**

Distance (ft): **132.6**
Structural Grade: **2**
O&M Grade: **0**
Clock Start/From:
Clock To:
1st Value:
2nd Value:
Value Percent: **5.000**
Continuous Index: **F06**
Within 8" of Joint: **NO**
Remarks:

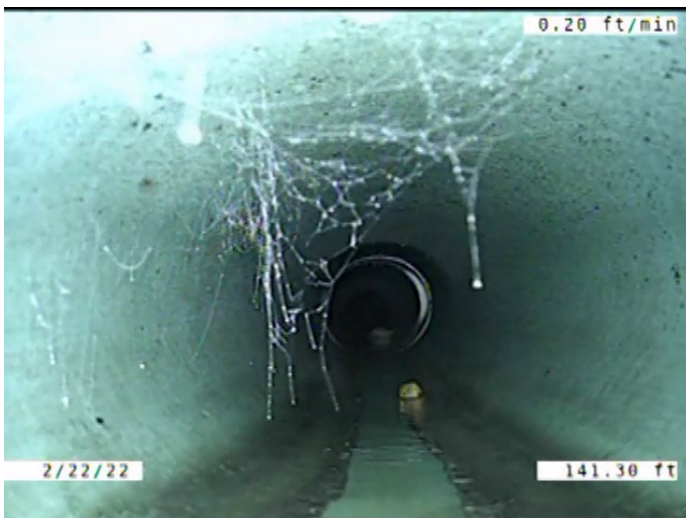
Code: **MWLS**
Description: **Miscellaneous Water Level Sag**

Distance (ft): **141.3**
Structural Grade: **2**
O&M Grade: **0**
Clock Start/From:
Clock To:
1st Value:
2nd Value:
Value Percent: **5.000**
Continuous Index: **F07**
Within 8" of Joint: **NO**
Remarks:

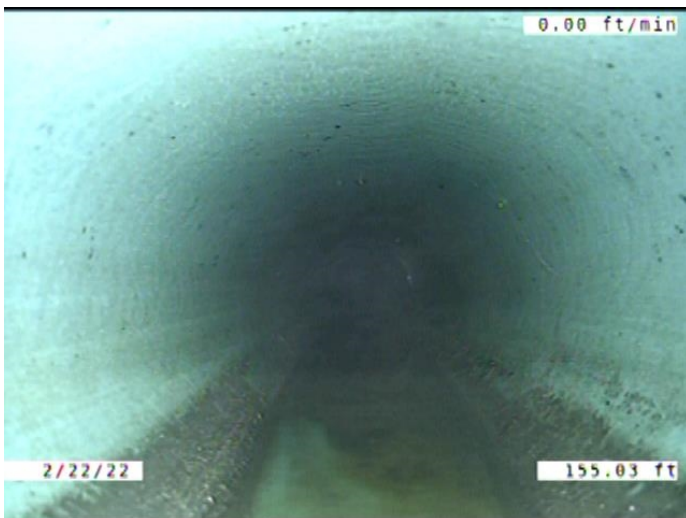
Code: **MWLS**
 Description: **Miscellaneous Water Level Sag**

Distance (ft): **155.0**
 Structural Grade: **2**
 O&M Grade: **0**
 Clock Start/From:
 Clock To:
 1st Value:
 2nd Value:
 Value Percent: **5.000**
 Continuous Index: **S08**
 Within 8" of Joint: **NO**
 Remarks:

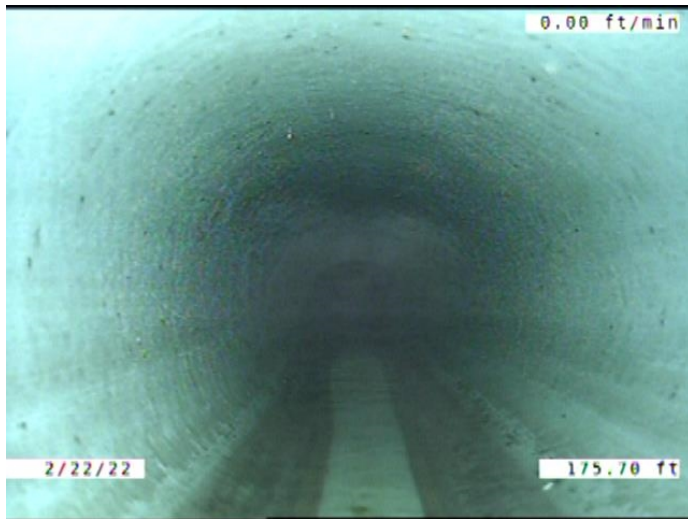
Code: **MWLS**
Description: **Miscellaneous Water Level Sag**

Distance (ft): **175.7**
Structural Grade: **2**
O&M Grade: **0**
Clock Start/From:
Clock To:
1st Value:
2nd Value:
Value Percent: **10.000**
Continuous Index: **F09**
Within 8" of Joint: **NO**
Remarks:

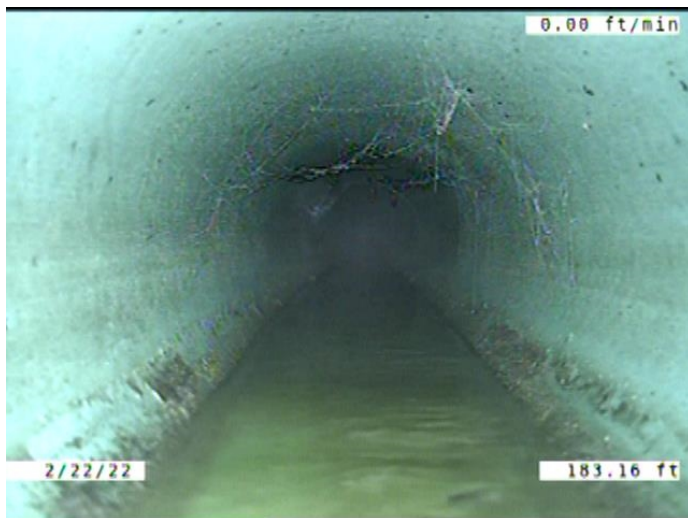
Code: **MWLS**
Description: **Miscellaneous Water Level Sag**

Distance (ft): **183.2**
Structural Grade: **2**
O&M Grade: **0**
Clock Start/From:
Clock To:
1st Value:
2nd Value:
Value Percent: **10.000**
Continuous Index: **S10**
Within 8" of Joint: **NO**
Remarks:

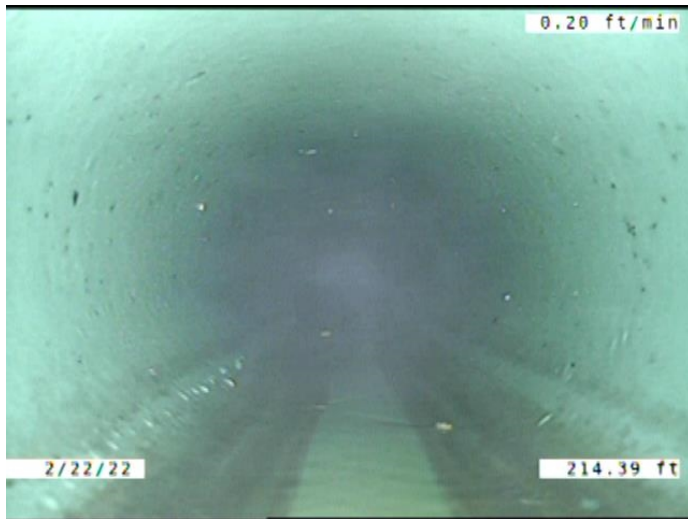
Code: **MWLS**
Description: **Miscellaneous Water Level Sag**

Distance (ft): **214.4**
Structural Grade: **2**
O&M Grade: **0**
Clock Start/From:
Clock To:
1st Value:
2nd Value:
Value Percent: **10.000**
Continuous Index: **F10**
Within 8" of Joint: **NO**
Remarks:

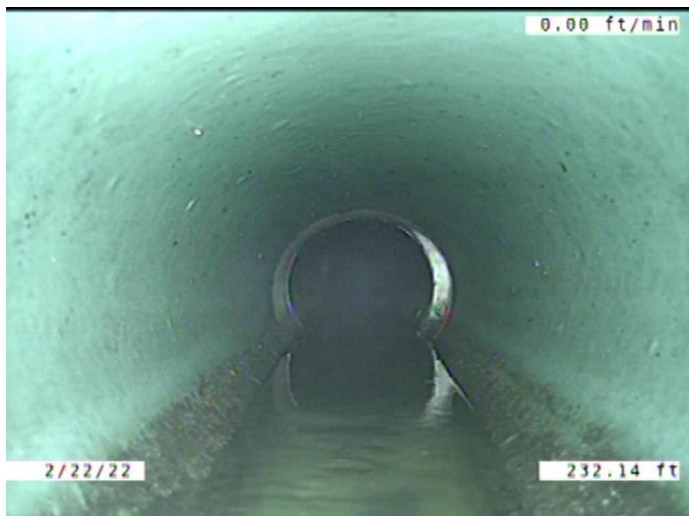
Code: **MWLS**
Description: **Miscellaneous Water Level Sag**

Distance (ft): **232.1**
Structural Grade: **2**
O&M Grade: **0**
Clock Start/From:
Clock To:
1st Value:
2nd Value:
Value Percent: **10.000**
Continuous Index: **S11**
Within 8" of Joint: **NO**
Remarks:

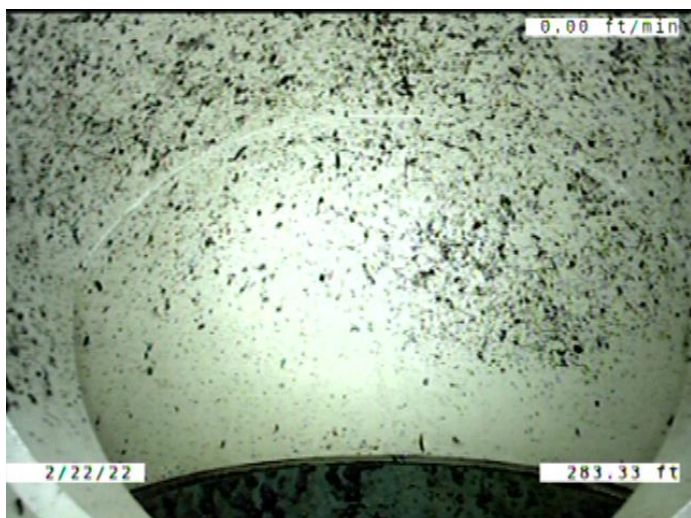
Code: **DSF**
 Description: **Deposits Settled Fine**

Distance (ft): **283.3**
 Structural Grade: **0**
 O&M Grade: **2**
 Clock Start/From: **5**
 Clock To: **7**
 1st Value:
 2nd Value:
 Value Percent: **5.000**
 Continuous Index: **F02**
 Within 8" of Joint: **YES**
 Remarks:
