Profile/Photo Observation Report

Street:	GARFIELD ST & E 8TH PL	Flow Control:	Not Controlled
City:	Hobart, IN	Year Renewed:	
Location:	Light Highway	Tape/Media #:	
Purpose:	Maintenance Related	Dia/Height:	8"
Use:	Sanitary	Material:	VCP
Drain Area:	NA	Lining:	Cured in Place
Category:	NA		
Comment:	Roots at 4'.

Location Details:		Direction of Survey:	Downstream
US MH:	M-706-008.1	DS MH:	M-706-008.2
		Total Length Surveyed (ft):	5.3

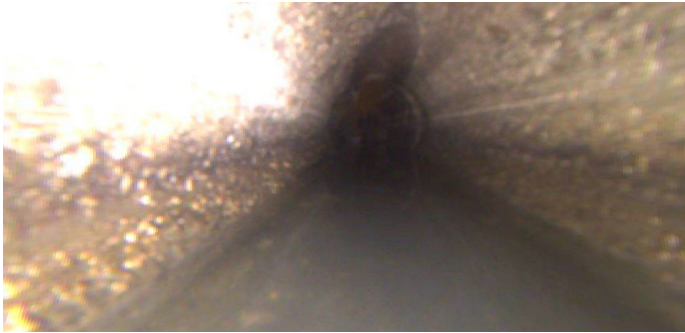
Code:	AMH
Description:	Manhole

Distance (ft):	.0
Structural Grade:	0
O&M Grade:	0
Clock Start/From:	
Clock To:	
1st Value:	
2nd Value:	
Value Percent:	
Continuous Index:	
Within 8" of Joint:	NO
Remarks:	M-706-008.1

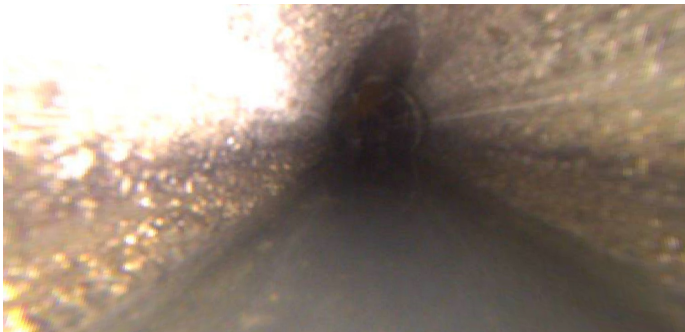
Code:	MWL
Description:	Water Level

Distance (ft):	.0
Structural Grade:	0
O&M Grade:	0
Clock Start/From:	
Clock To:	
1st Value:	
2nd Value:	
Value Percent:	5.000
Continuous Index:	
Within 8" of Joint:	NO
Remarks:

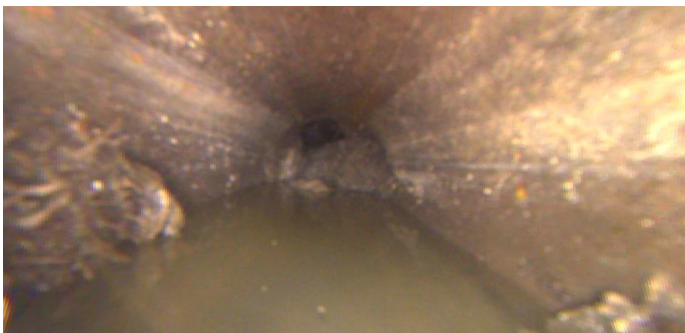
Code: **MSA**
Description: **Abandoned Survey**

Distance (ft): **5.3**
Structural Grade: **0**
O&M Grade: **0**
Clock Start/From:
Clock To:
1st Value:
2nd Value:
Value Percent:
Continuous Index:
Within 8" of Joint: **NO**
Remarks: **rbj**
