Profile/Photo Observation Report

Date:	05/07/2018	Weather:		Coding:	PACP 6.0
Pipe Length (ft):		Owner:	City of Hobart	Pre Clean:	No Pre-Cleaning
P.O.#:	611	Surveyor:	M. Pielacha	PSR:	P-706-008.4-008.3
Customer:	City of Hobart	Clean Date:		Shape:	C

Location Details:		Direction of Survey:	Downstream
US MH:	M-706-008.3	DS MH:	M-706-008.4
		Total Length Surveyed (ft):	162.1

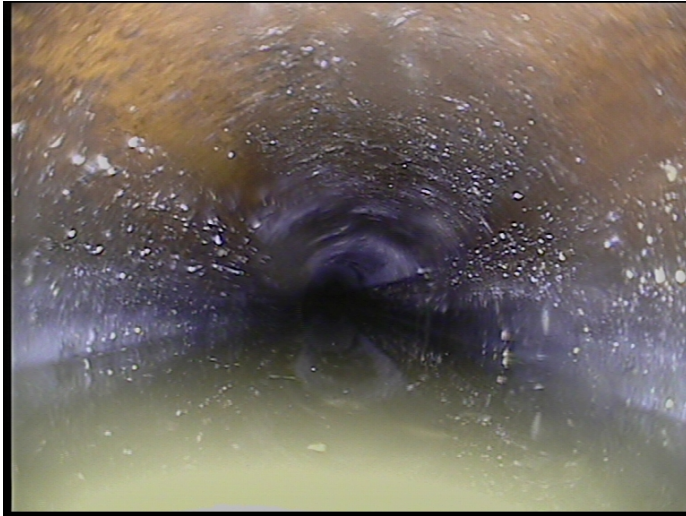
Code: **MWL**
Description: **Water Level**

Distance (ft): **.0**
Structural Grade: **0**
O&M Grade: **0**
Clock Start/From:
Clock To:
1st Value:
2nd Value:
Value Percent: **30.000**
Continuous Index:
Within 8" of Joint: **NO**
Remarks:

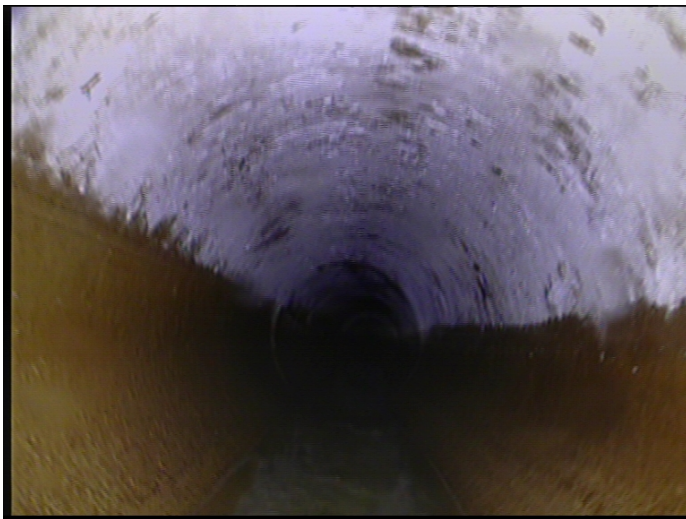
Code: **MWL**
Description: **Water Level**

Distance (ft): **12.4**
Structural Grade: **0**
O&M Grade: **0**
Clock Start/From:
Clock To:
1st Value:
2nd Value:
Value Percent: **10.000**
Continuous Index:
Within 8" of Joint: **NO**
Remarks:

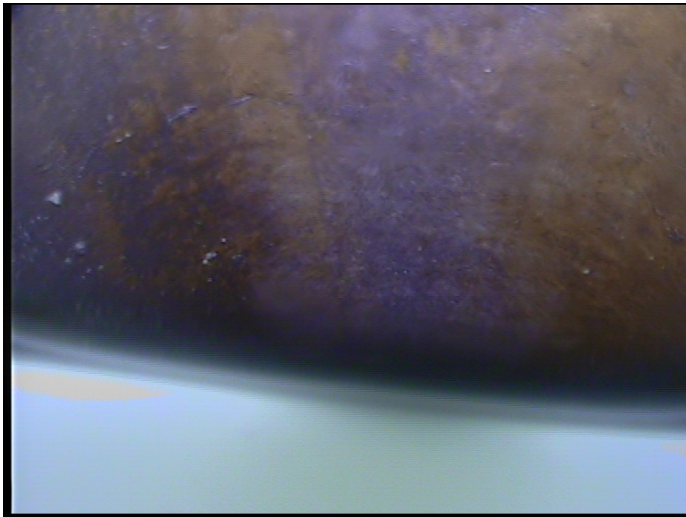
Code: **MWL**
Description: **Water Level**

Distance (ft): **144.3**
Structural Grade: **0**
O&M Grade: **0**
Clock Start/From:
Clock To:
1st Value:
2nd Value:
Value Percent: **45.000**
Continuous Index:
Within 8" of Joint: **NO**
Remarks:

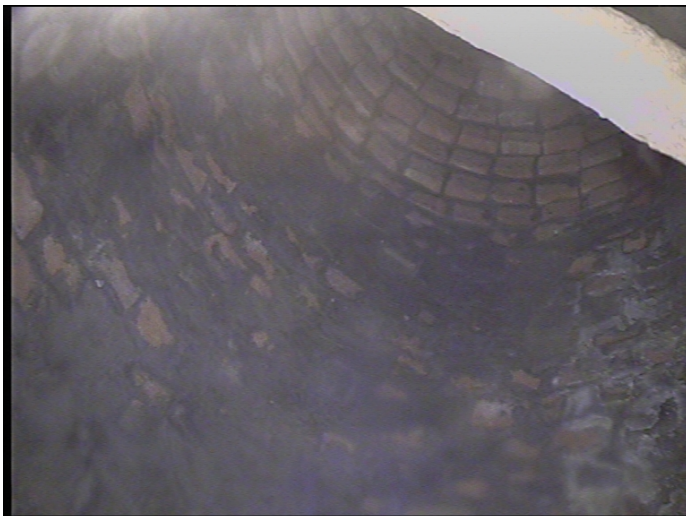
Code: **AMH**
Description: **Manhole**

Distance (ft): **162.1**
Structural Grade: **0**
O&M Grade: **0**
Clock Start/From:
Clock To:
1st Value:
2nd Value:
Value Percent:
Continuous Index:
Within 8" of Joint: **NO**
Remarks: **M-706-008.3**
