## Profile/Photo Observation Report

Street:	<b>Lincoln Street</b>	Flow Control:	
City:	<b>Hobart, IN</b>	Year Renewed:	
Location:	<b>Light Highway</b>	Tape/Media #:	<b>956</b>
Purpose:	<b>Routine Assessment</b>	Dia/Height:	<b>8"</b>
Use:	<b>Sanitary</b>	Material:	<b>PVC</b>
Drain Area:		Lining:	
Category:	<b>NA</b>		
Comment:

Location Details:		Direction of Survey:	<b>Downstream</b>
US MH:	<b>M-706-9</b>	DS MH:	<b>M-706-9.1</b>
		Total Length Surveyed (ft):	<b>238.9</b>

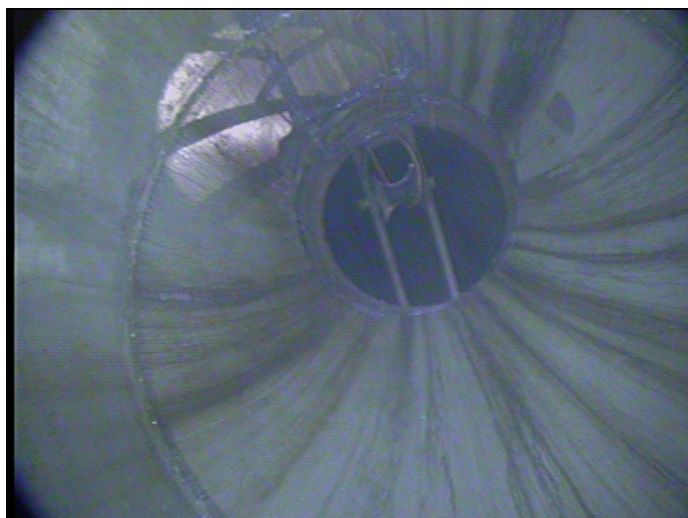
Code: **AMH**  
Description: **Manhole**

Distance (ft): **.0**  
Structural Grade: **0**  
O&M Grade: **0**  
Clock Start/From:  
Clock To:  
1st Value:  
2nd Value:  
Value Percent:  
Continuous Index:  
Within 8" of Joint: **NO**  
Remarks: **M-706-9**

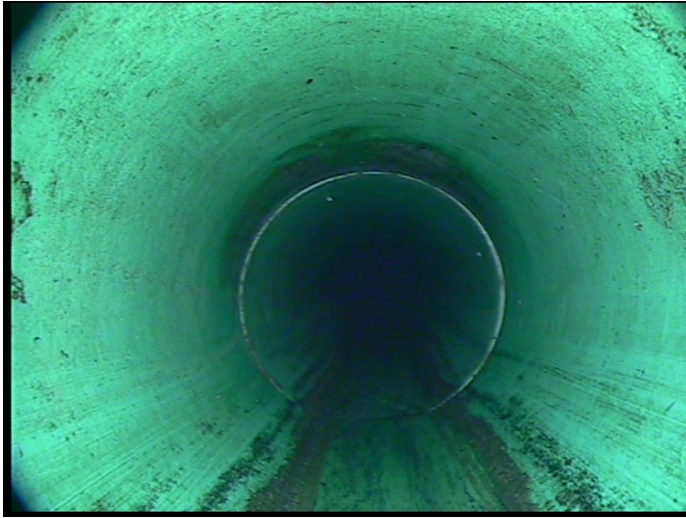
Code:	<b>MWL</b>
Description:	<b>Water Level</b>
Distance (ft):	<b>.0</b>
Structural Grade:	<b>0</b>
O&M Grade:	<b>0</b>
Clock Start/From:	
Clock To:	
1st Value:	
2nd Value:	
Value Percent:	<b>5.000</b>
Continuous Index:	
Within 8" of Joint:	<b>NO</b>
Remarks:

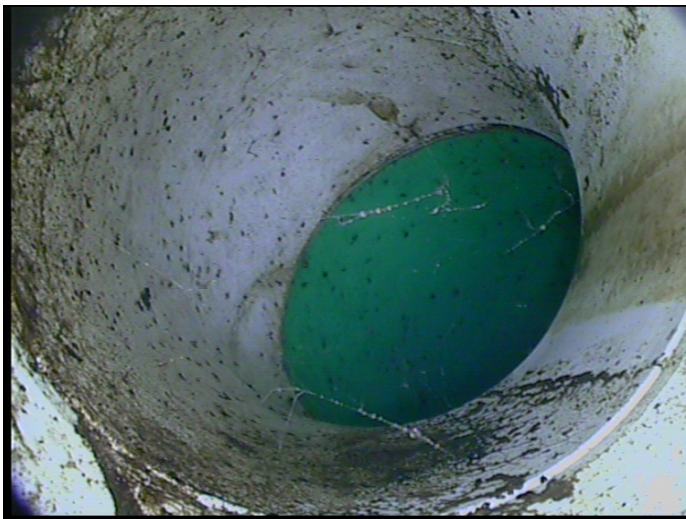
Code:	<b>TF</b>
Description:	<b>Tap Factory</b>
Distance (ft):	<b>26.9</b>
Structural Grade:	<b>0</b>
O&M Grade:	<b>0</b>
Clock Start/From:	<b>2</b>
Clock To:	
1st Value:	<b>4.000</b>
2nd Value:	
Value Percent:	
Continuous Index:	
Within 8" of Joint:	<b>NO</b>
Remarks:

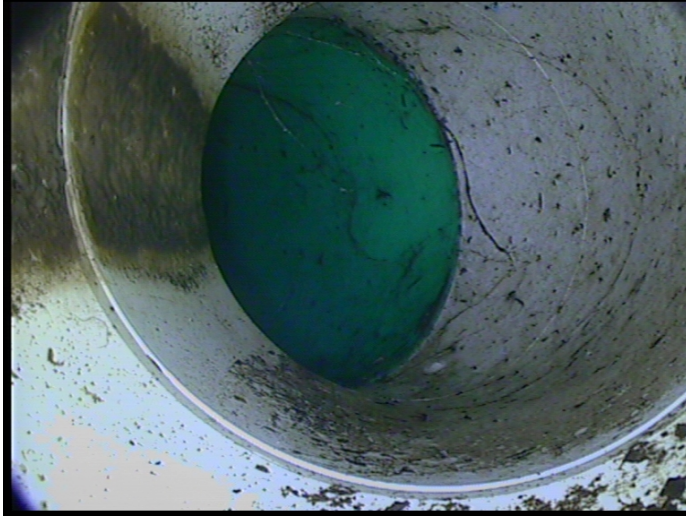
Code: **TF**  
Description: **Tap Factory**

Distance (ft): **30.3**  
Structural Grade: **0**  
O&M Grade: **0**  
Clock Start/From: **10**  
Clock To:  
1st Value: **4.000**  
2nd Value:  
Value Percent:  
Continuous Index:  
Within 8" of Joint: **NO**  
Remarks:

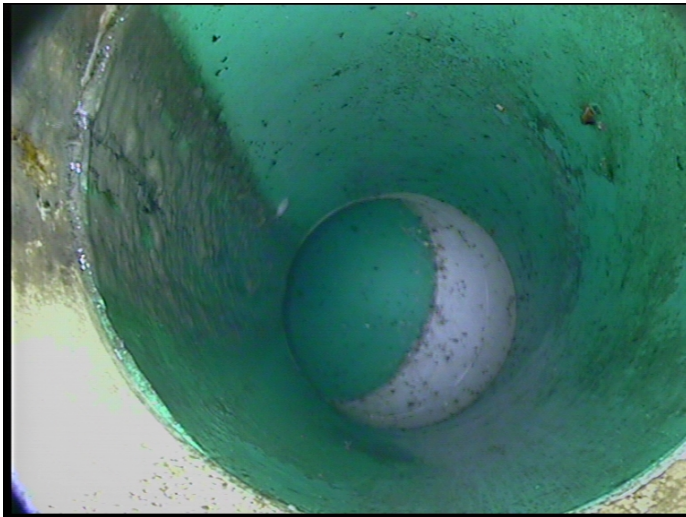
Code: **TF**  
Description: **Tap Factory**

Distance (ft): **50.0**  
Structural Grade: **0**  
O&M Grade: **0**  
Clock Start/From: **10**  
Clock To:  
1st Value: **4.000**  
2nd Value:  
Value Percent:  
Continuous Index:  
Within 8" of Joint: **NO**  
Remarks:

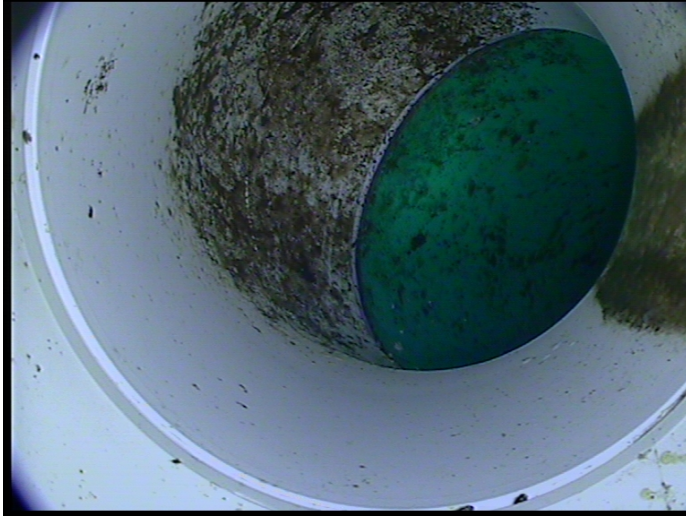
Code: **TF**  
Description: **Tap Factory**

Distance (ft): **79.6**  
Structural Grade: **0**  
O&M Grade: **0**  
Clock Start/From: **2**  
Clock To:  
1st Value: **4.000**  
2nd Value:  
Value Percent:  
Continuous Index:  
Within 8" of Joint: **NO**  
Remarks:

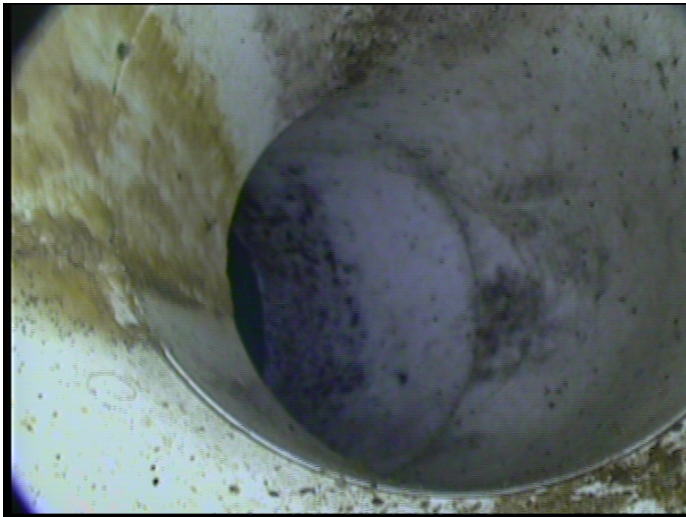
Code: **TF**  
Description: **Tap Factory**

Distance (ft): **83.1**  
Structural Grade: **0**  
O&M Grade: **0**  
Clock Start/From: **10**  
Clock To:  
1st Value: **4.000**  
2nd Value:  
Value Percent:  
Continuous Index:  
Within 8" of Joint: **NO**  
Remarks:

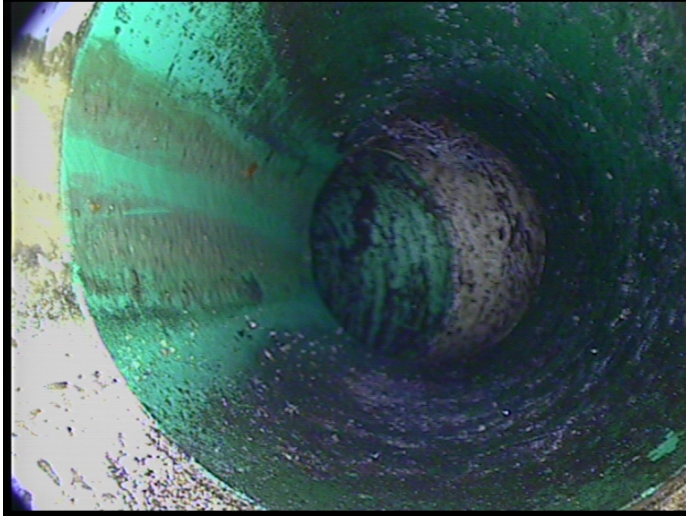
Code: **TF**  
Description: **Tap Factory**

Distance (ft): **129.1**  
Structural Grade: **0**  
O&M Grade: **0**  
Clock Start/From: **10**  
Clock To:  
1st Value: **4.000**  
2nd Value:  
Value Percent:  
Continuous Index:  
Within 8" of Joint: **NO**  
Remarks:

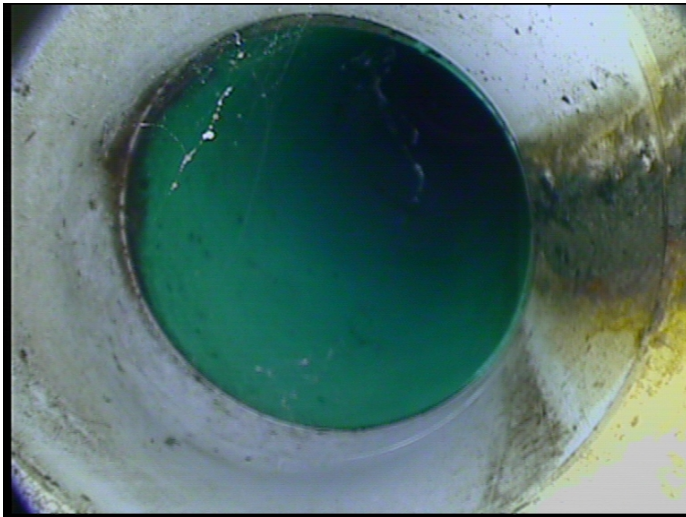
Code: **TF**  
Description: **Tap Factory**

Distance (ft): **132.1**  
Structural Grade: **0**  
O&M Grade: **0**  
Clock Start/From: **3**  
Clock To:  
1st Value: **4.000**  
2nd Value:  
Value Percent:  
Continuous Index:  
Within 8" of Joint: **NO**  
Remarks:

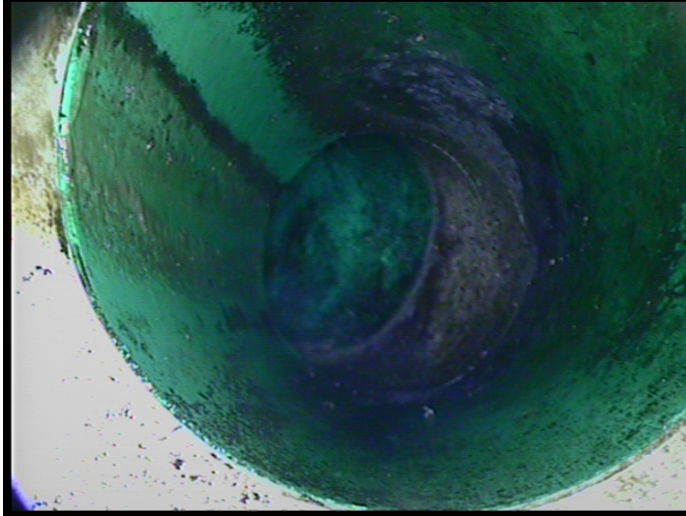
Code: **TF**  
Description: **Tap Factory**

Distance (ft): **176.1**  
Structural Grade: **0**  
O&M Grade: **0**  
Clock Start/From: **10**  
Clock To:  
1st Value: **4.000**  
2nd Value:  
Value Percent:  
Continuous Index:  
Within 8" of Joint: **NO**  
Remarks:

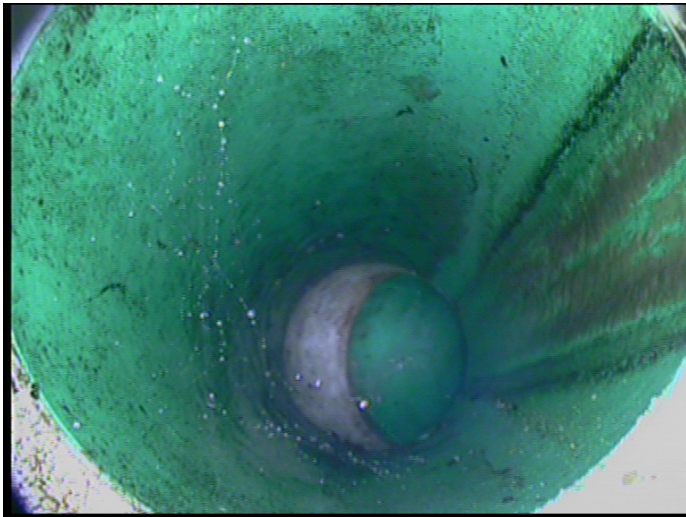
Code: **TF**  
Description: **Tap Factory**

Distance (ft): **177.9**  
Structural Grade: **0**  
O&M Grade: **0**  
Clock Start/From: **2**  
Clock To:  
1st Value: **4.000**  
2nd Value:  
Value Percent:  
Continuous Index:  
Within 8" of Joint: **NO**  
Remarks:

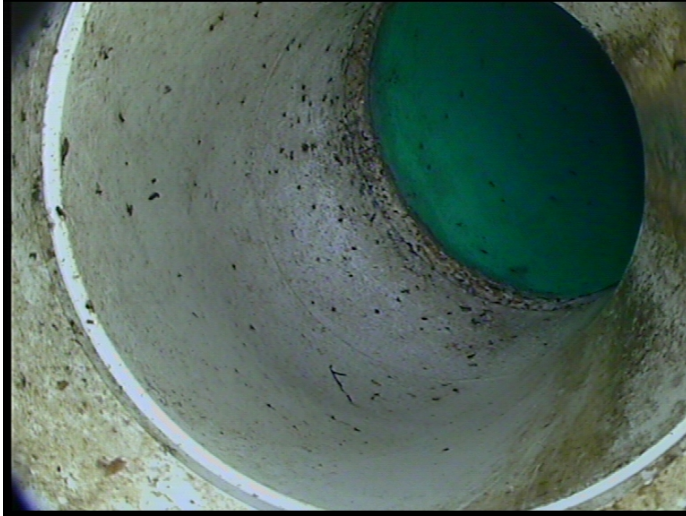
Code: **TF**  
Description: **Tap Factory**

Distance (ft): **211.1**  
Structural Grade: **0**  
O&M Grade: **0**  
Clock Start/From: **2**  
Clock To:  
1st Value: **4.000**  
2nd Value:  
Value Percent:  
Continuous Index:  
Within 8" of Joint: **NO**  
Remarks:

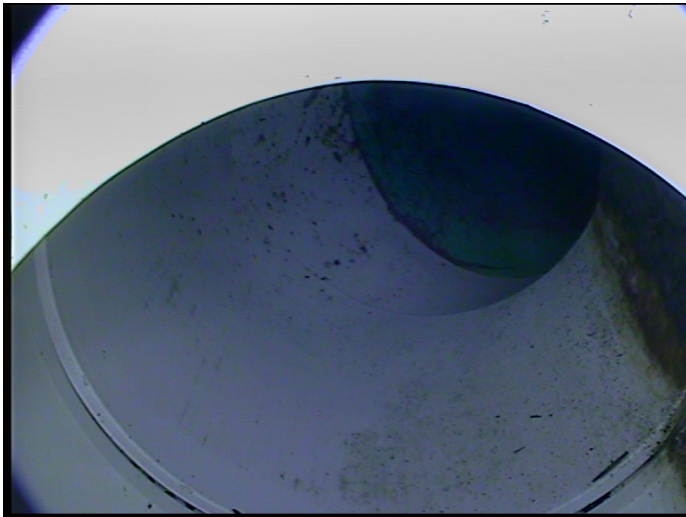
Code: **TF**  
Description: **Tap Factory**

Distance (ft): **236.4**  
Structural Grade: **0**  
O&M Grade: **0**  
Clock Start/From: **2**  
Clock To:  
1st Value: **4.000**  
2nd Value:  
Value Percent:  
Continuous Index:  
Within 8" of Joint: **NO**  
Remarks:

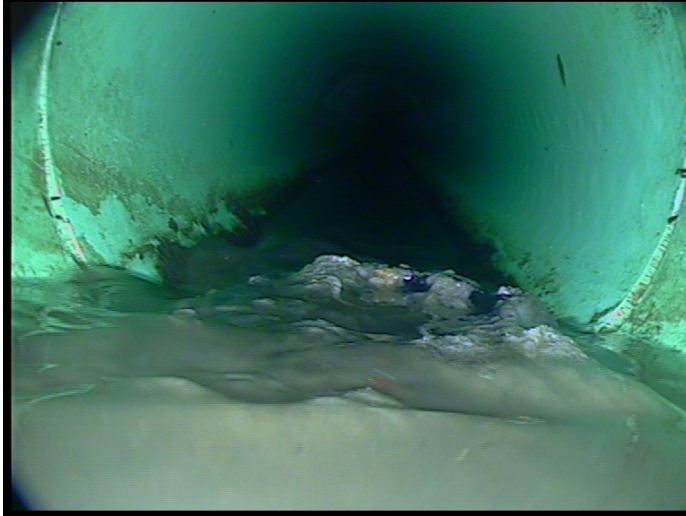
Code: **OBR**  
Description: **Obstacle Rocks**

Distance (ft): **238.7**  
Structural Grade: **0**  
O&M Grade: **2**  
Clock Start/From: **5**  
Clock To: **7**  
1st Value:  
2nd Value:  
Value Percent: **10.000**  
Continuous Index:  
Within 8" of Joint: **NO**  
Remarks:

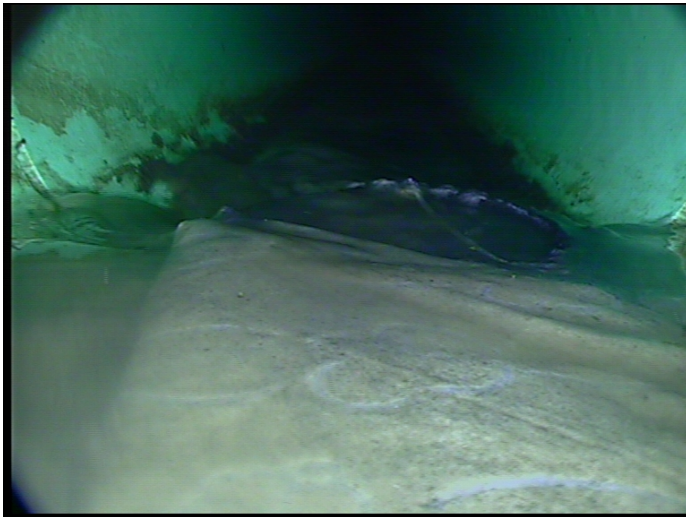
Code: **MSA**  
Description: **Abandoned Survey**

Distance (ft): **238.8**  
Structural Grade: **0**  
O&M Grade: **0**  
Clock Start/From:  
Clock To:  
1st Value:  
2nd Value:  
Value Percent:  
Continuous Index:  
Within 8" of Joint: **NO**  
Remarks: **large Rock**
