Profile/Photo Observation Report

Street:	Lincoln Street	Flow Control:	
City:	Hobart, IN	Year Renewed:	
Location:	Light Highway	Tape/Media #:	957
Purpose:	Routine Assessment	Dia/Height:	8"
Use:	Sanitary	Material:	PVC
Drain Area:		Lining:	
Category:	NA		
Comment:

Location Details:		Direction of Survey:	Upstream
US MH:	M-706-9.1	DS MH:	M-706-24
		Total Length Surveyed (ft):	221.6

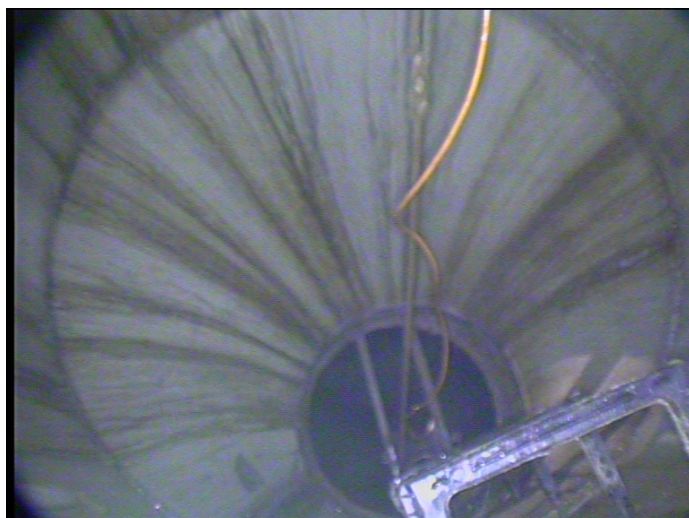
Code: **AMH**
 Description: **Manhole**

Distance (ft): **.0**
 Structural Grade: **0**
 O&M Grade: **0**
 Clock Start/From:
 Clock To:
 1st Value:
 2nd Value:
 Value Percent:
 Continuous Index:
 Within 8" of Joint: **NO**
 Remarks: **M-706-24**

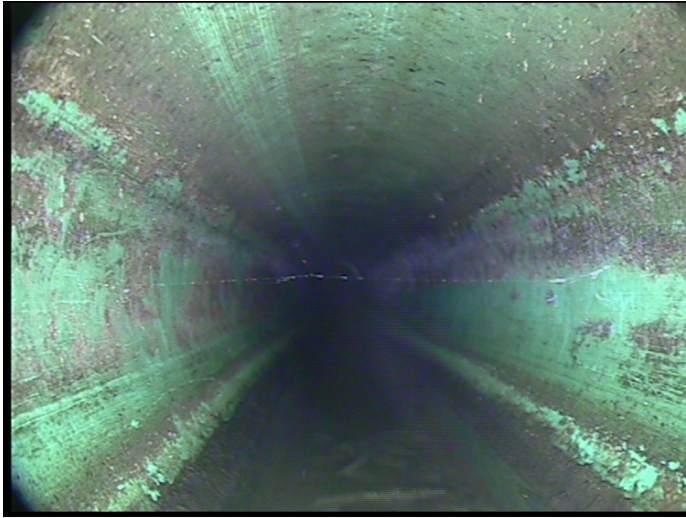
Code:	MWL
Description:	Water Level
Distance (ft):	.0
Structural Grade:	0
O&M Grade:	0
Clock Start/From:	
Clock To:	
1st Value:	
2nd Value:	
Value Percent:	5.000
Continuous Index:	
Within 8" of Joint:	NO
Remarks:

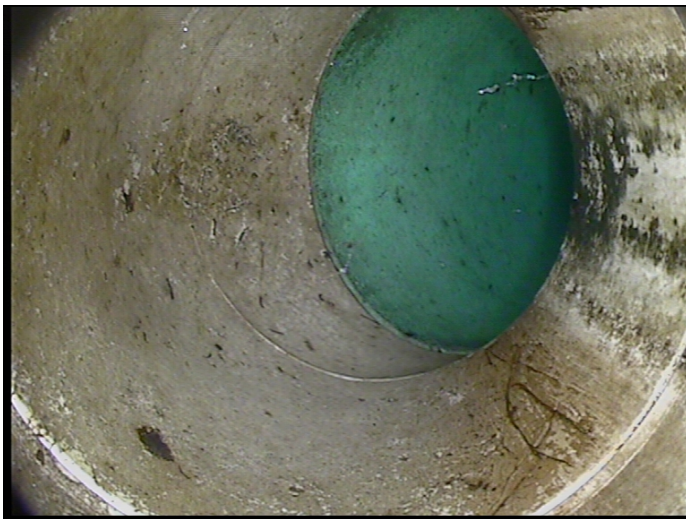
Code:	TF
Description:	Tap Factory
Distance (ft):	10.8
Structural Grade:	0
O&M Grade:	0
Clock Start/From:	2
Clock To:	
1st Value:	4.000
2nd Value:	
Value Percent:	
Continuous Index:	
Within 8" of Joint:	NO
Remarks:

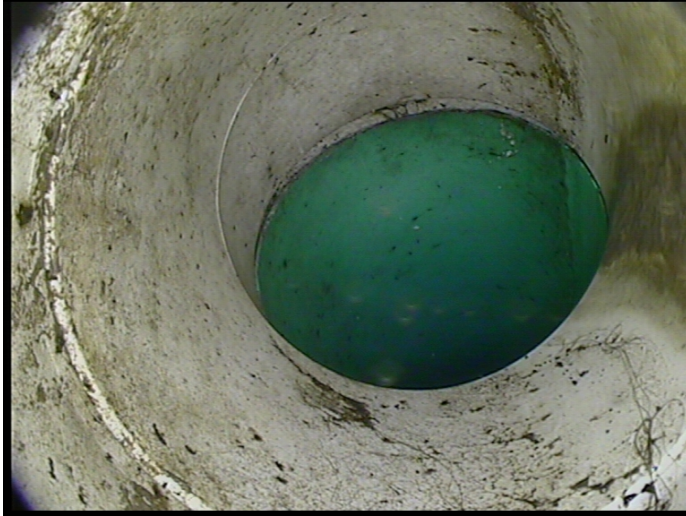
Code: **TF**
Description: **Tap Factory**

Distance (ft): **60.7**
Structural Grade: **0**
O&M Grade: **0**
Clock Start/From: **2**
Clock To:
1st Value: **4.000**
2nd Value:
Value Percent:
Continuous Index:
Within 8" of Joint: **NO**
Remarks:

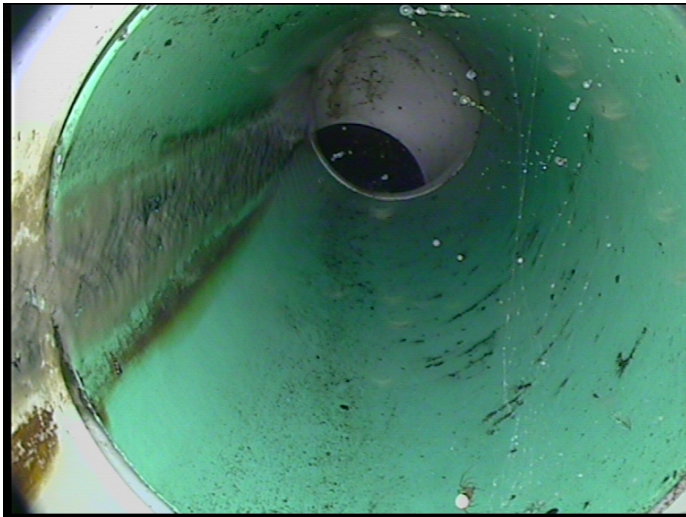
Code: **TF**
Description: **Tap Factory**

Distance (ft): **62.7**
Structural Grade: **0**
O&M Grade: **0**
Clock Start/From: **9**
Clock To:
1st Value: **4.000**
2nd Value:
Value Percent:
Continuous Index:
Within 8" of Joint: **NO**
Remarks:

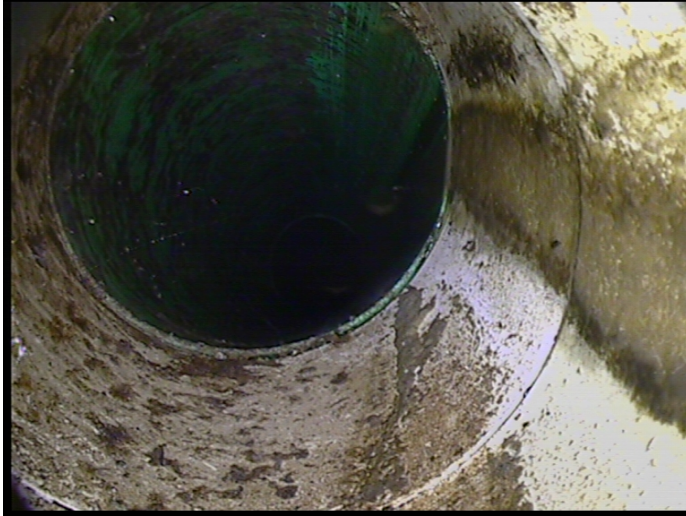
Code:	TF
Description:	Tap Factory
Distance (ft):	91.8
Structural Grade:	0
O&M Grade:	0
Clock Start/From:	3
Clock To:	
1st Value:	4.000
2nd Value:	
Value Percent:	
Continuous Index:	
Within 8" of Joint:	NO
Remarks:

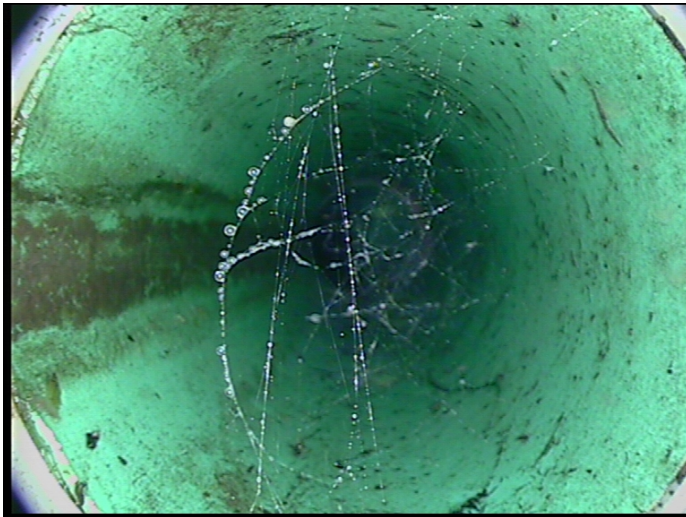
Code:	TF
Description:	Tap Factory
Distance (ft):	101.7
Structural Grade:	0
O&M Grade:	0
Clock Start/From:	9
Clock To:	
1st Value:	4.000
2nd Value:	
Value Percent:	
Continuous Index:	
Within 8" of Joint:	NO
Remarks:

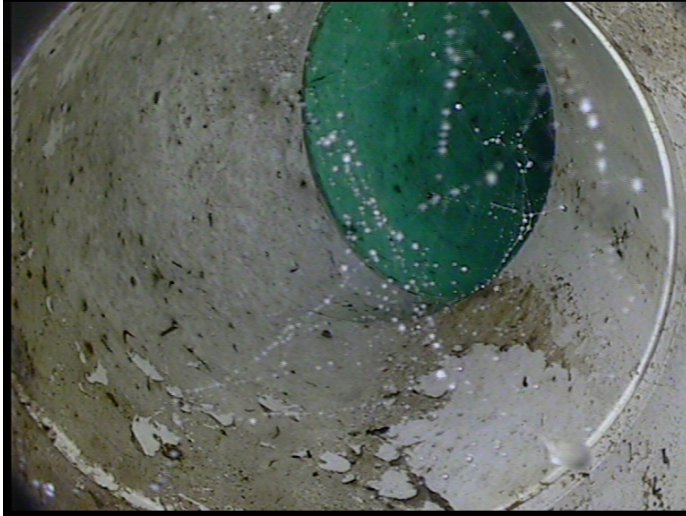
Code: **TF**
Description: **Tap Factory**

Distance (ft): **134.4**
Structural Grade: **0**
O&M Grade: **0**
Clock Start/From: **2**
Clock To:
1st Value: **4.000**
2nd Value:
Value Percent:
Continuous Index:
Within 8" of Joint: **NO**
Remarks:

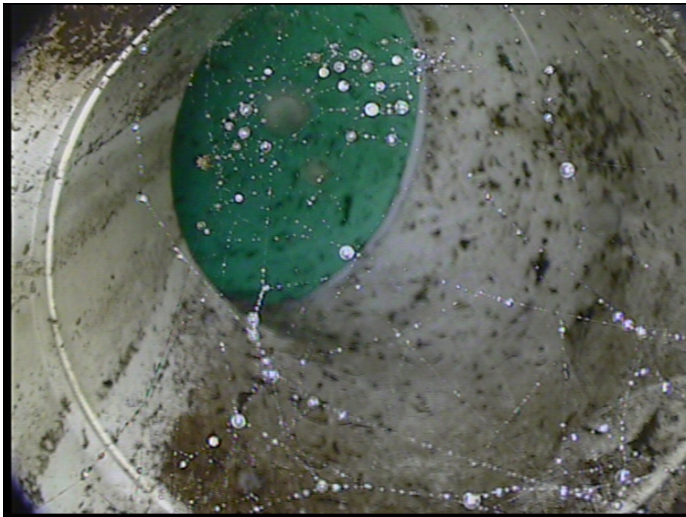
Code: **TF**
Description: **Tap Factory**

Distance (ft): **146.7**
Structural Grade: **0**
O&M Grade: **0**
Clock Start/From: **10**
Clock To:
1st Value: **4.000**
2nd Value:
Value Percent:
Continuous Index:
Within 8" of Joint: **NO**
Remarks:

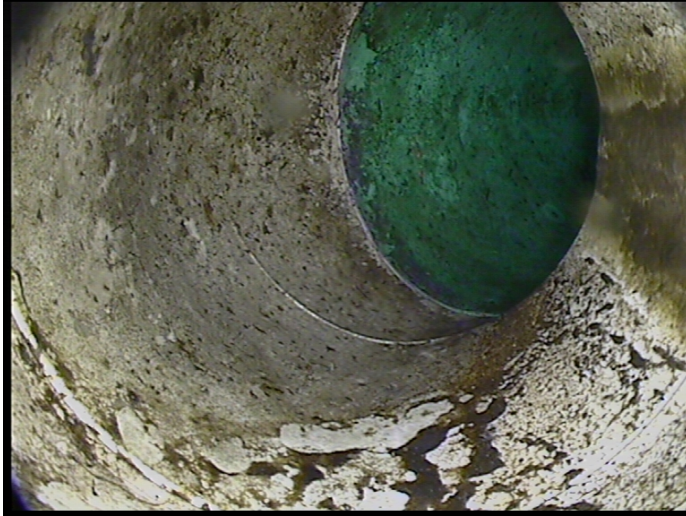
Code: **TF**
Description: **Tap Factory**

Distance (ft): **184.6**
Structural Grade: **0**
O&M Grade: **0**
Clock Start/From: **2**
Clock To:
1st Value: **4.000**
2nd Value:
Value Percent:
Continuous Index:
Within 8" of Joint: **NO**
Remarks:

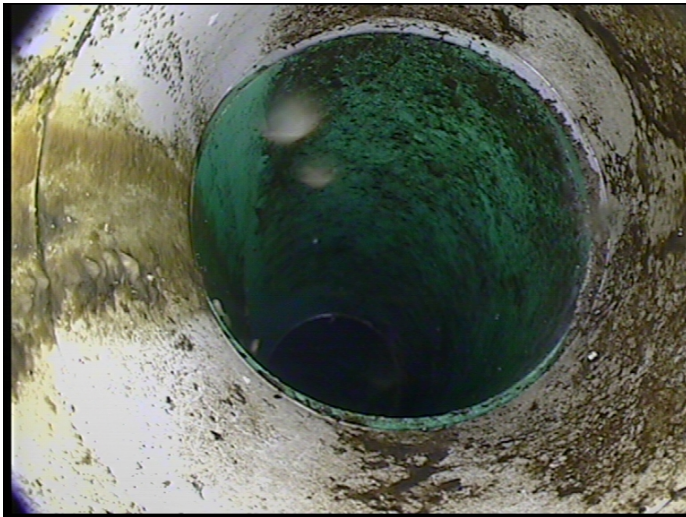
Code: **TF**
Description: **Tap Factory**

Distance (ft): **193.6**
Structural Grade: **0**
O&M Grade: **0**
Clock Start/From: **9**
Clock To:
1st Value: **4.000**
2nd Value:
Value Percent:
Continuous Index:
Within 8" of Joint: **NO**
Remarks:

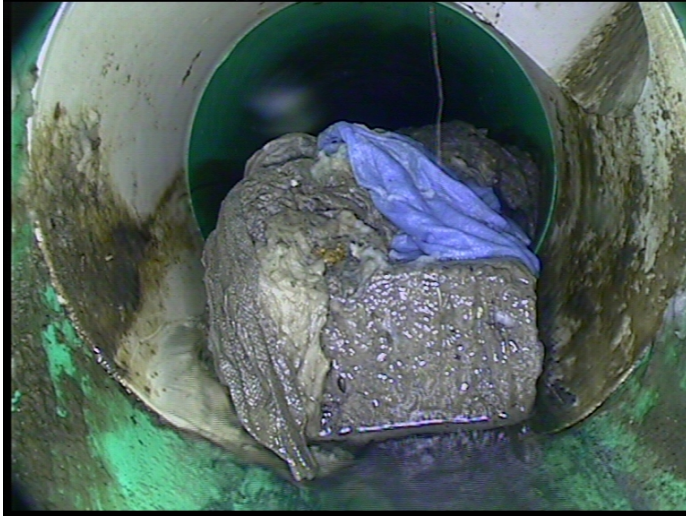
Code: **OBB**
Description: **Obstacle Brick**

Distance (ft): **220.7**
Structural Grade: **0**
O&M Grade: **4**
Clock Start/From: **4**
Clock To: **8**
1st Value:
2nd Value:
Value Percent: **30.000**
Continuous Index:
Within 8" of Joint: **NO**
Remarks:

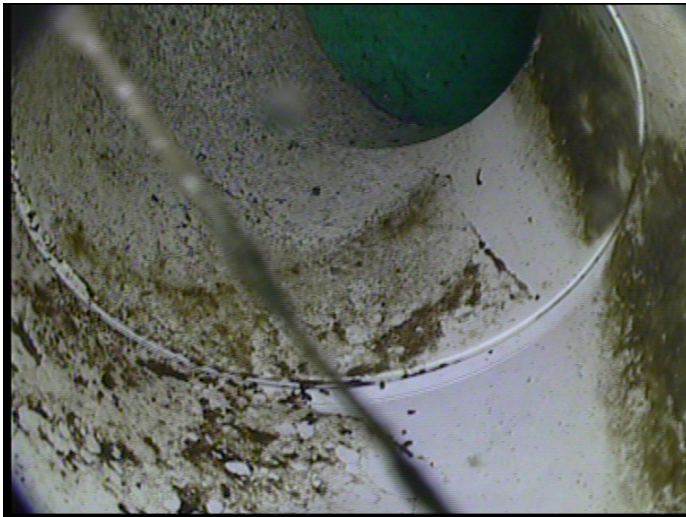
Code: **TF**
Description: **Tap Factory**

Distance (ft): **220.9**
Structural Grade: **0**
O&M Grade: **0**
Clock Start/From: **2**
Clock To:
1st Value: **4.000**
2nd Value:
Value Percent:
Continuous Index:
Within 8" of Joint: **NO**
Remarks:

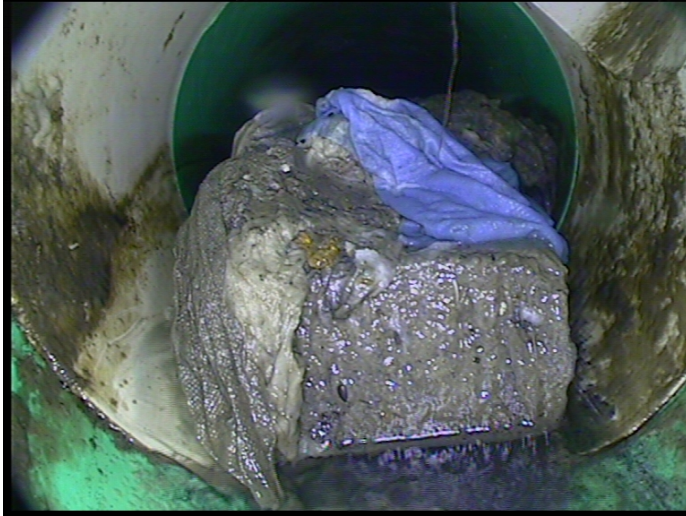
Code:	MSA
Description:	Abandoned Survey
Distance (ft):	221.6
Structural Grade:	0
O&M Grade:	0
Clock Start/From:	
Clock To:	
1st Value:	
2nd Value:	
Value Percent:	
Continuous Index:	
Within 8" of Joint:	NO
Remarks:	bricks
