Profile/Photo Observation Report

Date:	04/16/2018	Weather:		Coding:	PACP 6.0
Pipe Length (ft):	181.0	Owner:	NA	Pre Clean:	Not Known
P.O.#:		Surveyor:	Selasie Honu	PSR:	P-706-010.6-010.5
Customer:		Clean Date:	01/01/1900	Shape:	C

Street:	Capitol	Flow Control:	Not Controlled
City:	Hobart, IN	Year Renewed:	
Location:	Ditch	Tape/Media #:	
Purpose:	Maintenance Related	Dia/Height:	12"
Use:	Sanitary	Material:	PVC
Drain Area:	NA	Lining:	Cured in Place
Category:	NA		
Comment:	flow incorrect.

Location Details:		Direction of Survey:	Downstream
US MH:	M-706-010.5	DS MH:	M-706-010.6
		Total Length Surveyed (ft):	179.1

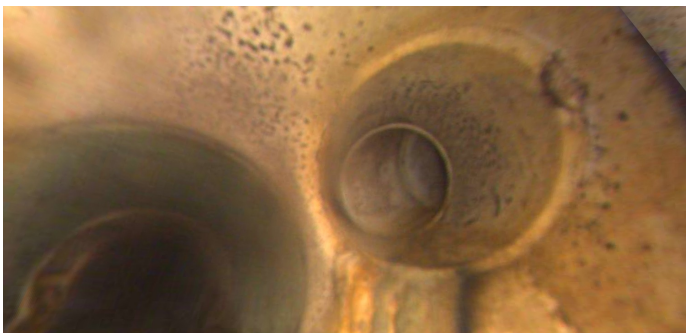
Code: **TF**
Description: **Tap Factory**

Distance (ft): **66.2**
Structural Grade: **0**
O&M Grade: **0**
Clock Start/From: **2**
Clock To:
1st Value: **4.000**
2nd Value:
Value Percent:
Continuous Index:
Within 8" of Joint:
Remarks:
