## Profile/Photo Observation Report

Date:	<b>04/20/2018</b>	Weather:		Coding:	<b>PACP 6.0</b>
Pipe Length (ft):	<b>194.5</b>	Owner:	<b>NA</b>	Pre Clean:	<b>Not Known</b>
P.O.#:		Surveyor:	<b>Byrd Fitzgerald</b>	PSR:	<b>P-706-011.2-011.1</b>
Customer:		Clean Date:	<b>01/01/1900</b>	Shape:	<b>C</b>

Street:	<b>LAKE ST</b>	Flow Control:	<b>Not Controlled</b>
City:	<b>Hobart, IN</b>	Year Renewed:	
Location:	<b>Light Highway</b>	Tape/Media #:	
Purpose:	<b>Maintenance Related</b>	Dia/Height:	<b>12"</b>
Use:	<b>Sanitary</b>	Material:	<b>PVC</b>
Drain Area:	<b>NA</b>	Lining:	<b>Cured in Place</b>
Category:	<b>NA</b>		
Comment:	<b>unknown rollover at 120'. flow incorrect.</b>		
Location Details:		Direction of Survey:	<b>Downstream</b>
US MH:	<b>M-706-011.1</b>	DS MH:	<b>M-706-011.2</b>
		Total Length Surveyed (ft):	<b>121.1</b>

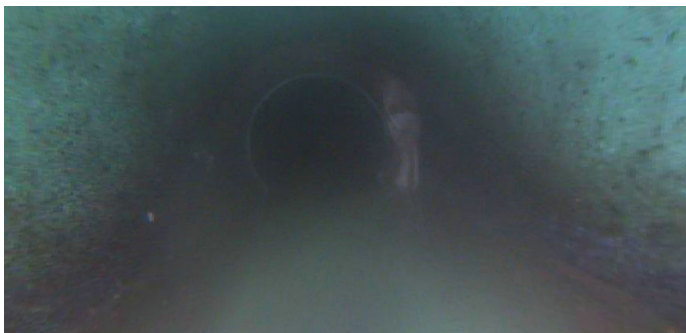
Code: **AMH**  
Description: **Manhole**

Distance (ft): **.0**  
Structural Grade: **0**  
O&M Grade: **0**  
Clock Start/From:  
Clock To:  
1st Value:  
2nd Value:  
Value Percent:  
Continuous Index:  
Within 8" of Joint: **NO**  
Remarks: **M-706-011.1**

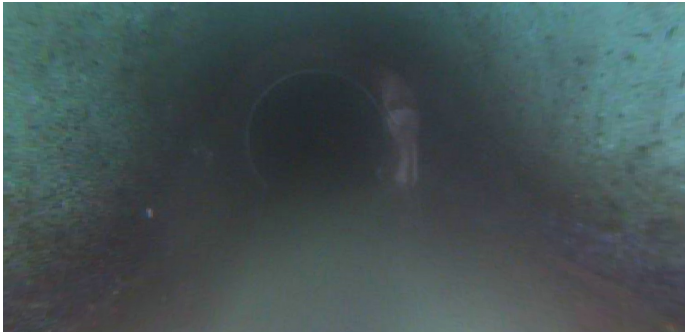
Code:	<b>MWL</b>
Description:	<b>Water Level</b>

Distance (ft):	<b>.0</b>
Structural Grade:	<b>0</b>
O&M Grade:	<b>0</b>
Clock Start/From:	
Clock To:	
1st Value:	
2nd Value:	
Value Percent:	<b>5.000</b>
Continuous Index:	
Within 8" of Joint:	<b>NO</b>
Remarks:

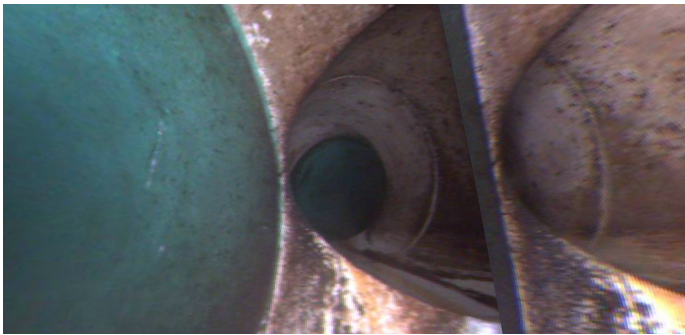
Code:	<b>TF</b>
Description:	<b>Tap Factory</b>

Distance (ft):	<b>3.0</b>
Structural Grade:	<b>0</b>
O&M Grade:	<b>0</b>
Clock Start/From:	<b>2</b>
Clock To:	
1st Value:	<b>4.000</b>
2nd Value:	
Value Percent:	
Continuous Index:	
Within 8" of Joint:	<b>YES</b>
Remarks:

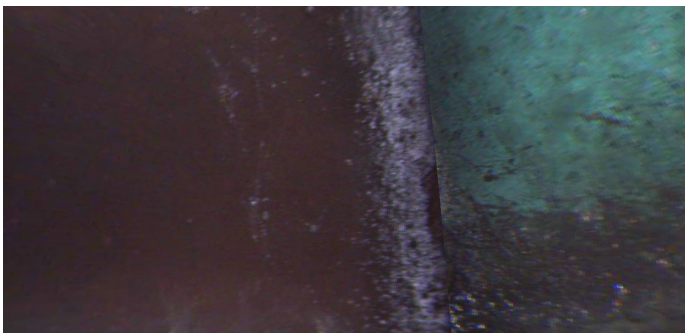
Code: **MMC**  
Description: **Material Change**

Distance (ft): **15.2**  
Structural Grade: **0**  
O&M Grade: **0**  
Clock Start/From:  
Clock To:  
1st Value:  
2nd Value:  
Value Percent:  
Continuous Index:  
Within 8" of Joint: **NO**  
Remarks: **vcp**

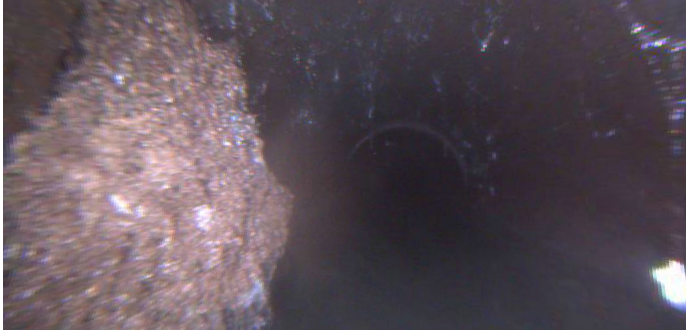
Code: **RMJ**  
Description: **Roots Medium Joint**

Distance (ft): **16.9**  
Structural Grade: **0**  
O&M Grade: **3**  
Clock Start/From: **7**  
Clock To: **5**  
1st Value:  
2nd Value:  
Value Percent: **5.000**  
Continuous Index:  
Within 8" of Joint: **YES**  
Remarks:

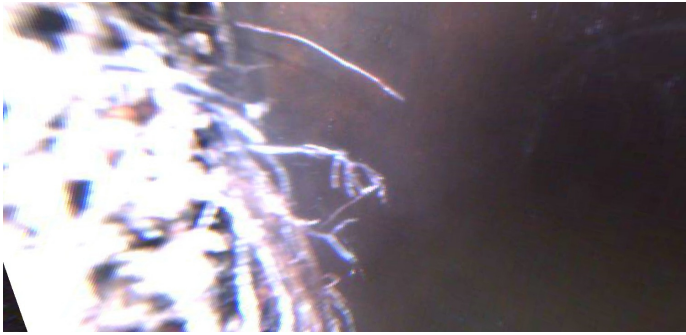
Code: **RMJ**  
Description: **Roots Medium Joint**

Distance (ft): **20.8**  
Structural Grade: **0**  
O&M Grade: **3**  
Clock Start/From: **9**  
Clock To:  
1st Value:  
2nd Value:  
Value Percent: **5.000**  
Continuous Index:  
Within 8" of Joint: **YES**  
Remarks:

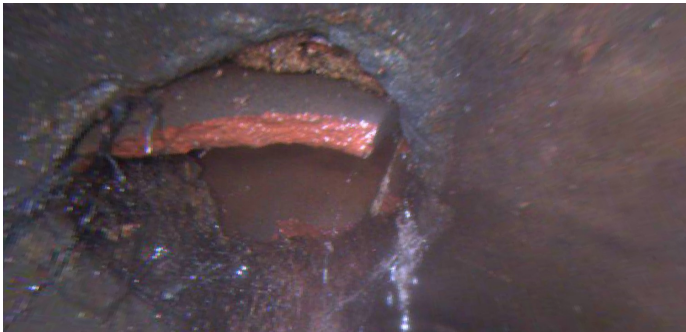
Code: **TBD**  
Description: **Tap Break-in Defective**

Distance (ft): **27.7**  
Structural Grade: **0**  
O&M Grade: **3**  
Clock Start/From: **11**  
Clock To:  
1st Value: **4.000**  
2nd Value:  
Value Percent:  
Continuous Index:  
Within 8" of Joint:  
Remarks: **tap broken**

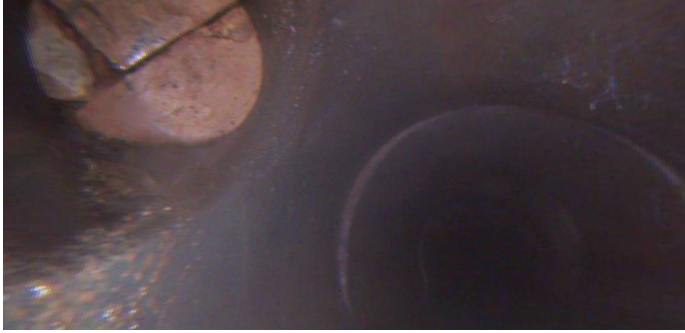
Code: **TFC**  
Description: **Tap Factory Capped**

Distance (ft): **38.3**  
Structural Grade: **0**  
O&M Grade: **0**  
Clock Start/From: **11**  
Clock To:  
1st Value: **4.000**  
2nd Value:  
Value Percent:  
Continuous Index:  
Within 8" of Joint: **YES**  
Remarks:

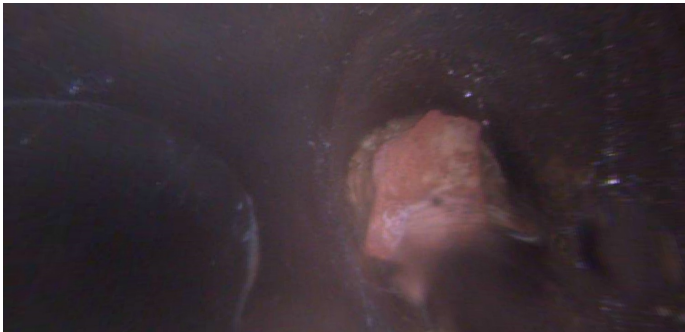
Code: **TFC**  
Description: **Tap Factory Capped**

Distance (ft): **40.1**  
Structural Grade: **0**  
O&M Grade: **0**  
Clock Start/From: **2**  
Clock To:  
1st Value: **4.000**  
2nd Value:  
Value Percent:  
Continuous Index:  
Within 8" of Joint: **YES**  
Remarks: **capped or blocked???**

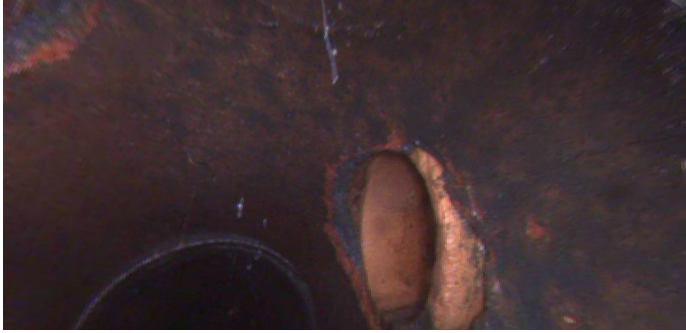
Code: **TB**  
Description: **Tap Break-in**

Distance (ft): **59.4**  
Structural Grade: **0**  
O&M Grade: **0**  
Clock Start/From: **10**  
Clock To:  
1st Value: **4.000**  
2nd Value:  
Value Percent:  
Continuous Index:  
Within 8" of Joint: **YES**  
Remarks:

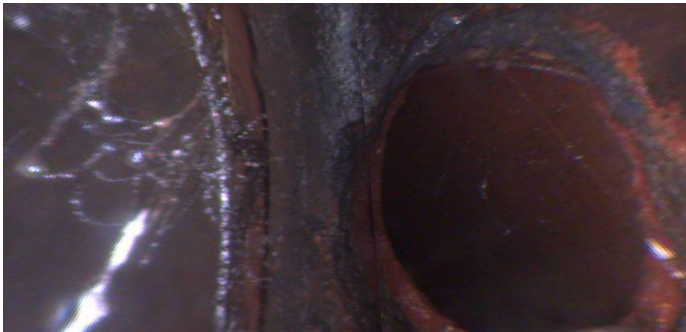
Code: **TB**  
Description: **Tap Break-in**

Distance (ft): **59.4**  
Structural Grade: **0**  
O&M Grade: **0**  
Clock Start/From: **2**  
Clock To:  
1st Value: **4.000**  
2nd Value:  
Value Percent:  
Continuous Index:  
Within 8" of Joint: **YES**  
Remarks:

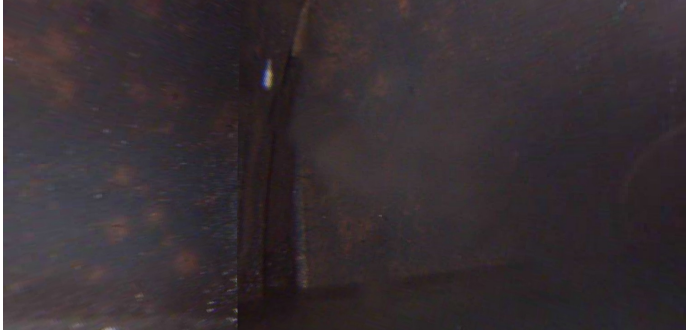
Code: **RMJ**  
Description: **Roots Medium Joint**

Distance (ft): **75.9**  
Structural Grade: **0**  
O&M Grade: **3**  
Clock Start/From: **7**  
Clock To: **5**  
1st Value:  
2nd Value:  
Value Percent: **5.000**  
Continuous Index: **F01**  
Within 8" of Joint: **YES**  
Remarks: **wandering**

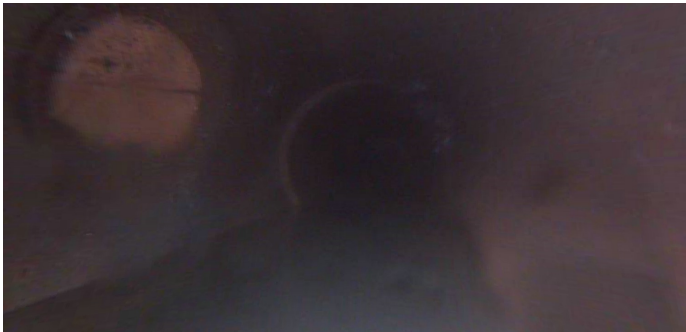
Code: **TF**  
Description: **Tap Factory**

Distance (ft): **83.4**  
Structural Grade: **0**  
O&M Grade: **0**  
Clock Start/From: **10**  
Clock To:  
1st Value: **4.000**  
2nd Value:  
Value Percent:  
Continuous Index:  
Within 8" of Joint: **YES**  
Remarks:

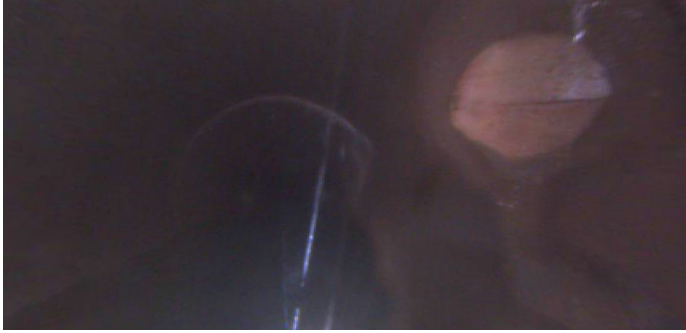
Code: **TFC**  
Description: **Tap Factory Capped**

Distance (ft): **86.6**  
Structural Grade: **0**  
O&M Grade: **0**  
Clock Start/From: **2**  
Clock To:  
1st Value: **4.000**  
2nd Value:  
Value Percent:  
Continuous Index:  
Within 8" of Joint: **YES**  
Remarks:

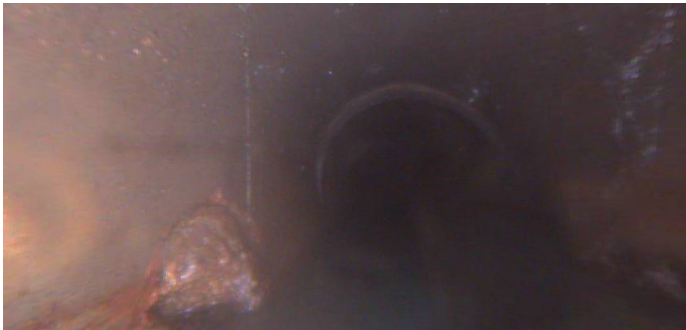
Code: **DAZ**  
Description: **Deposits Attached Other**

Distance (ft): **89.6**  
Structural Grade: **0**  
O&M Grade: **2**  
Clock Start/From: **8**  
Clock To:  
1st Value:  
2nd Value:  
Value Percent: **5.000**  
Continuous Index:  
Within 8" of Joint: **NO**  
Remarks: **mud?**
