Profile/Photo Observation Report

Date:	04/17/2018	Weather:		Coding:	PACP 6.0
Pipe Length (ft):	193.2	Owner:	NA	Pre Clean:	Not Known
P.O.#:		Surveyor:	Jen Costello	PSR:	P-706-011.7-011.6
Customer:		Clean Date:	01/01/1900	Shape:	C

Street:	LAKE ST	Flow Control:	Not Controlled
City:	Hobart, IN	Year Renewed:	
Location:	Light Highway	Tape/Media #:	
Purpose:	Maintenance Related	Dia/Height:	12"
Use:	Sanitary	Material:	VCP
Drain Area:	NA	Lining:	Cured in Place
Category:	NA		
Comment:	Reverse setup. debris rollover at 18', may be brick.		
Location Details:		Direction of Survey:	Upstream
US MH:	M-706-011.6	DS MH:	M-706-011.7
		Total Length Surveyed (ft):	19.1

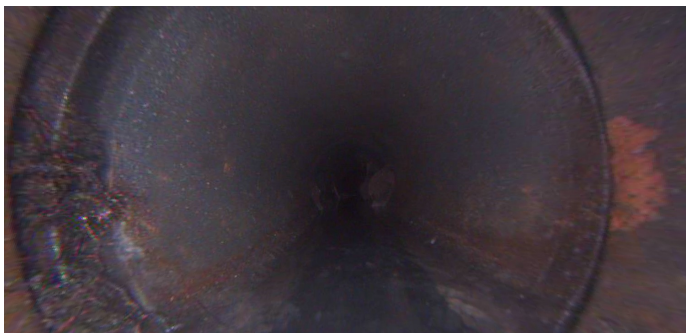
Code: **AMH**
Description: **Manhole**

Distance (ft): **.0**
Structural Grade: **0**
O&M Grade: **0**
Clock Start/From:
Clock To:
1st Value:
2nd Value:
Value Percent:
Continuous Index:
Within 8" of Joint: **NO**
Remarks: **M-706-011.7**

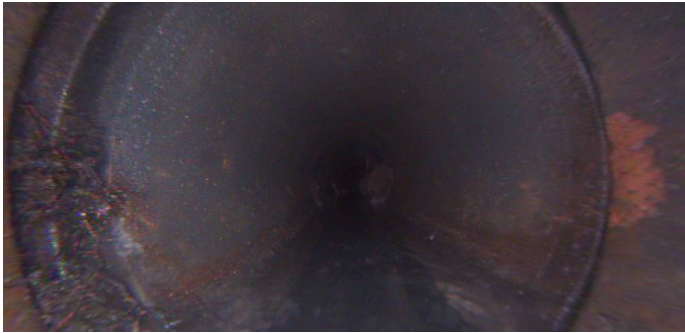
Code:	MWL
Description:	Water Level

Distance (ft):	.0
Structural Grade:	0
O&M Grade:	0
Clock Start/From:	
Clock To:	
1st Value:	
2nd Value:	
Value Percent:	5.000
Continuous Index:	
Within 8" of Joint:	NO
Remarks:

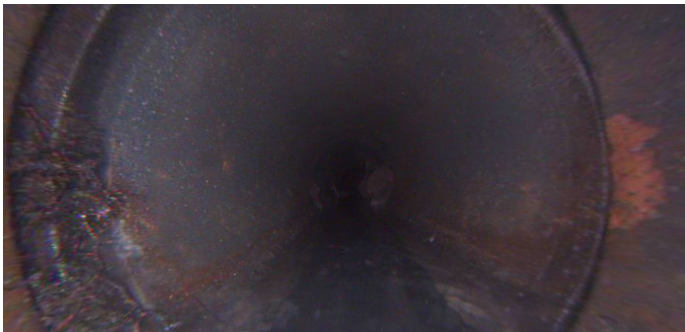
Code:	RFJ
Description:	Roots Fine Joint

Distance (ft):	.0
Structural Grade:	0
O&M Grade:	1
Clock Start/From:	8
Clock To:	9
1st Value:	
2nd Value:	
Value Percent:	
Continuous Index:	
Within 8" of Joint:	YES
Remarks:

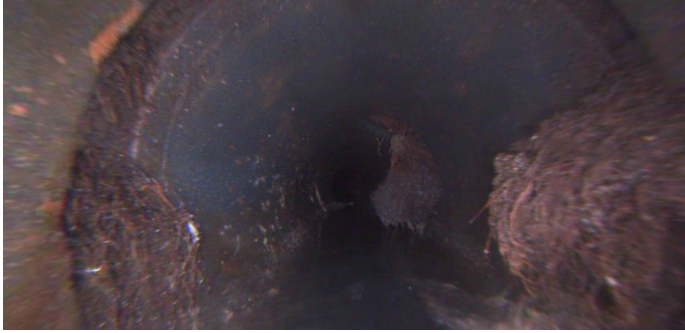
Code: **RMJ**
Description: **Roots Medium Joint**

Distance (ft): **3.1**
Structural Grade: **0**
O&M Grade: **3**
Clock Start/From: **7**
Clock To: **5**
1st Value:
2nd Value:
Value Percent: **10.000**
Continuous Index:
Within 8" of Joint: **YES**
Remarks:

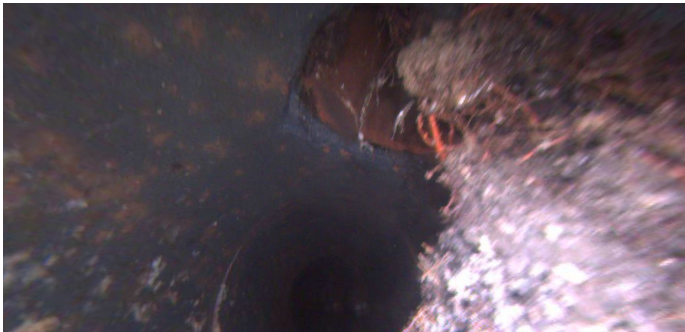
Code: **TBD**
Description: **Tap Break-in Defective**

Distance (ft): **4.2**
Structural Grade: **0**
O&M Grade: **3**
Clock Start/From: **1**
Clock To:
1st Value: **4.000**
2nd Value:
Value Percent:
Continuous Index:
Within 8" of Joint:
Remarks: **rml**

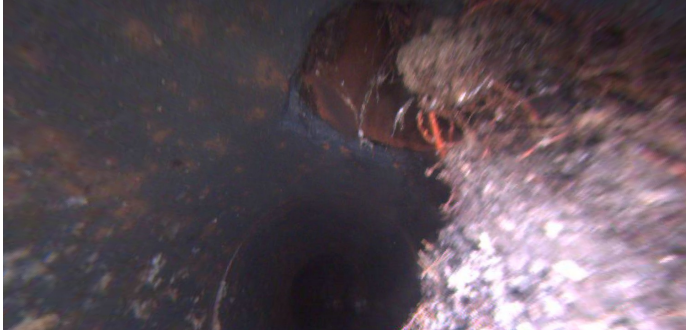
Code: **RML**
Description: **Roots Medium Lateral**

Distance (ft): **4.2**
Structural Grade: **0**
O&M Grade: **3**
Clock Start/From: **1**
Clock To: **6**
1st Value:
2nd Value:
Value Percent: **30.000**
Continuous Index:
Within 8" of Joint: **NO**
Remarks:

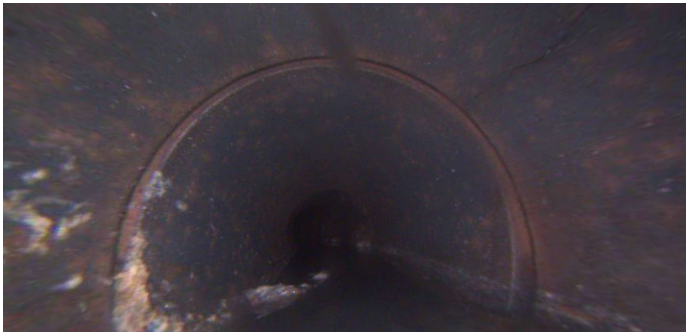
Code: **FL**
Description: **Fracture Longitudinal**

Distance (ft): **4.8**
Structural Grade: **3**
O&M Grade: **0**
Clock Start/From: **1**
Clock To:
1st Value:
2nd Value:
Value Percent:
Continuous Index:
Within 8" of Joint: **YES**
Remarks:

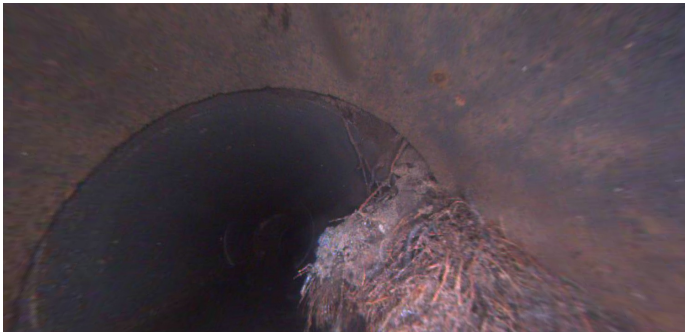
Code: **RMJ**
Description: **Roots Medium Joint**

Distance (ft): **8.8**
Structural Grade: **0**
O&M Grade: **3**
Clock Start/From: **1**
Clock To: **4**
1st Value:
2nd Value:
Value Percent: **20.000**
Continuous Index:
Within 8" of Joint: **YES**
Remarks:

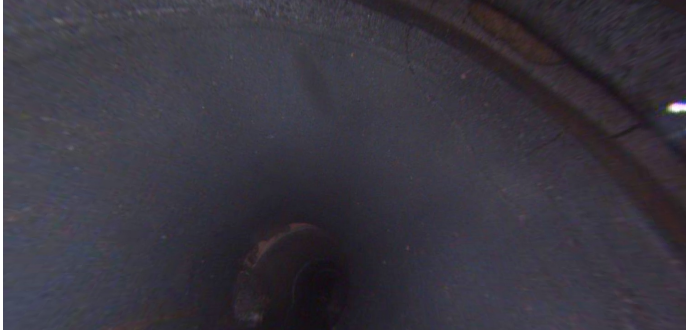
Code: **FM**
Description: **Fracture Multiple**

Distance (ft): **11.3**
Structural Grade: **4**
O&M Grade: **0**
Clock Start/From: **1**
Clock To: **3**
1st Value:
2nd Value:
Value Percent:
Continuous Index:
Within 8" of Joint: **YES**
Remarks:

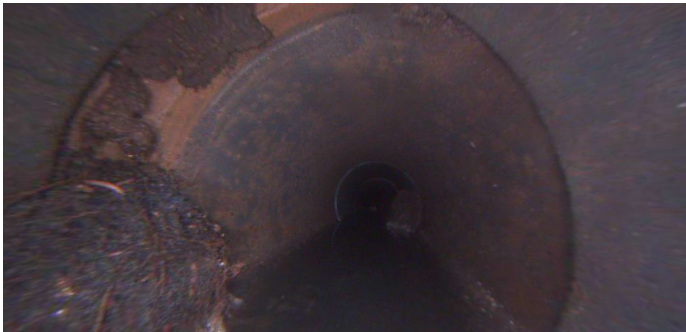
Code: **JOM**
Description: **Joint Offset Medium**

Distance (ft): **12.9**
Structural Grade: **1**
O&M Grade: **0**
Clock Start/From:
Clock To:
1st Value:
2nd Value:
Value Percent:
Continuous Index:
Within 8" of Joint: **NO**
Remarks:

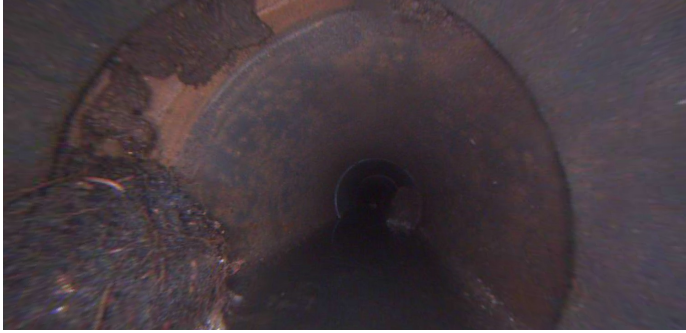
Code: **RMJ**
Description: **Roots Medium Joint**

Distance (ft): **12.9**
Structural Grade: **0**
O&M Grade: **3**
Clock Start/From: **7**
Clock To: **11**
1st Value:
2nd Value:
Value Percent: **10.000**
Continuous Index:
Within 8" of Joint: **YES**
Remarks:

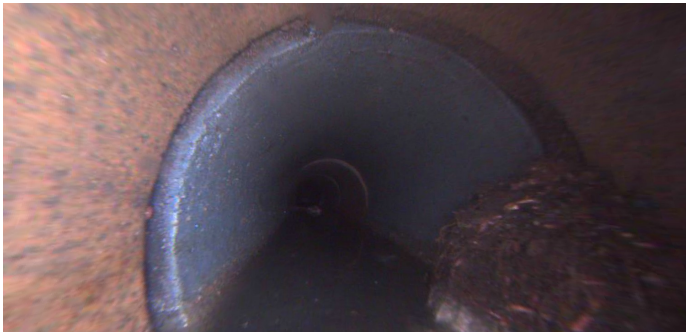
Code: **RMJ**
Description: **Roots Medium Joint**

Distance (ft): **15.0**
Structural Grade: **0**
O&M Grade: **3**
Clock Start/From: **3**
Clock To: **5**
1st Value:
2nd Value:
Value Percent: **15.000**
Continuous Index:
Within 8" of Joint: **YES**
Remarks:

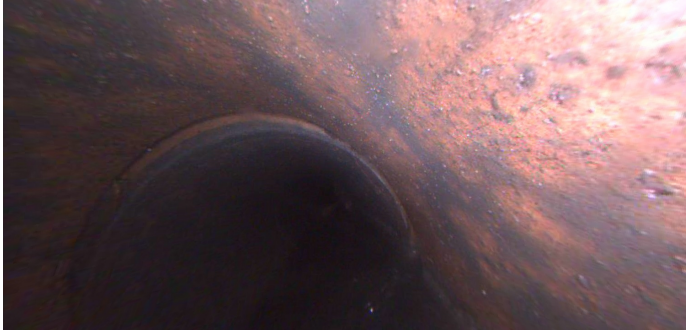
Code: **RFJ**
Description: **Roots Fine Joint**

Distance (ft): **19.1**
Structural Grade: **0**
O&M Grade: **1**
Clock Start/From: **8**
Clock To: **11**
1st Value:
2nd Value:
Value Percent:
Continuous Index:
Within 8" of Joint: **YES**
Remarks:

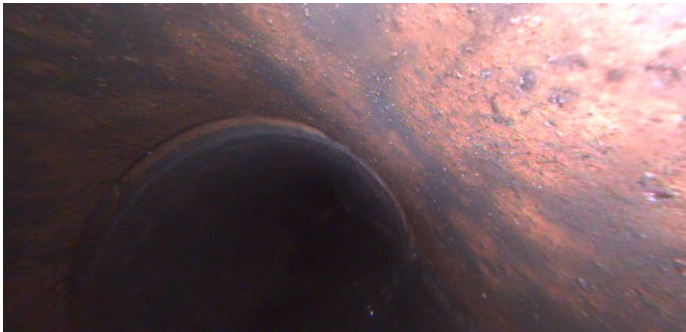
Code: **MSA**
Description: **Abandoned Survey**

Distance (ft): **19.1**
Structural Grade: **0**
O&M Grade: **0**
Clock Start/From:
Clock To:
1st Value:
2nd Value:
Value Percent:
Continuous Index:
Within 8" of Joint: **NO**
Remarks: **roots**
