## Profile/Photo Observation Report

Date:	<b>04/29/2018</b>	Weather:		Coding:	<b>PACP 6.0</b>
Pipe Length (ft):		Owner:	<b>City of Hobart</b>	Pre Clean:	<b>Not Known</b>
P.O.#:	<b>259</b>	Surveyor:	<b>B. Helbling</b>	PSR:	<b>P-706-011.8-011.7</b>
Customer:	<b>City of Hobart</b>	Clean Date:		Shape:	<b>C</b>

Street:	<b>Lake Street</b>	Flow Control:	<b>Not Controlled</b>
City:	<b>Hobart, IN</b>	Year Renewed:	
Location:	<b>Light Highway</b>	Tape/Media #:	<b>DEP259</b>
Purpose:	<b>Routine Assessment</b>	Dia/Height:	<b>12"</b>
Use:	<b>Sanitary</b>	Material:	<b>VCP</b>
Drain Area:		Lining:	
Category:	<b>NA</b>		
Comment:	<b>5-21-2018</b>		
Location Details:		Direction of Survey:	<b>Upstream</b>
US MH:	<b>M-706-011.7</b>	DS MH:	<b>M-706-011.8</b>
		Total Length Surveyed (ft):	<b>47.6</b>

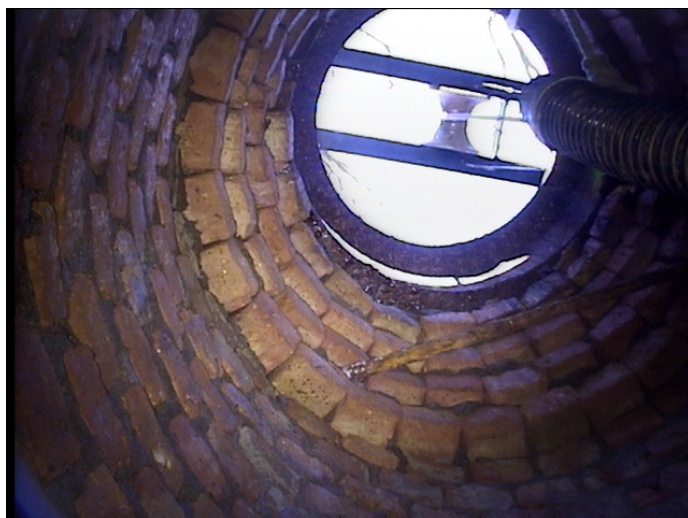
Code: **AMH**  
 Description: **Manhole**

Distance (ft): **.0**  
 Structural Grade: **0**  
 O&M Grade: **0**  
 Clock Start/From:  
 Clock To:  
 1st Value:  
 2nd Value:  
 Value Percent:  
 Continuous Index:  
 Within 8" of Joint: **NO**  
 Remarks: **M-706-011.7**

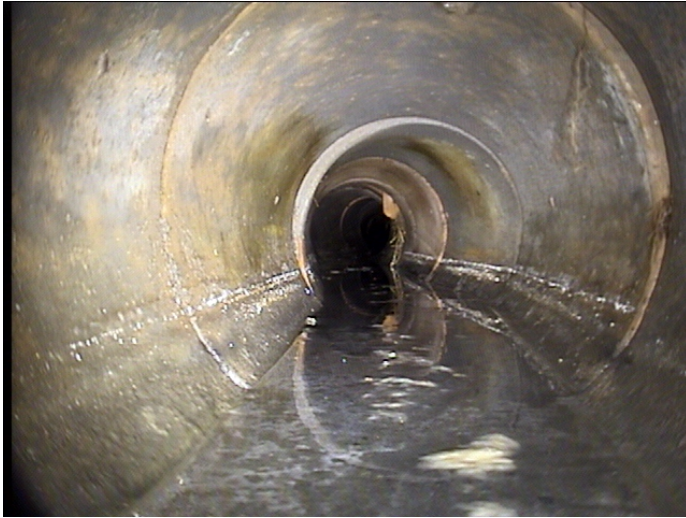
Code: **MWL**  
Description: **Water Level**

Distance (ft): **.0**  
Structural Grade: **0**  
O&M Grade: **0**  
Clock Start/From:  
Clock To:  
1st Value:  
2nd Value:  
Value Percent: **5.000**  
Continuous Index:  
Within 8" of Joint: **NO**  
Remarks:

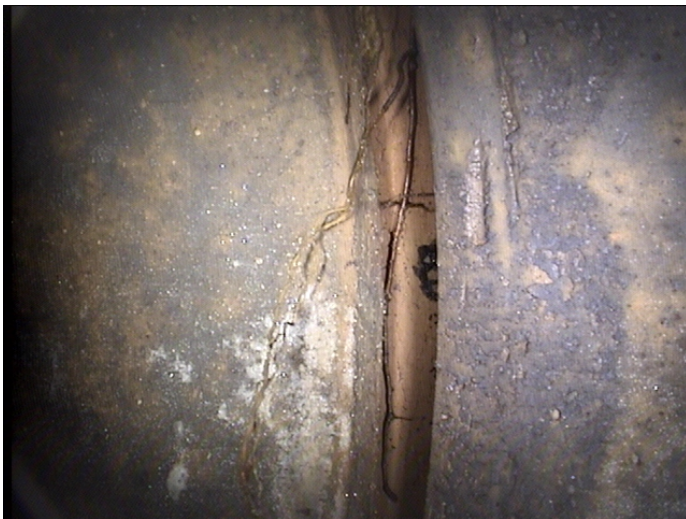
Code: **RFJ**  
Description: **Roots Fine Joint**

Distance (ft): **.0**  
Structural Grade: **0**  
O&M Grade: **1**  
Clock Start/From: **2**  
Clock To:  
1st Value:  
2nd Value:  
Value Percent:  
Continuous Index:  
Within 8" of Joint: **YES**  
Remarks:

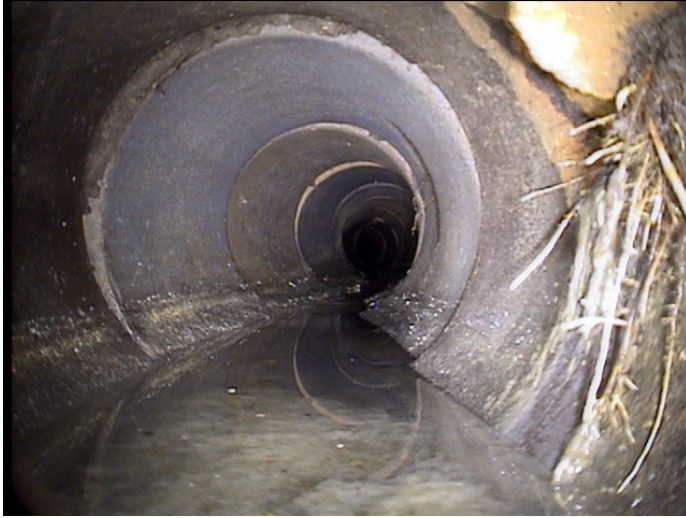
Code: **DSF**  
Description: **Deposits Settled Fine**

Distance (ft): **5.0**  
Structural Grade: **0**  
O&M Grade: **2**  
Clock Start/From: **5**  
Clock To: **7**  
1st Value:  
2nd Value:  
Value Percent: **5.000**  
Continuous Index: **S01**  
Within 8" of Joint: **NO**  
Remarks:

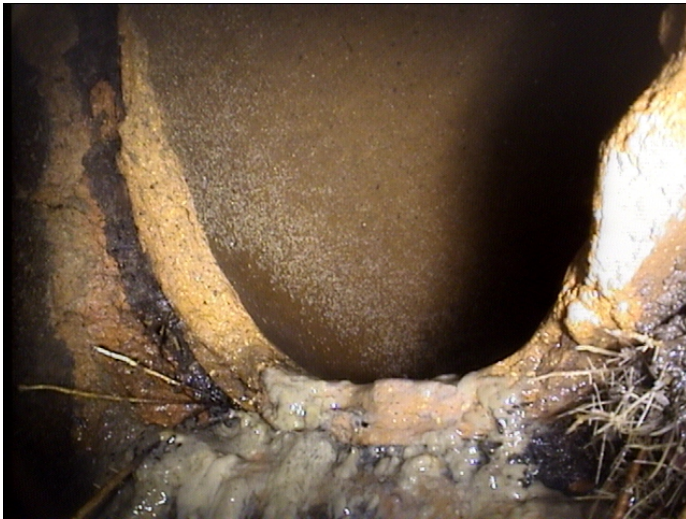
Code: **TBD**  
Description: **Tap Break-in Defective**

Distance (ft): **5.9**  
Structural Grade: **0**  
O&M Grade: **3**  
Clock Start/From: **2**  
Clock To:  
1st Value: **6.000**  
2nd Value:  
Value Percent:  
Continuous Index:  
Within 8" of Joint: **NO**  
Remarks: **Defective**

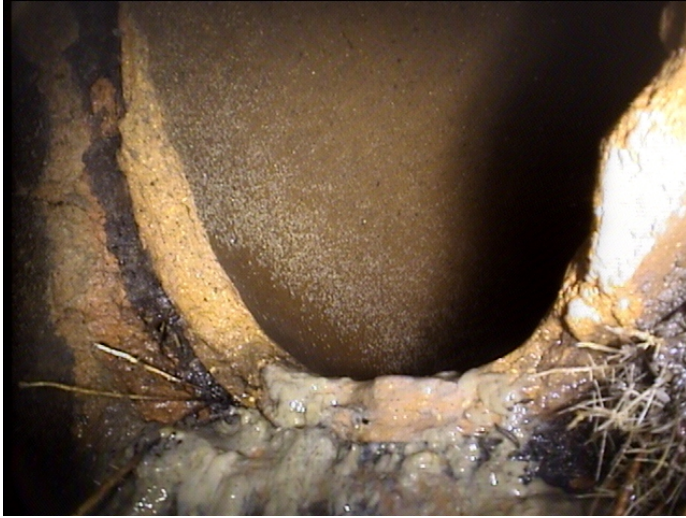
Code:	<b>RFL</b>
Description:	<b>Roots Fine Lateral</b>
Distance (ft):	<b>5.9</b>
Structural Grade:	<b>0</b>
O&M Grade:	<b>1</b>
Clock Start/From:	<b>2</b>
Clock To:	
1st Value:	
2nd Value:	
Value Percent:	
Continuous Index:	
Within 8" of Joint:	<b>NO</b>
Remarks:

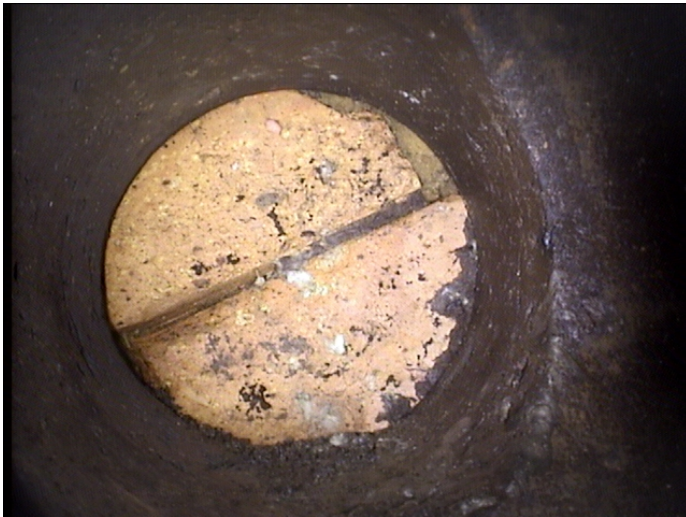
Code:	<b>TFC</b>
Description:	<b>Tap Factory Capped</b>
Distance (ft):	<b>5.9</b>
Structural Grade:	<b>0</b>
O&M Grade:	<b>0</b>
Clock Start/From:	<b>10</b>
Clock To:	
1st Value:	<b>4.000</b>
2nd Value:	
Value Percent:	
Continuous Index:	
Within 8" of Joint:	<b>NO</b>
Remarks:

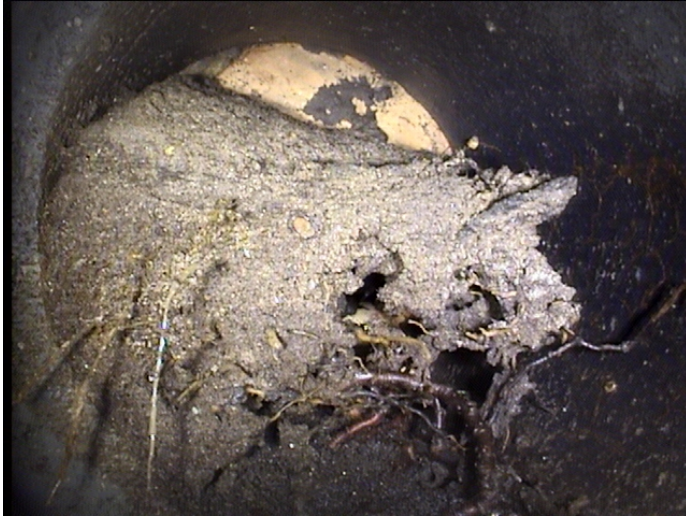
Code: **TFC**  
Description: **Tap Factory Capped**

Distance (ft): **8.2**  
Structural Grade: **0**  
O&M Grade: **0**  
Clock Start/From: **2**  
Clock To:  
1st Value: **4.000**  
2nd Value:  
Value Percent:  
Continuous Index:  
Within 8" of Joint: **NO**  
Remarks:

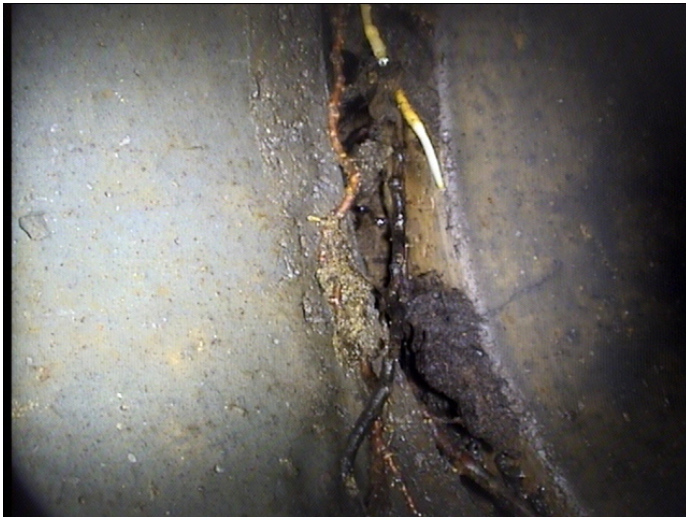
Code: **RFJ**  
Description: **Roots Fine Joint**

Distance (ft): **27.4**  
Structural Grade: **0**  
O&M Grade: **1**  
Clock Start/From: **9**  
Clock To:  
1st Value:  
2nd Value:  
Value Percent:  
Continuous Index:  
Within 8" of Joint: **YES**  
Remarks:

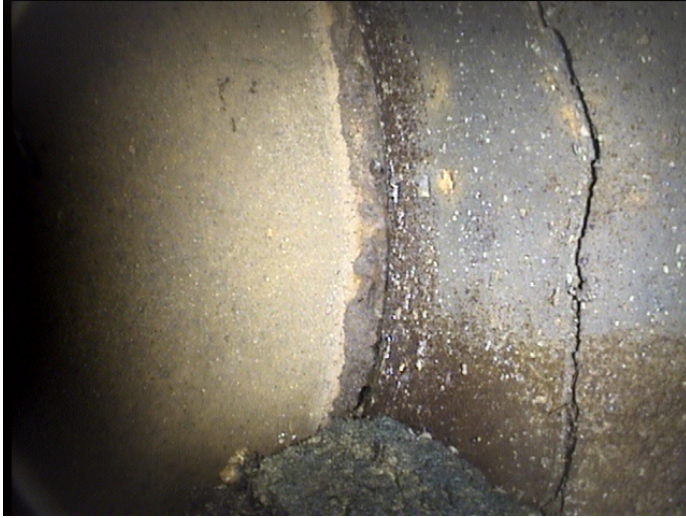
Code: **FM**  
Description: **Fracture Multiple**

Distance (ft): **31.4**  
Structural Grade: **4**  
O&M Grade: **0**  
Clock Start/From: **2**  
Clock To: **5**  
1st Value:  
2nd Value:  
Value Percent:  
Continuous Index:  
Within 8" of Joint: **NO**  
Remarks:

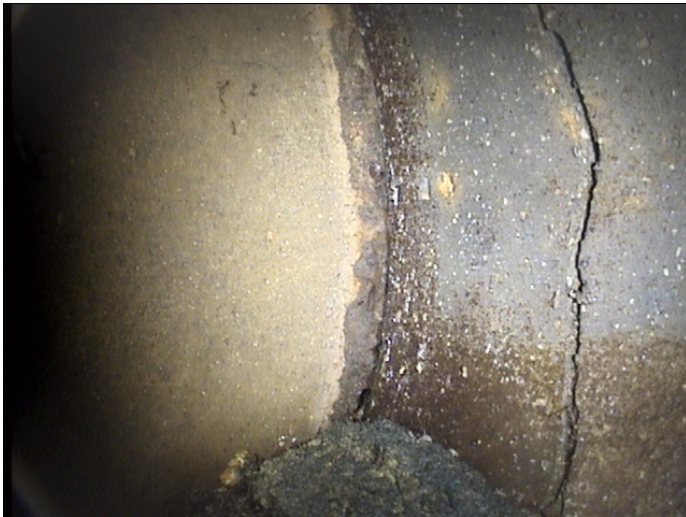
Code: **RFJ**  
Description: **Roots Fine Joint**

Distance (ft): **31.4**  
Structural Grade: **0**  
O&M Grade: **1**  
Clock Start/From: **3**  
Clock To:  
1st Value:  
2nd Value:  
Value Percent:  
Continuous Index:  
Within 8" of Joint: **YES**  
Remarks:

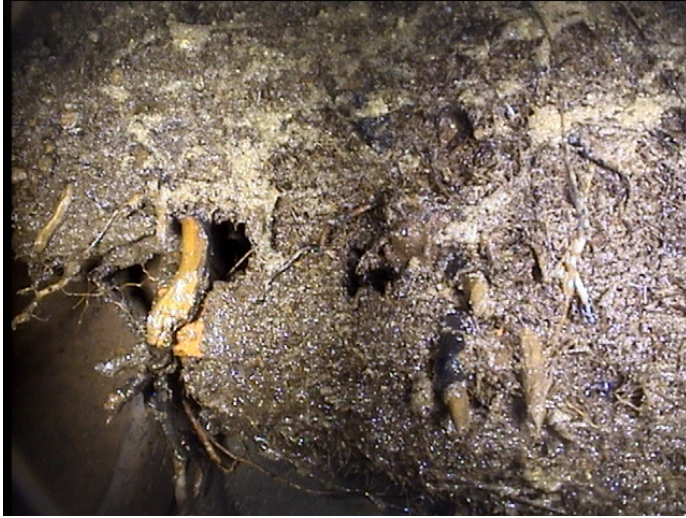
Code: **RMJ**  
Description: **Roots Medium Joint**

Distance (ft): **43.9**  
Structural Grade: **0**  
O&M Grade: **3**  
Clock Start/From: **2**  
Clock To: **5**  
1st Value:  
2nd Value:  
Value Percent: **5.000**  
Continuous Index:  
Within 8" of Joint: **YES**  
Remarks:

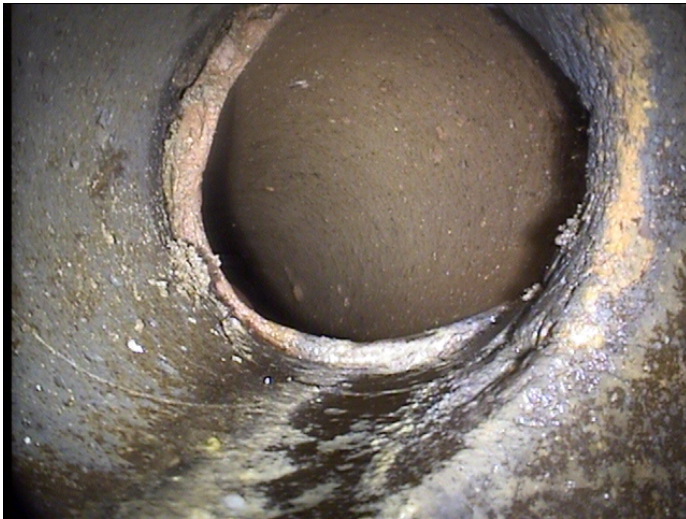
Code: **TF**  
Description: **Tap Factory**

Distance (ft): **47.6**  
Structural Grade: **0**  
O&M Grade: **0**  
Clock Start/From: **10**  
Clock To:  
1st Value: **4.000**  
2nd Value:  
Value Percent:  
Continuous Index:  
Within 8" of Joint: **NO**  
Remarks:

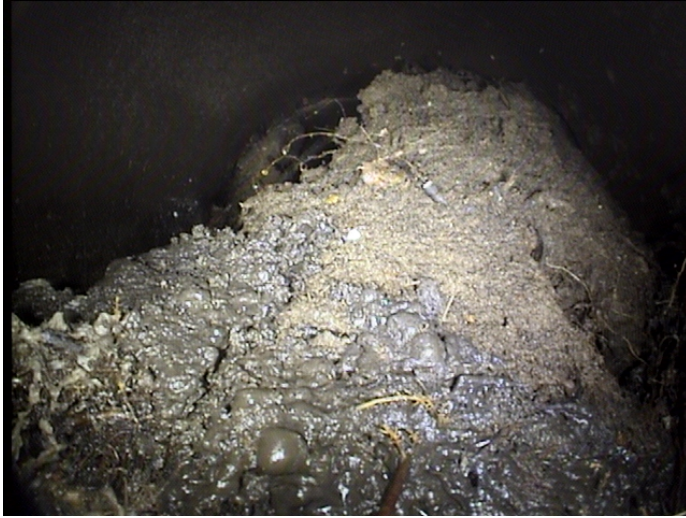
Code: **RBJ**  
Description: **Roots Ball Joint**

Distance (ft): **47.6**  
Structural Grade: **0**  
O&M Grade: **4**  
Clock Start/From: **2**  
Clock To: **9**  
1st Value:  
2nd Value:  
Value Percent: **55.000**  
Continuous Index:  
Within 8" of Joint: **YES**  
Remarks:

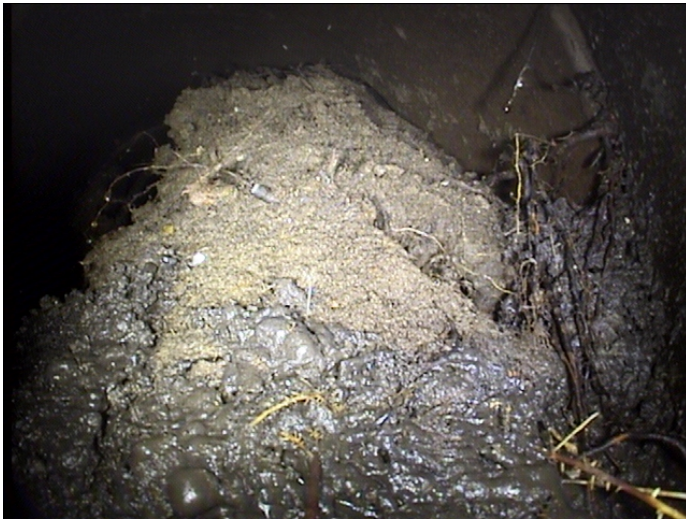
Code: **DSF**  
Description: **Deposits Settled Fine**

Distance (ft): **47.6**  
Structural Grade: **0**  
O&M Grade: **2**  
Clock Start/From: **5**  
Clock To: **7**  
1st Value:  
2nd Value:  
Value Percent: **5.000**  
Continuous Index: **F01**  
Within 8" of Joint: **NO**  
Remarks:

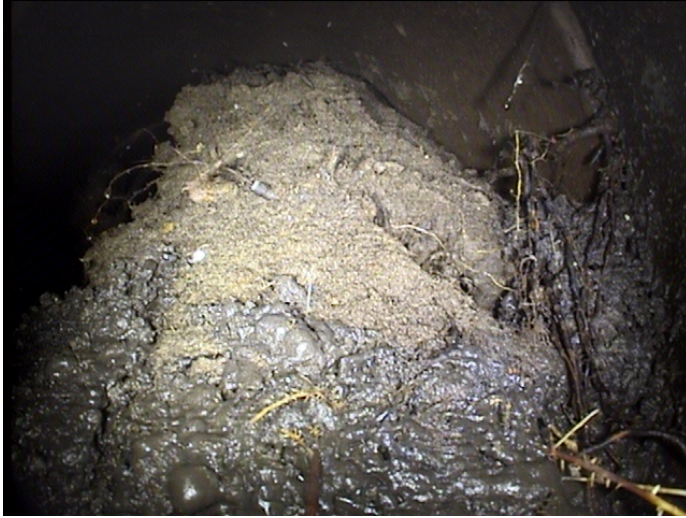
Code:	<b>MSA</b>
Description:	<b>Abandoned Survey</b>
Distance (ft):	<b>47.6</b>
Structural Grade:	<b>0</b>
O&M Grade:	<b>0</b>
Clock Start/From:	
Clock To:	
1st Value:	
2nd Value:	
Value Percent:	
Continuous Index:	
Within 8" of Joint:	<b>NO</b>
Remarks:	<b>Rootball</b>
