## Profile/Photo Observation Report

Street:	<b>E 8TH ST &amp; WATER ST</b>	Flow Control:	<b>Not Controlled</b>
City:	<b>Hobart, IN</b>	Year Renewed:	
Location:	<b>Light Highway</b>	Tape/Media #:	
Purpose:	<b>Maintenance Related</b>	Dia/Height:	<b>12"</b>
Use:	<b>Sanitary</b>	Material:	<b>PVC</b>
Drain Area:	<b>NA</b>	Lining:	<b>Cured in Place</b>
Category:	<b>NA</b>		
Comment:	<b>Reverse setup. blk silt at 101'.</b>		
Location Details:		Direction of Survey:	<b>Upstream</b>
US MH:	<b>M-706-013</b>	DS MH:	<b>M-706-013.1</b>
		Total Length Surveyed (ft):	<b>102.9</b>

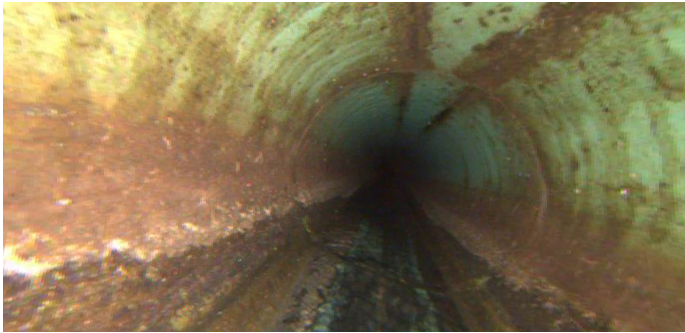
Code:	<b>MWL</b>
Description:	<b>Water Level</b>

Distance (ft):	<b>.0</b>
Structural Grade:	<b>0</b>
O&M Grade:	<b>0</b>
Clock Start/From:	
Clock To:	
1st Value:	
2nd Value:	
Value Percent:	<b>5.000</b>
Continuous Index:	
Within 8" of Joint:	<b>NO</b>
Remarks:

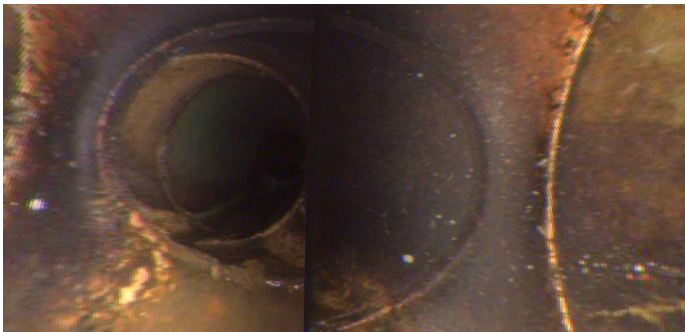
Code:	<b>TF</b>
Description:	<b>Tap Factory</b>

Distance (ft):	<b>53.8</b>
Structural Grade:	<b>0</b>
O&M Grade:	<b>0</b>
Clock Start/From:	<b>9</b>
Clock To:	
1st Value:	<b>4.000</b>
2nd Value:	
Value Percent:	
Continuous Index:	
Within 8" of Joint:	<b>YES</b>
Remarks:

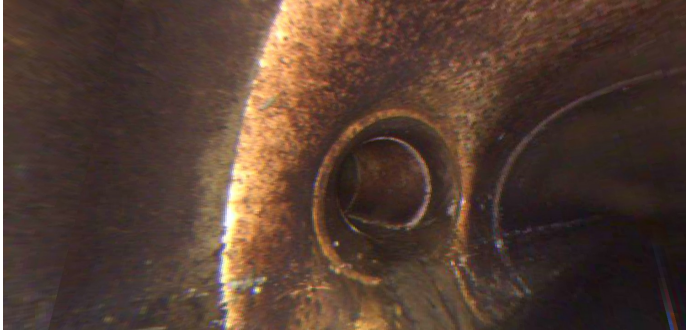
Code: **TF**  
Description: **Tap Factory**

Distance (ft): **63.7**  
Structural Grade: **0**  
O&M Grade: **0**  
Clock Start/From: **3**  
Clock To:  
1st Value: **4.000**  
2nd Value:  
Value Percent:  
Continuous Index:  
Within 8" of Joint: **YES**  
Remarks:

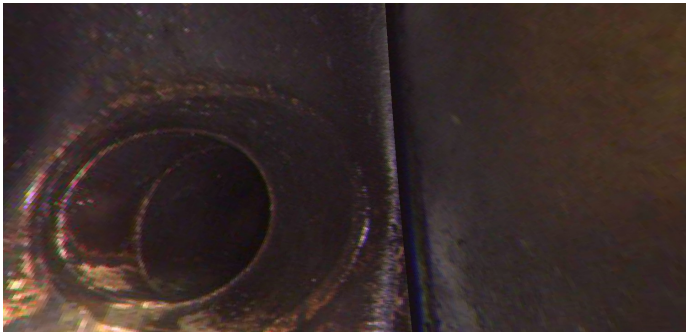
Code: **TF**  
Description: **Tap Factory**

Distance (ft): **84.6**  
Structural Grade: **0**  
O&M Grade: **0**  
Clock Start/From: **10**  
Clock To:  
1st Value: **4.000**  
2nd Value:  
Value Percent:  
Continuous Index:  
Within 8" of Joint: **YES**  
Remarks:

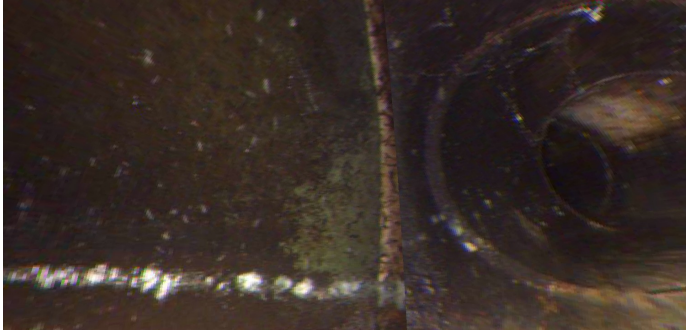
Code: **TF**  
Description: **Tap Factory**

Distance (ft): **98.2**  
Structural Grade: **0**  
O&M Grade: **0**  
Clock Start/From: **3**  
Clock To:  
1st Value: **4.000**  
2nd Value:  
Value Percent:  
Continuous Index:  
Within 8" of Joint: **YES**  
Remarks:

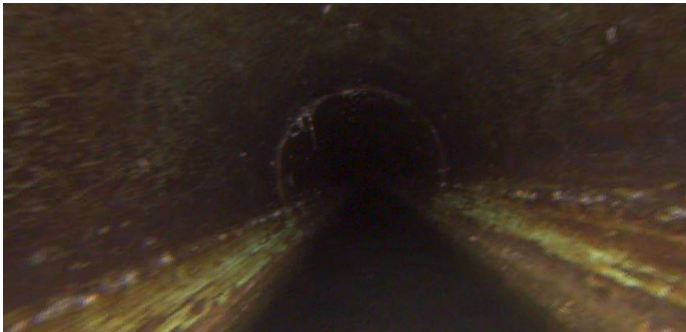
Code: **MSA**  
Description: **Abandoned Survey**

Distance (ft): **102.9**  
Structural Grade: **0**  
O&M Grade: **0**  
Clock Start/From:  
Clock To:  
1st Value:  
2nd Value:  
Value Percent:  
Continuous Index:  
Within 8" of Joint: **NO**  
Remarks: **no blockage**
