Profile/Photo Observation Report

Street:	Capitol	Flow Control:	Not Controlled
City:	Hobart, IN	Year Renewed:	
Location:	Light Highway	Tape/Media #:	
Purpose:	Maintenance Related	Dia/Height:	12"
Use:	Sanitary	Material:	PVC
Drain Area:	NA	Lining:	Cured in Place
Category:	NA		
Comment:	Debris pile at 20'.

Location Details:		Direction of Survey:	Downstream
US MH:	M-706-013.1	DS MH:	M-706-013.2
		Total Length Surveyed (ft):	21.4

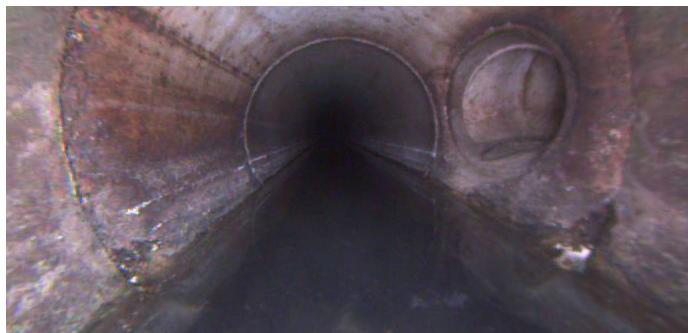
Code: **AMH**
Description: **Manhole**

Distance (ft): **.0**
Structural Grade: **0**
O&M Grade: **0**
Clock Start/From:
Clock To:
1st Value:
2nd Value:
Value Percent:
Continuous Index:
Within 8" of Joint: **NO**
Remarks: **M-706-013.1**

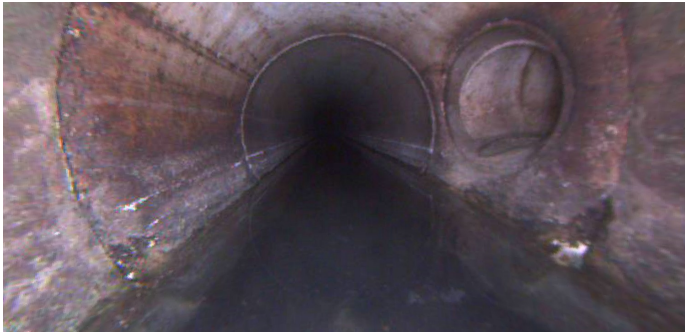
Code:	MWL
Description:	Water Level

Distance (ft):	.0
Structural Grade:	0
O&M Grade:	0
Clock Start/From:	
Clock To:	
1st Value:	
2nd Value:	
Value Percent:	10.000
Continuous Index:	
Within 8" of Joint:	NO
Remarks:

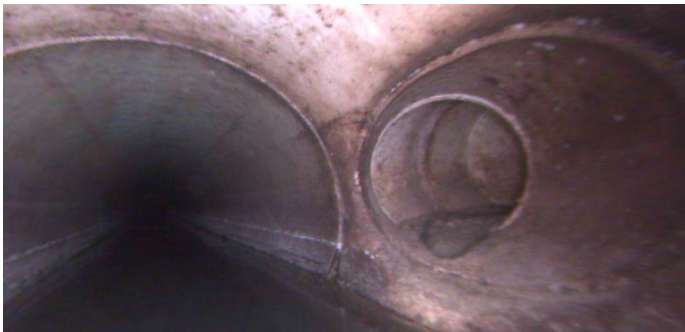
Code:	TF
Description:	Tap Factory

Distance (ft):	2.0
Structural Grade:	0
O&M Grade:	0
Clock Start/From:	3
Clock To:	
1st Value:	4.000
2nd Value:	
Value Percent:	
Continuous Index:	
Within 8" of Joint:	
Remarks:

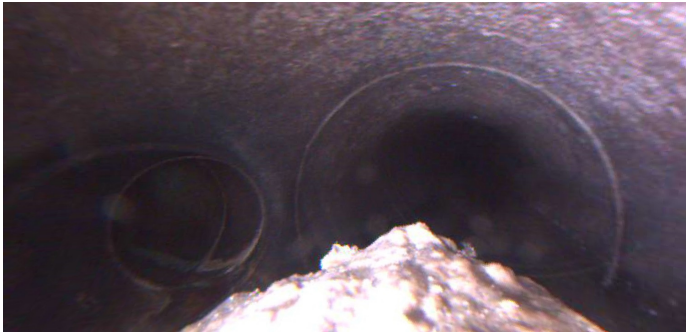
Code: **TFA**
Description: **Tap Factory Active**

Distance (ft): **20.3**
Structural Grade: **0**
O&M Grade: **0**
Clock Start/From: **9**
Clock To:
1st Value: **4.000**
2nd Value:
Value Percent:
Continuous Index:
Within 8" of Joint:
Remarks:

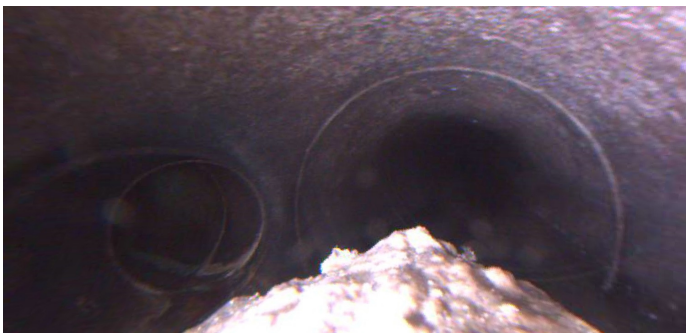
Code: **DSZ**
Description: **Deposits Settled Other**

Distance (ft): **20.3**
Structural Grade: **0**
O&M Grade: **4**
Clock Start/From: **4**
Clock To: **8**
1st Value:
2nd Value:
Value Percent: **30.000**
Continuous Index:
Within 8" of Joint: **NO**
Remarks: **MSA**

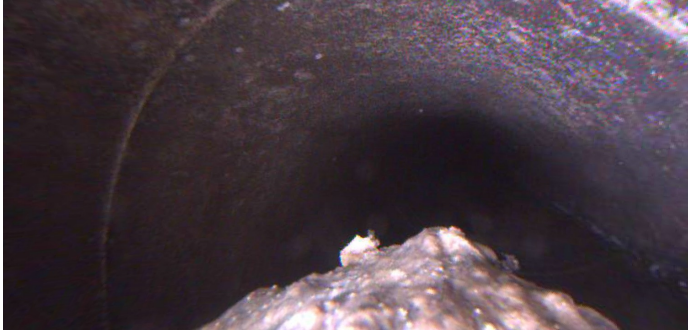
Code:	MSA
Description:	Abandoned Survey
Distance (ft):	21.4
Structural Grade:	0
O&M Grade:	0
Clock Start/From:	
Clock To:	
1st Value:	
2nd Value:	
Value Percent:	
Continuous Index:	
Within 8" of Joint:	NO
Remarks:	DSZ
